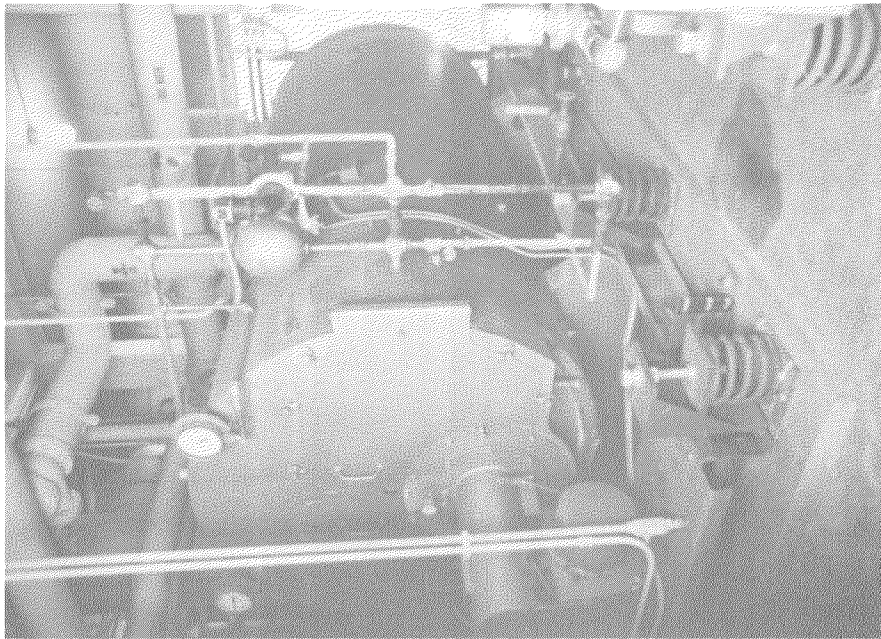
Fig. 8.14 Boiler on top of six-story Phelps Hall, UCSB. Vibration isolation supports were not damaged.

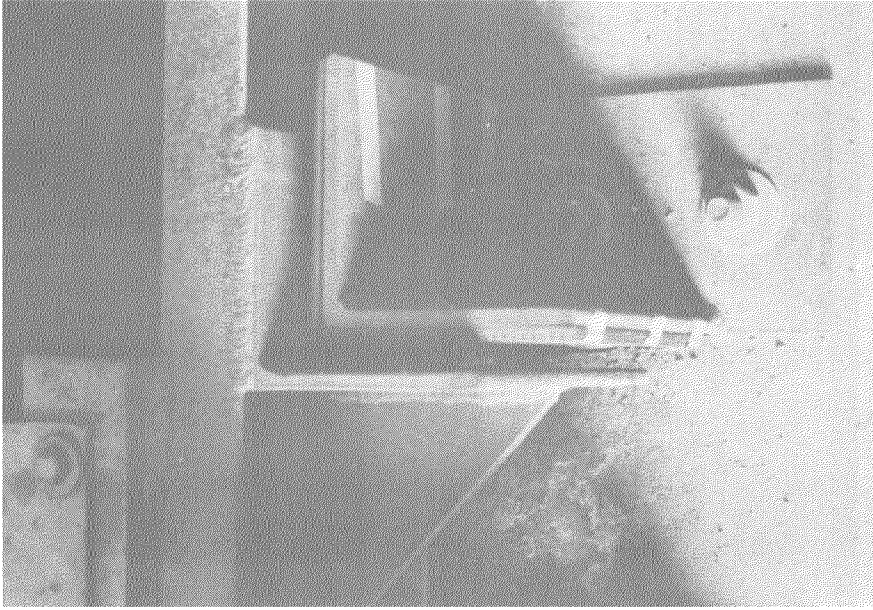
Fig. 8.15 Overhead close up of seismic restraint on boiler (Fig. 8.14).
