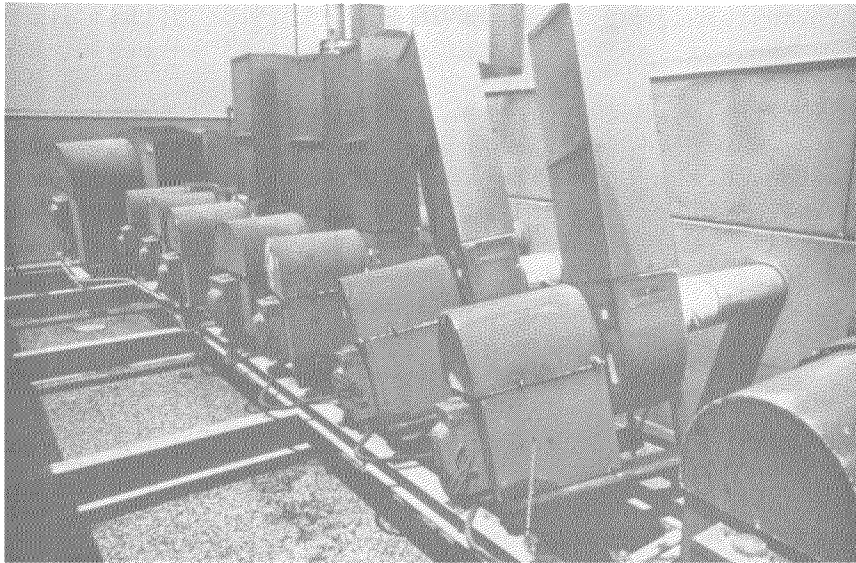
Fig. 8.16 Fans dislodged from their vibration isolation supports on top of Biological Sciences II, UCSB (see Fig. 3.14).

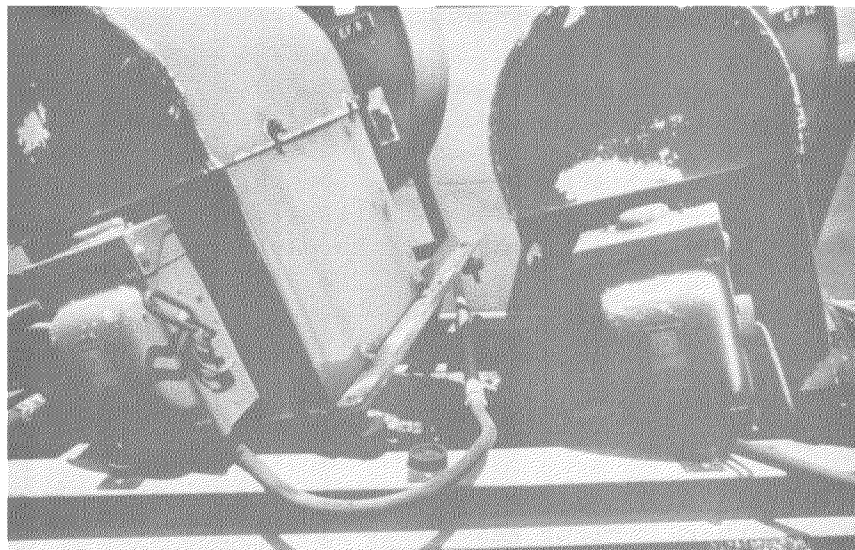
Fig. 8.17 Close up of damaged supports in Fig. 8.16.
