## 9. EARTHQUAKE EFFECTS ON SOILS AND DAMS

### 9.1 Effects on Soils

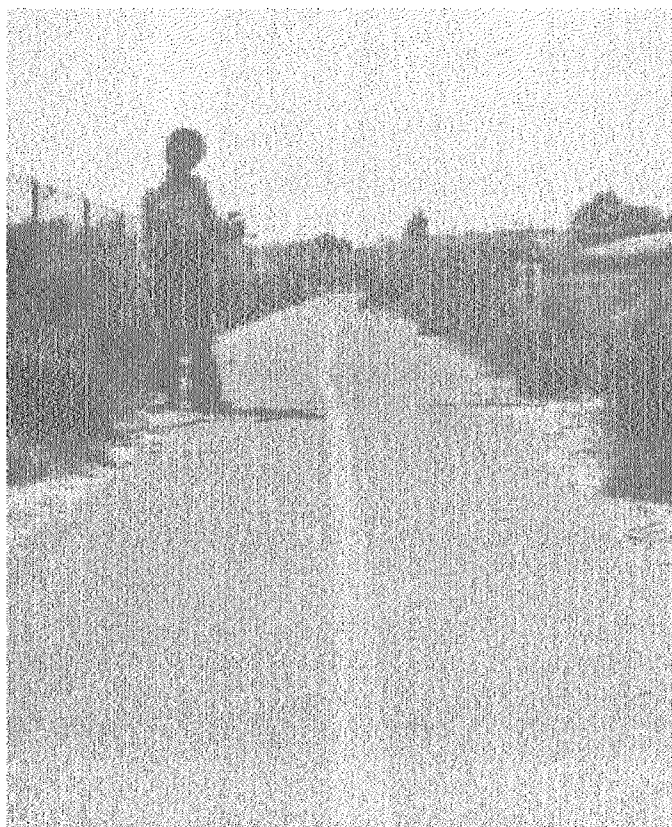
As previously noted, the major fault motion occurred offshore in the Santa Barbara Channel. Consequently, no surface traces of fault motion have been found onshore in Goleta or elsewhere. However, evidence of some extension fractures resulting from lateral spreading was found near Goleta beach near the northeast entrance to the UCSB campus. As shown in Figs. 9.1 through 9.4, several cracks opened in the bicycle path leading to the University. These cracks indicate a northward sense of slip of an arcuate slab, 200 feet long and 25 feet wide, of the south bank of the flood channel of Goleta slough. The maximum extension is approximately  $1\frac{1}{2}$  inches. No vertical relative slip was apparent. The cracks extended a considerable distance into the brush on each side of the path. Soil in this general vicinity is a relatively soft alluvial fill at the mouth of the Goleta slough.

Fig. 9.1 Extension fracture in the bicycle path north-east of UCSB. Note misalignment of centerline. Building at upper right is Biological Sciences II, UCSB. Cracks runs in a northwesterly direction.

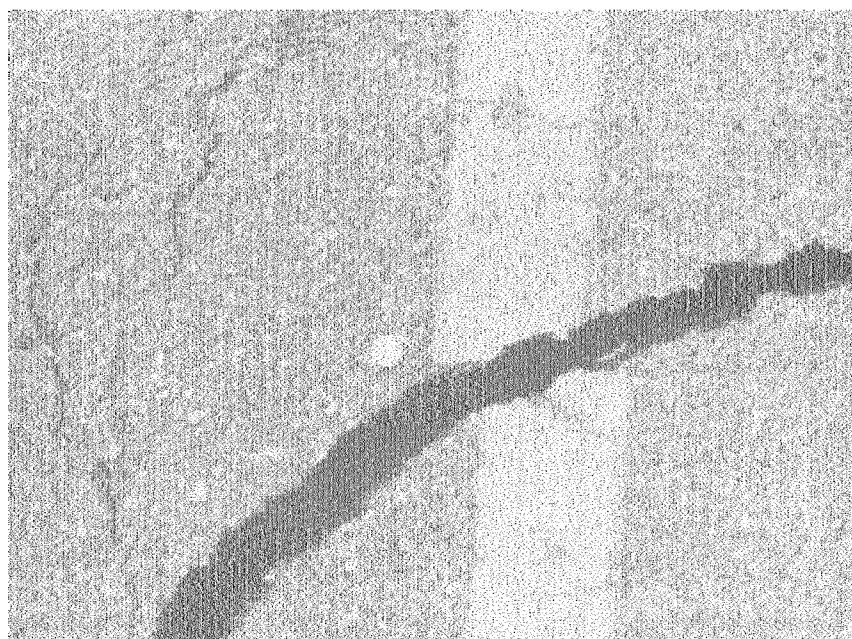
Fig. 9.2 Close up of extension fracture shown in Fig. 9.1. Scale given by the coin (quarter) in the center of the picture.
