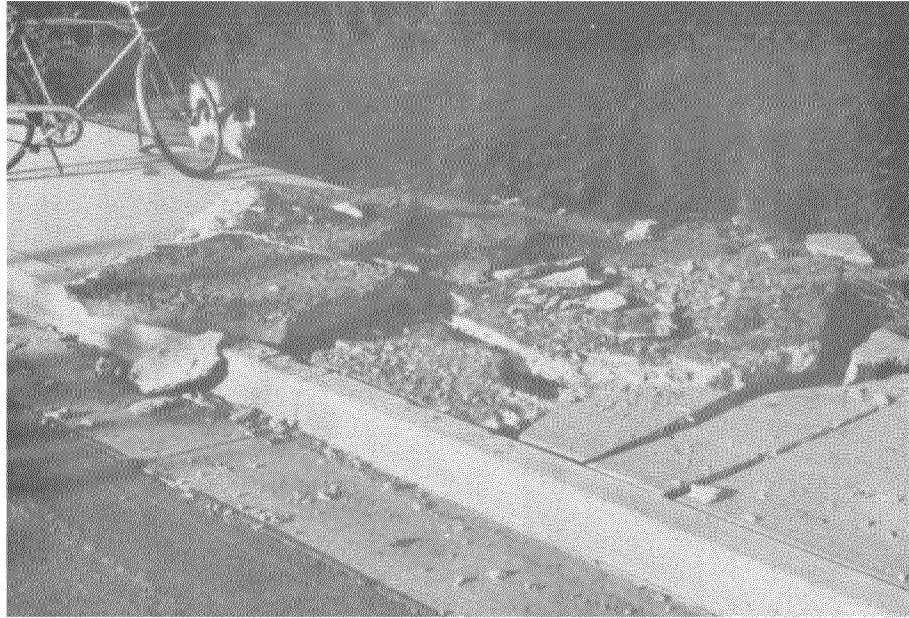
Fig. 9.7 Concrete sidewalk which buckled and fell upside down on Los Carneros Road north of Hollister Avenue, Adjacent pavement, curb, and gutter were not disturbed.

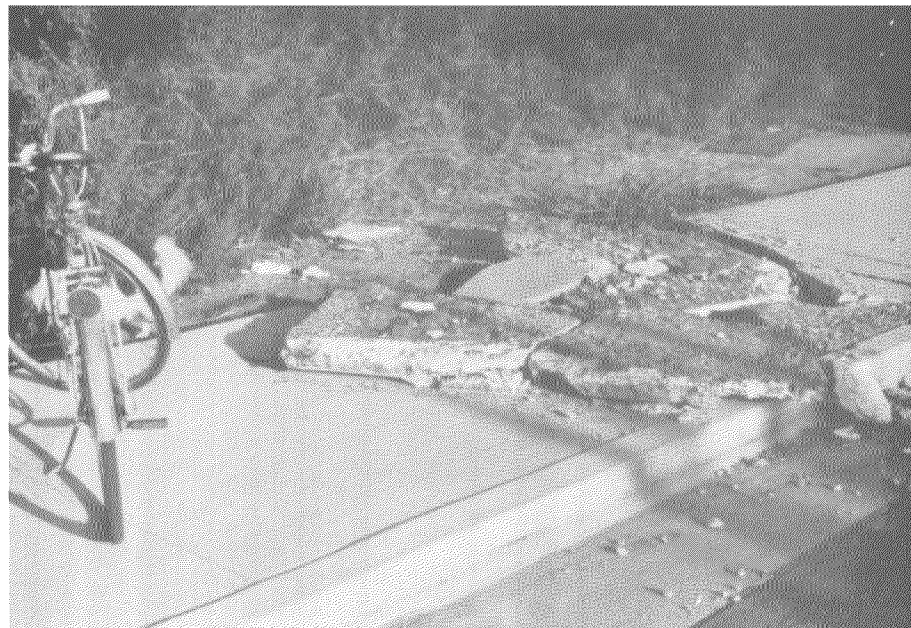
Fig. 9.8 View of sidewalk in Fig. 9.7 from opposite direction.
