9.2 Effects on Dams

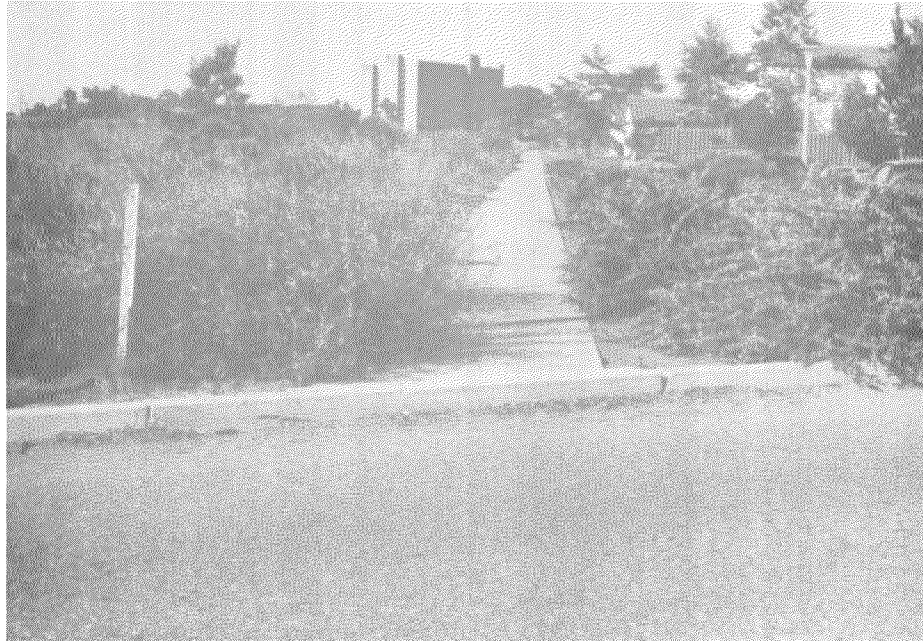
Fig. 9.9 East trending concrete sidewalk at UCSB Married Student Housing on Los Carneros Road. (View from east.)

At the facilities of Delco Electronics near the UCSB Married Student Housing shown in Figs. 9.9 and 9.10, an accurate triangulation was performed to check for relative soil displacements caused by the earthquake. The results of this survey showed that no such displacements occurred in this area.

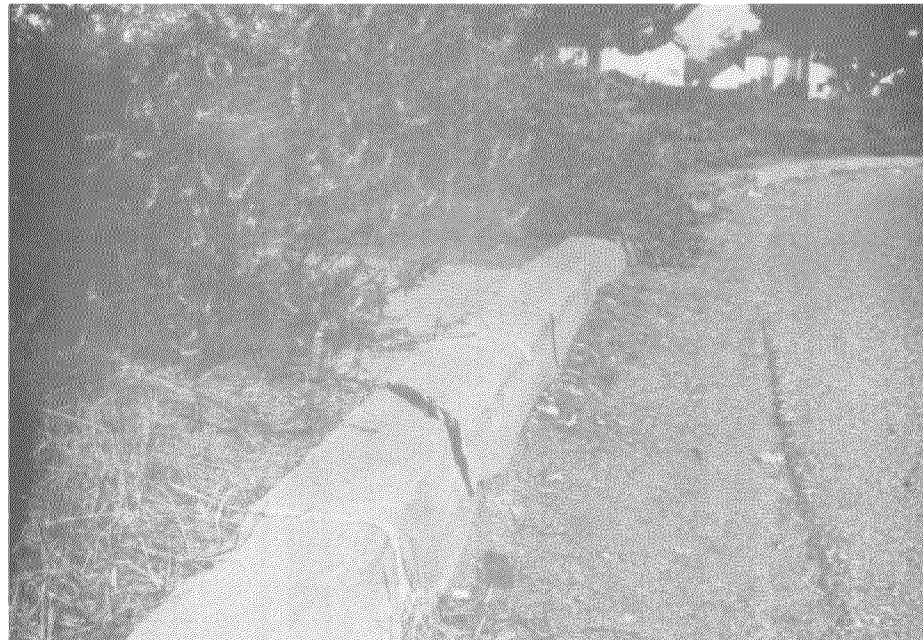
Fig. 9.10 Close up of curb push out shown in Fig. 9.9. (View from south.)

Horizontal lurching evidently thrust this sidewalk toward the pavement, fracturing the curb as shown in Fig. 9.10. An inspection of the surrounding area again revealed no evidence of surface ruptures or other damage to pavement or soil.
