11. EVIDENCE OF LOCALLY NONLINEAR BEHAVIOR OF STRUCTURES

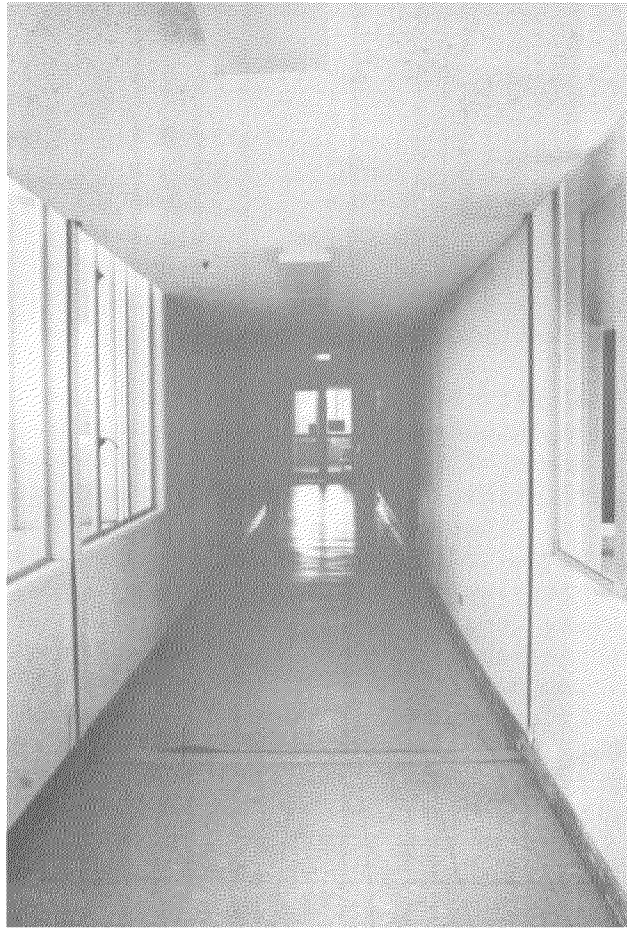
Fig. 11.1 Damage to seismic joint in South Hall, UCSB.

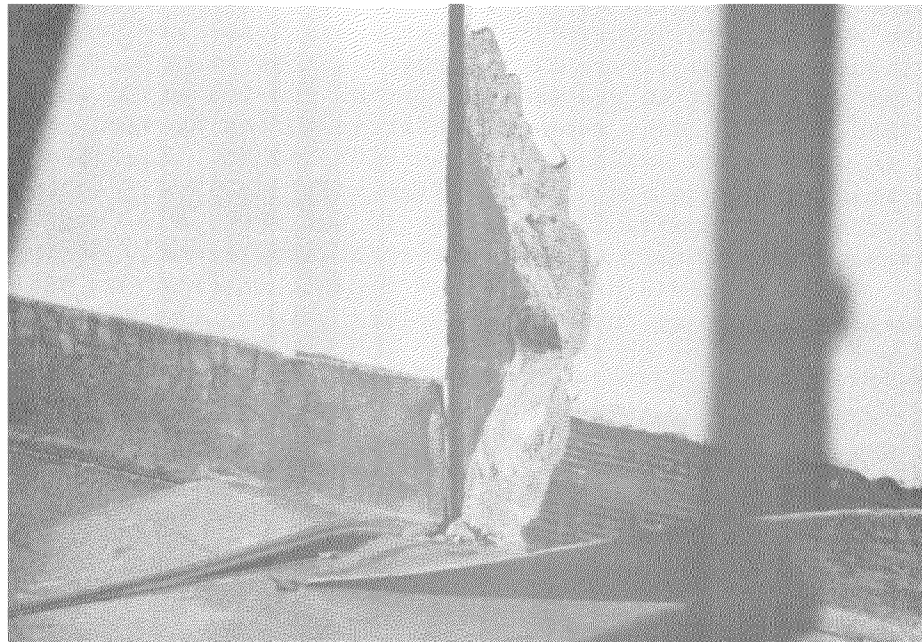
Fig. 11.2 Damage to seismic joint in South Hall, UCSB.
