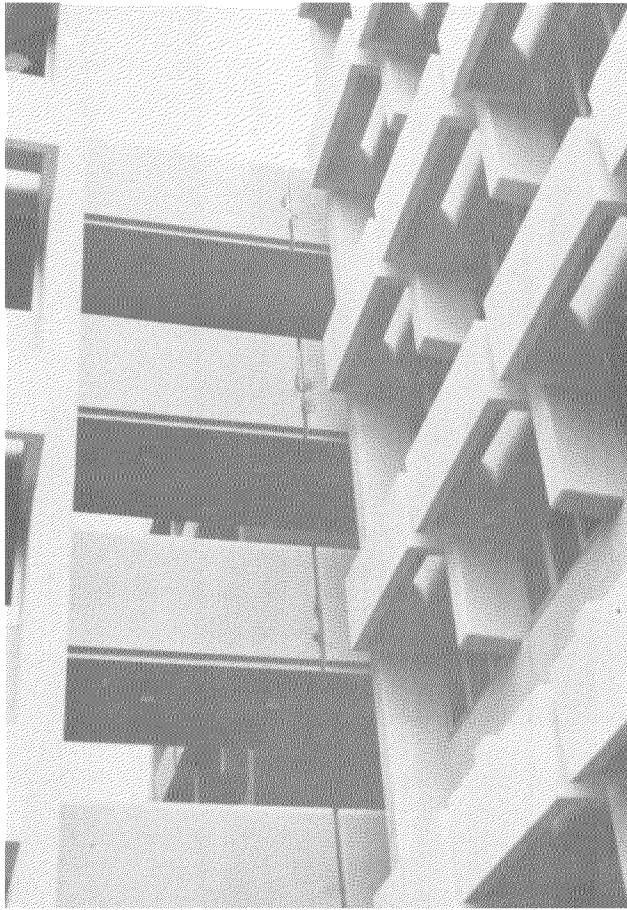
Fig. 11.5 Damage to seismic joints on third through sixth floor walkways between South Hall and the Graduate Tower, UCSB campus.

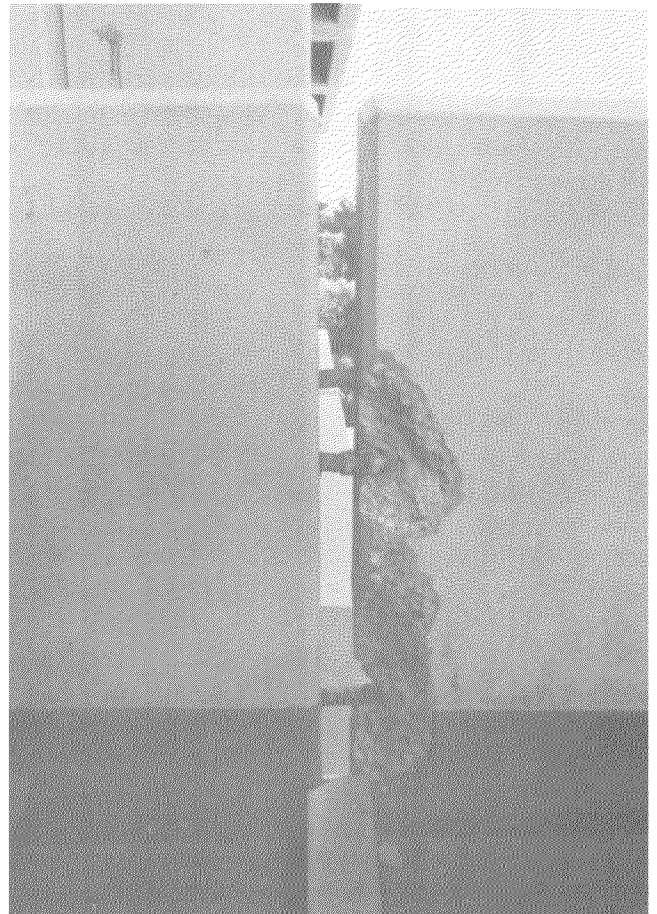
Fig. 11.6 Close up of damage to seismic joints shown in Fig. 11.5. View from inside walkway.
