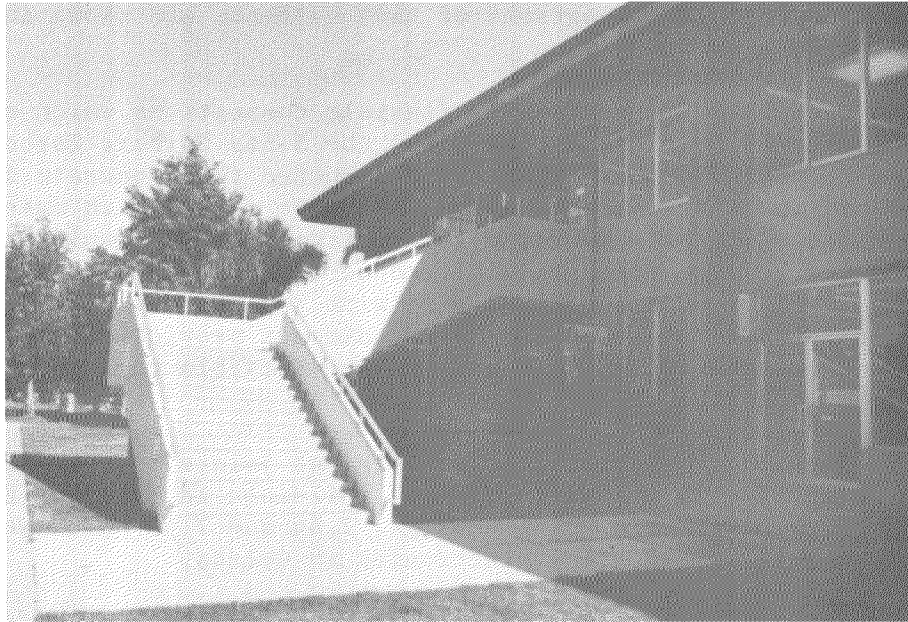
Fig. 11.7 Stairway from emergency exit on north side of UCSB Library I Building. Stairway and building are separated by a seismic joint.

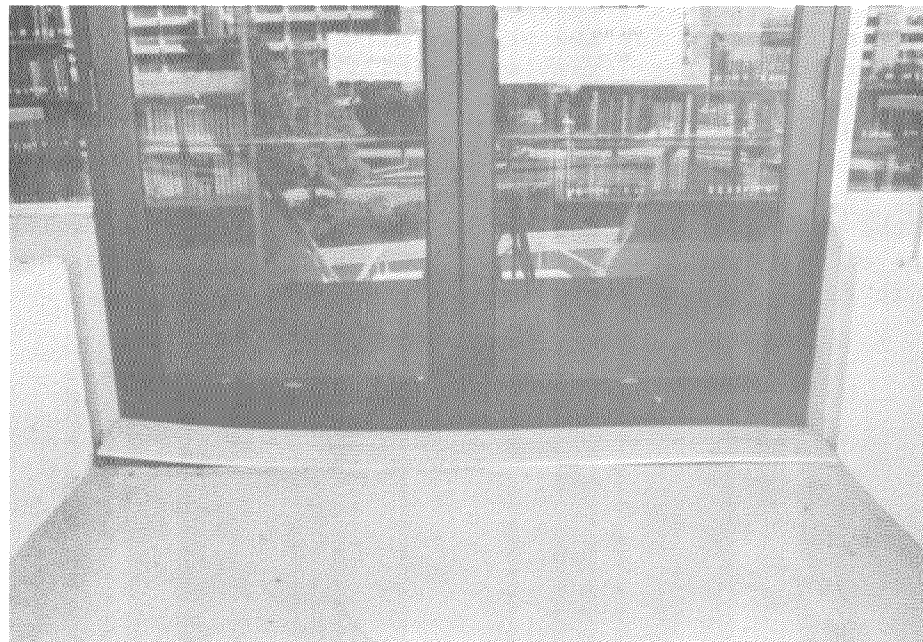
Fig. 11.8 Close-up of damage to seismic joint between stairway and building in Fig. 11.7. Note that damaged cover plate blocks the opening of emergency doors.
