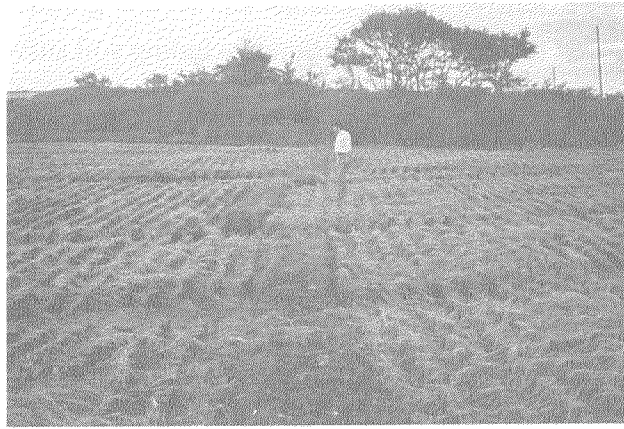
Photo 9 Fissures and Sharing of Ground Appeared in Kabutono Area  
( Area B. see Fig. 4, View to Crescent Lake taken at September 1993)

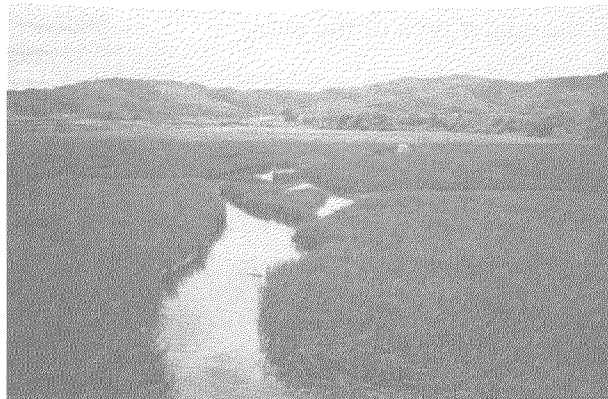
Photo 10 Fissures Appeared in Kabutono Area ( Same Place as in Photo 9.  
Taken at July 20, 1993 from right-hand side of Photo 9)

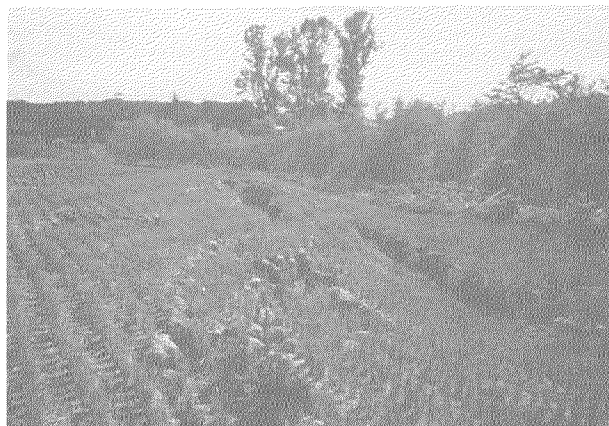
Photo 11 Fissures Appeared in Aichi Area ( Area D, see Fig. 4.Edge of Crescent Lake)

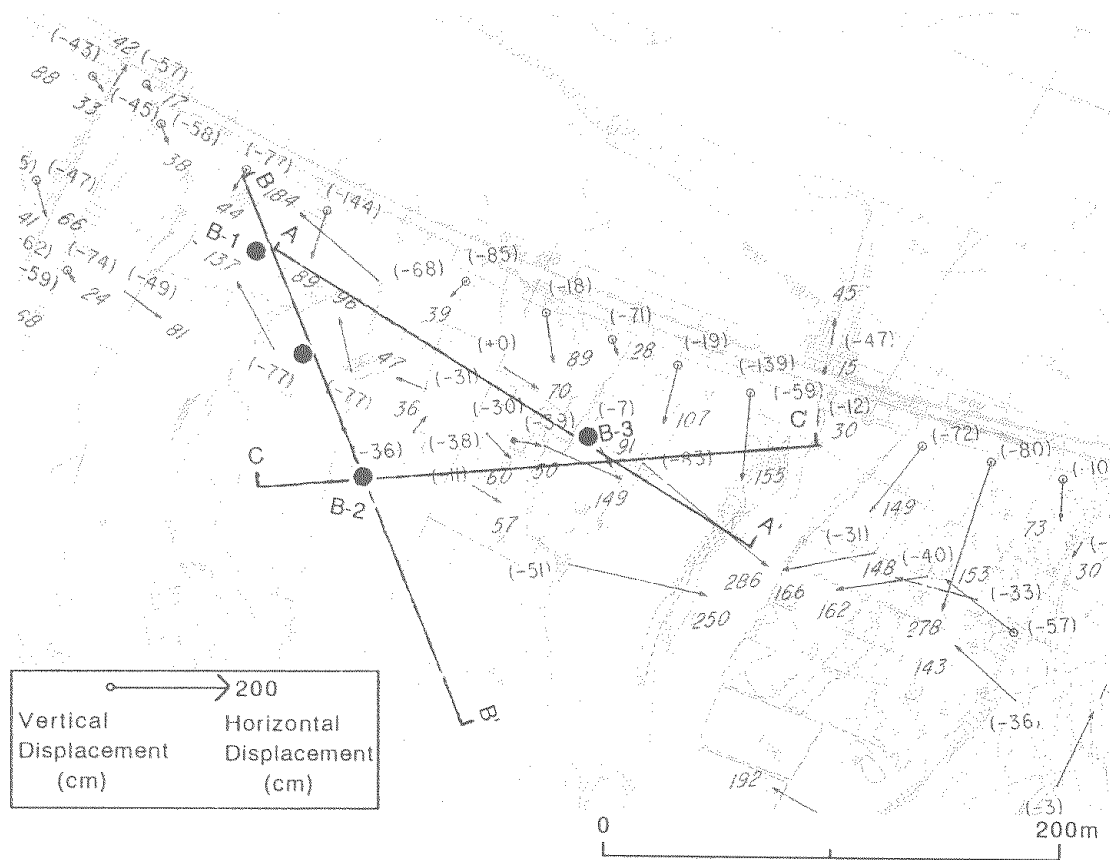
In this area the ground displaced toward the old riverbed including crescent lakes and waterways, generating circular fissures along the old river bed, demonstrating the typical pattern of the ground deformation along the Shiribeshi-toshibetsu River. Horizontal displacements were generated right next to the old riverbed toward the lake by approximately 1.5 to 3.0 meters. On the other hand, the displacement is small in the center area of the arc.

Figure 10 Map Showing Ground Deformations, Cracks and Sand Boils, Aichi Area  
( Area D, see Fig. 4)

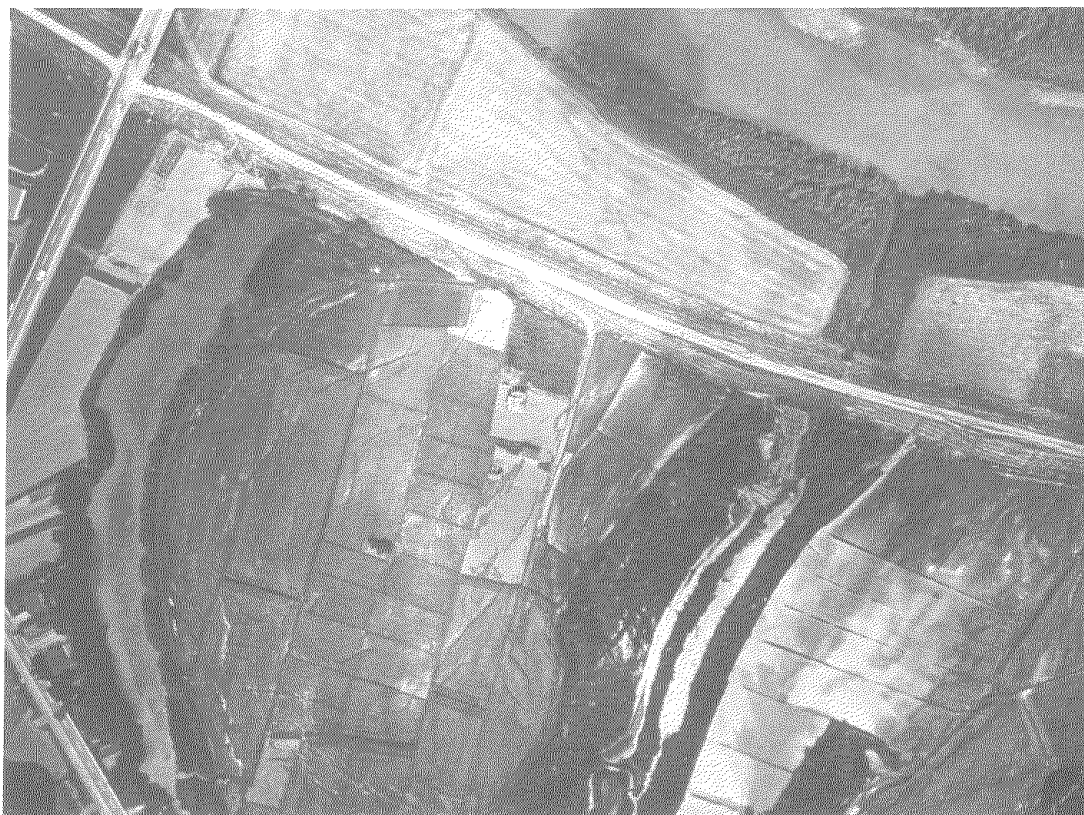
Photo 12 Aerial Photograph of Aichi Area ( Area D, Same Scale as in Fig.10)

The results of the survey and aerial photos of this area are shown in Figure 10 and Photo 12. It is noted that pre-earthquake aerial photos are available only for the portion along the levee (upper half of the Figure). Figure 11 shows the old topography the area upstream of the Shinei Bridge including Area D and E, interpreted by means of stereoscopy of the aerial photos taken by the US Forces in 1948.
