Photo 13 Ground Deformations and Damage to Electric Poles in Aichi Area (Area D)

Figure 13 Soil Profiles in Aichi Area ( Area D) at Cross-sections in Fig.10

Figure 14 Grain Size Distribution Curves from Sand Layers at Aichi Area  
( Boring Hole B-1, B-2 and B-3)

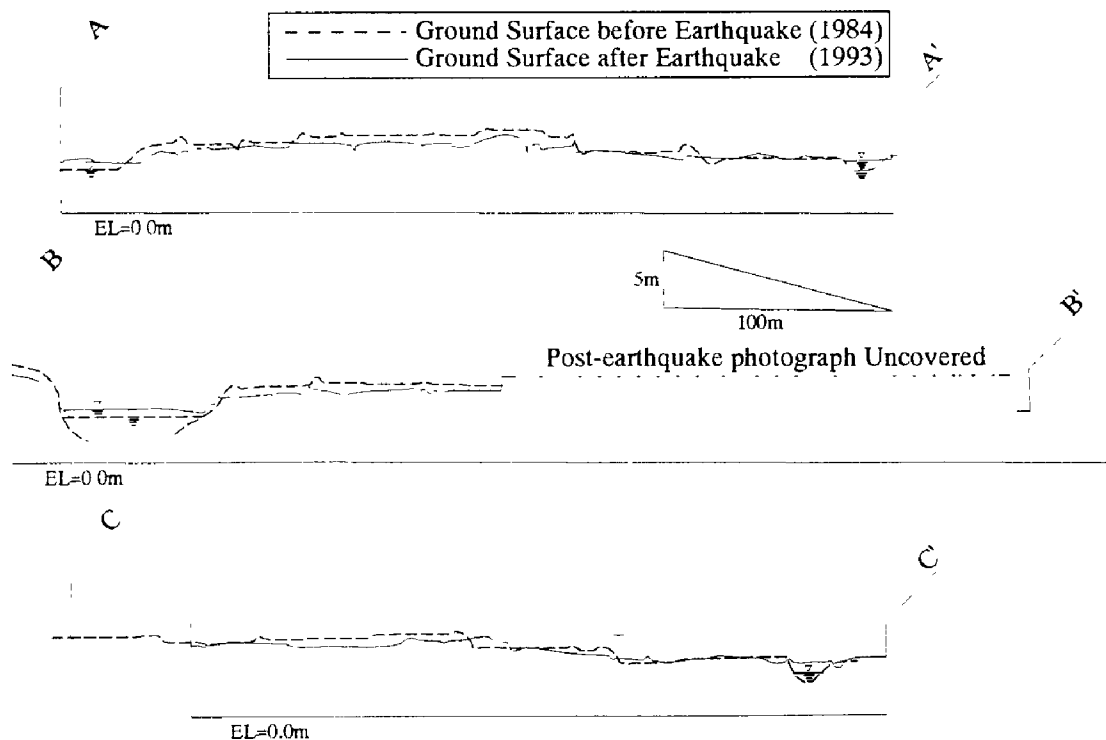
Figure 12 Measured Cross-Sections of Surfaces, Before (1984) and After(1993) the Earthquake ( Locations of the Cross-sections are Shown in Fig. 10 )

of these profiles follow the surface lines prior to the earthquake shown in Figure 12.

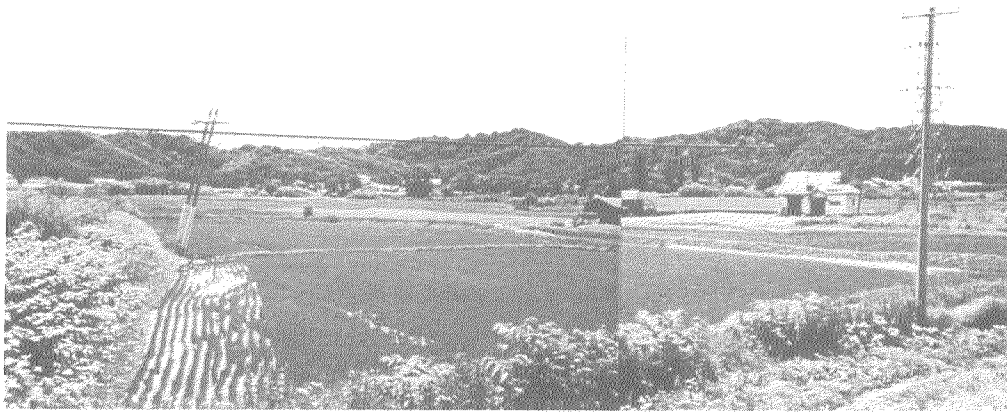
(a) Settlement and Tilting of Electric Pylon (One of Two Pylons, Gate-shaped, Settled and Tilted in the Center of the Photo)

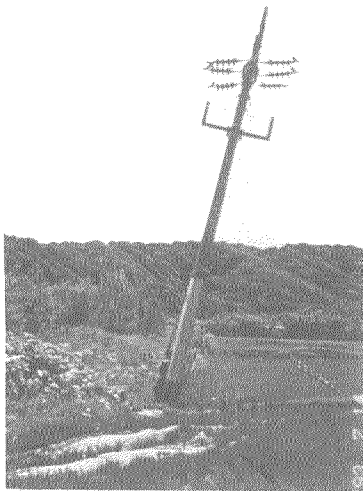
(b) Tilting of Electric Pylon

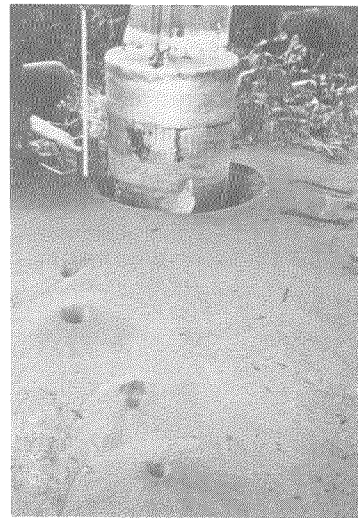
(c) Sand Boil from a Leg of Electric Pylon with four legs

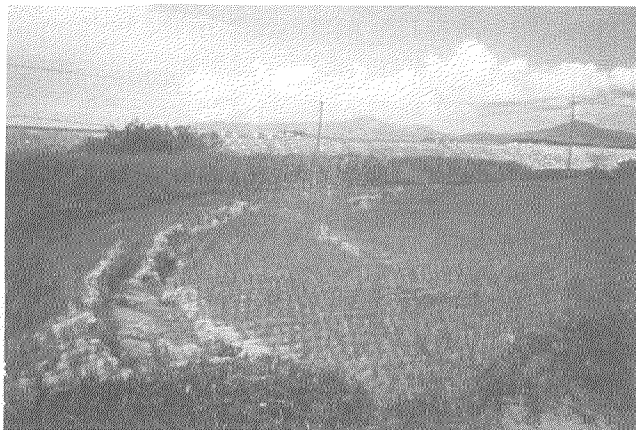
(d) Fissures

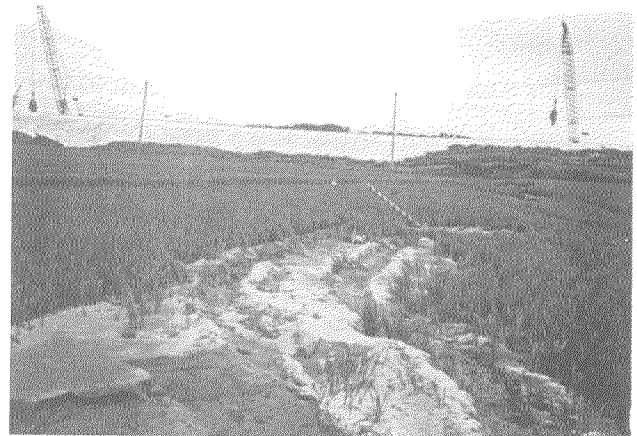
(e) Fissures and Sand Boils

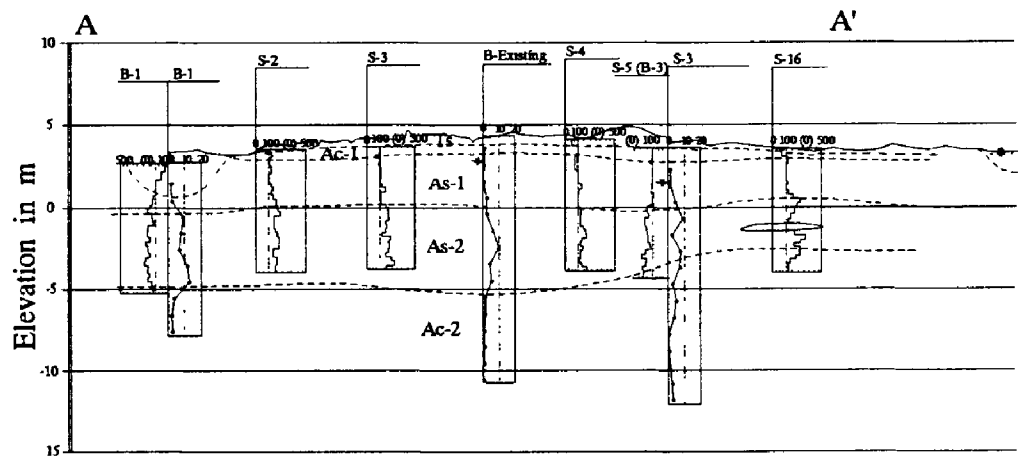
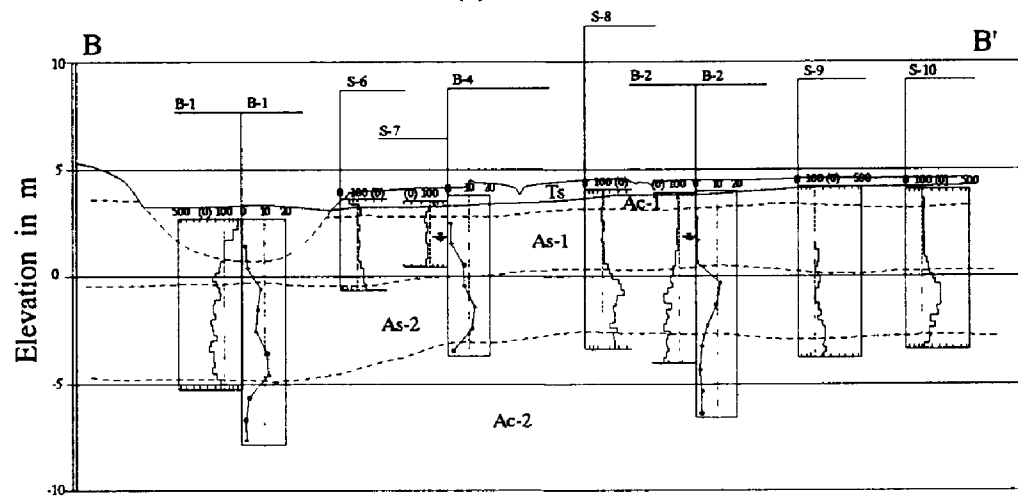
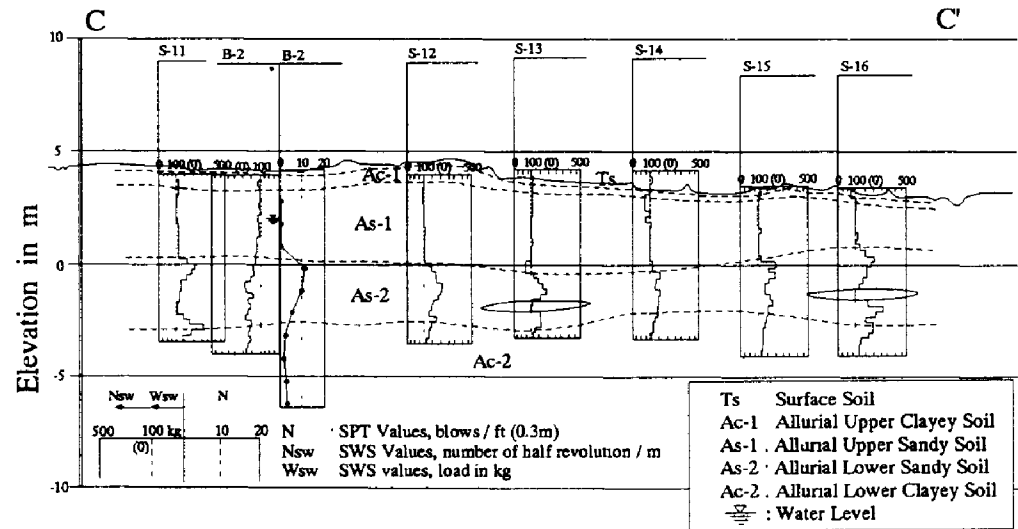
Figure 13 demonstrates that the strata of this area consist mainly of surface soil, upper clay layer, upper sandy soil layer (As-1), lower sandy soil layer (As-2) and lower clay layer. The upper sandy soil layer (As-1) lies underneath the upper clay layer at 1m to 5m from the ground surface and is extremely loose with N value of 1 to 4. The lower sandy layer (As-2) of somewhat hard with N value of approximately 10 appears. Ground water table is approximately 2 meters. (Soil survey was conducted in March 1994 and the water table at the moment of the earthquake could have been different from this.) Properties of the sandy soil layers (As-1 and As-2) are summarized as follows.

The upper sandy soil layer As-1 consists of sandy soil with much varied micro-fine sand, fine sand, and coarse sand with colors of brown-gray whose base is distributed around the sea level (elevation  $H=0$  m). This much-varied sandy soil is distributed in the entire region of Area D with the layer thickness of 2.0 ~ 4.0 m. Mixtures include silt and small gravel in some spots while mica pieces are mixed in overall in large quantities. N values are very low:  $N=1 \sim 4$ , and average N is 2. Sws values, number of half revolution/m by sounding  $N_{sw} 0 \sim 40$ , and average  $N_{sw}=10 \sim 20$ .

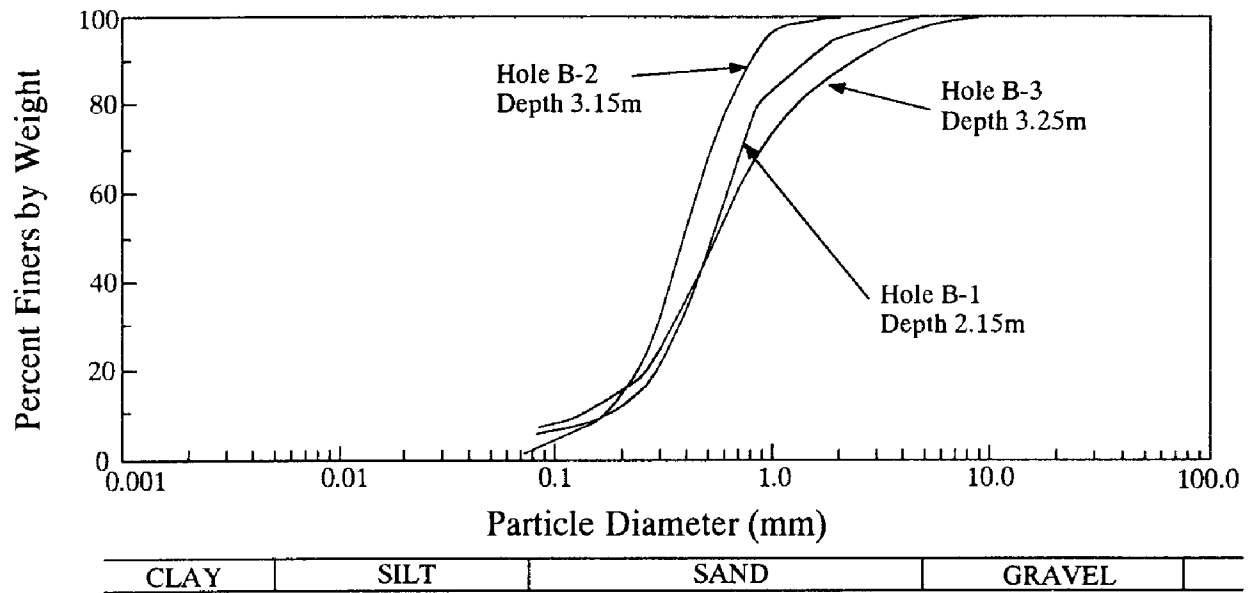
(a)  $A_{s-1}$

The property values of this layer is summarized in Table 1 with those of As-2. The grain size distribution curves are shown in Figure 14 (a). This soil can be described as clean sandy soil with uniform grain diameter of uniformity coefficient (Uc) 2.5 ~ 4.0 with fine grain content of over 95%. This sandy soil layer underneath the water table is thought to have liquefied completely.

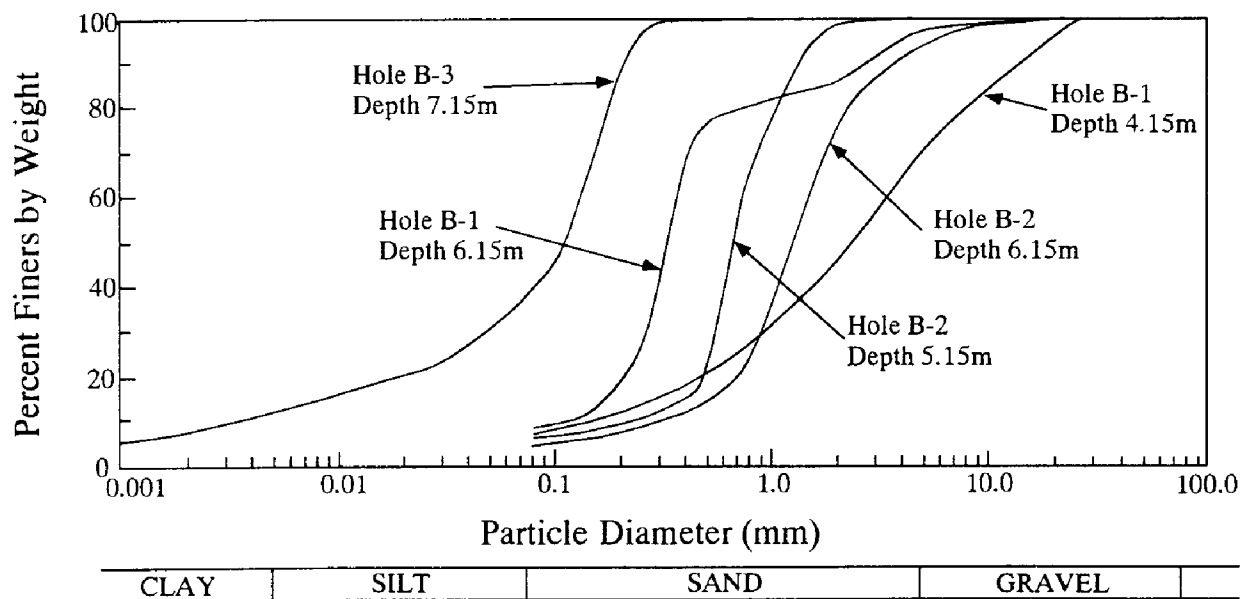
(b)  $A_{s-2}$

The lower sandy soil layer As-2 is predominantly sandy soil mixed with gravel of dark grey distributed mostly around  $H=0 \sim -5.0$  m. This layer is distributed 3.0 ~ 5.0 m thick under As-1 layer in the entire area investigated. The grain size distribution curves of this soil are shown in Fig. 14 (b). Gravel is mainly circular/semi circular with diameter  $\phi 2 \sim 5$  mm, max.  $\phi = 10$  mm approximately with a higher rate of mixture in top layer and lower rate of mixture in the bottom. The sand diameter varies from small to fine. More silt mixture is found in lower parts, forming silty sand. It is soft sandy soil whose N values are 3 ~ 13, average  $N \approx 7$ .  $N_{sw}$  is 15 ~ 80, with the average of  $N_{sw} \approx 50$  while  $N_{sw} \approx 100$  is obtained in spots with high gravel content.
