**GROUND DEFORMATIONS AND THEIR EFFECTS ON STRUCTURES
IN MIDORIGAOKA DISTRICT, KUSHIRO CITY,
DURING THE KUSHIRO-OKI EARTHQUAKE OF JANUARY 15, 1993**

Kazue Wakamatsu¹ and Nozomu Yoshida²

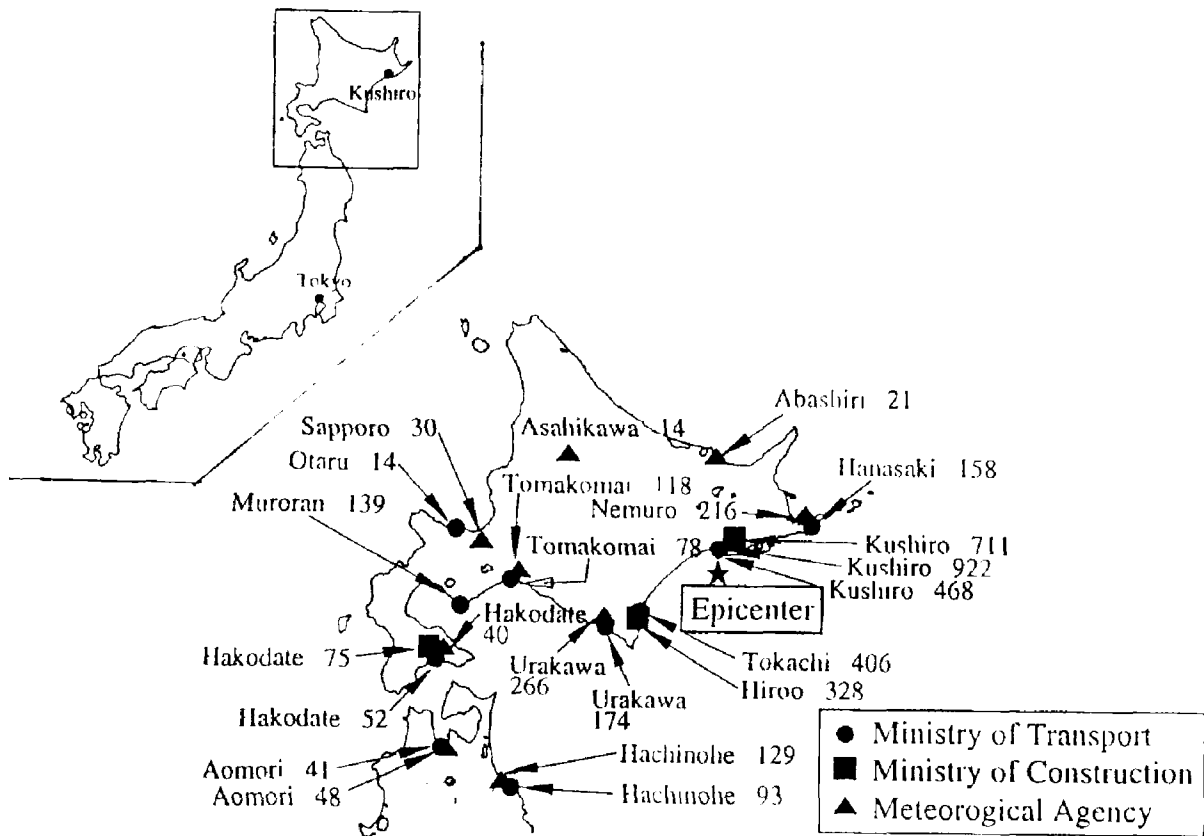
Strong motion data were recorded at more than 180 sites through the northern half of Japan. Peak accelerations observed at both free-field sites and the ground floors of structures in the epicentral region are plotted in Fig. 1. A peak horizontal acceleration of nearly 1 g was recorded at Kushiro Meteorological Observatory, 14 km north of the epicenter.

Fig.1 Peak Accelerations in cm/s² at Free-field Sites and Ground Floors of Structures during the 1993 Kushiro-oki Earthquake

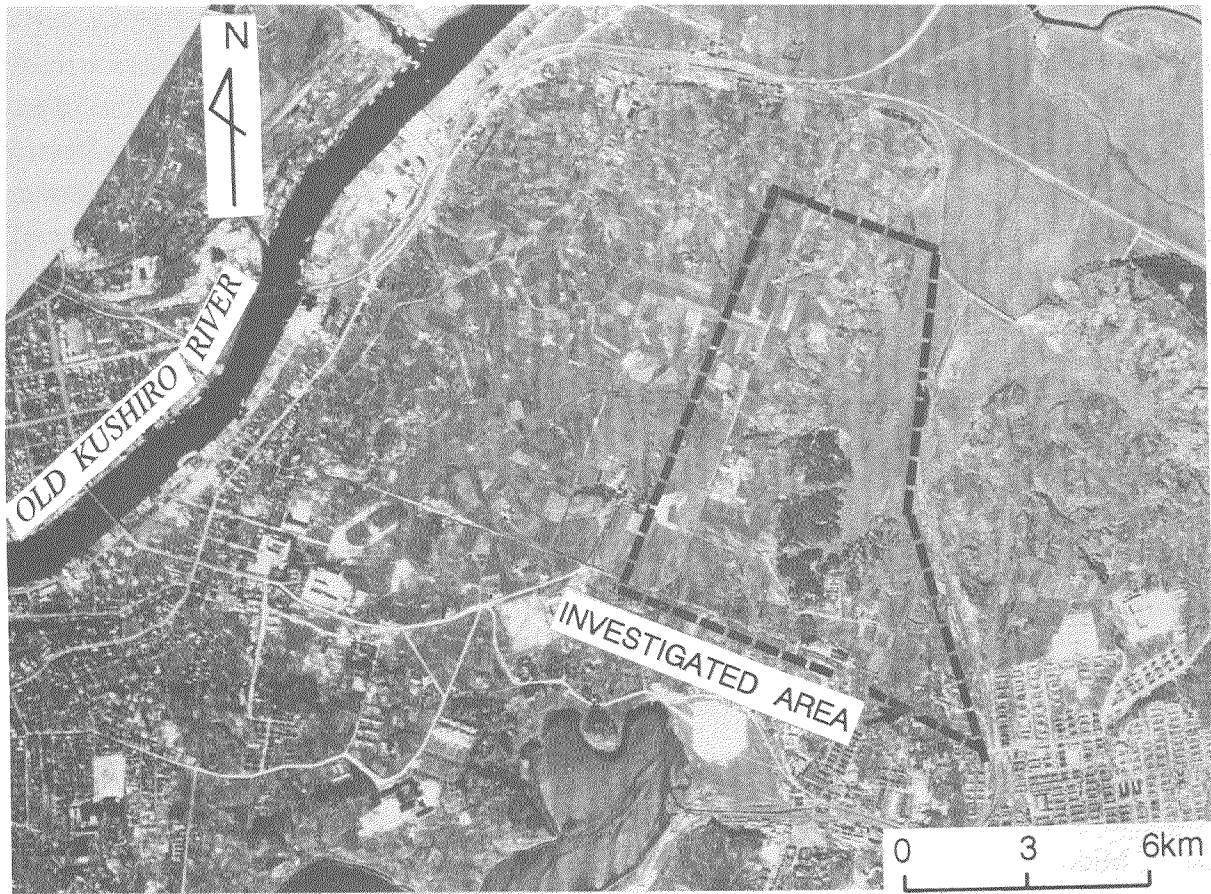
Photo 1 Aerial Photograph of the East of Kushiro City Taken in 1947

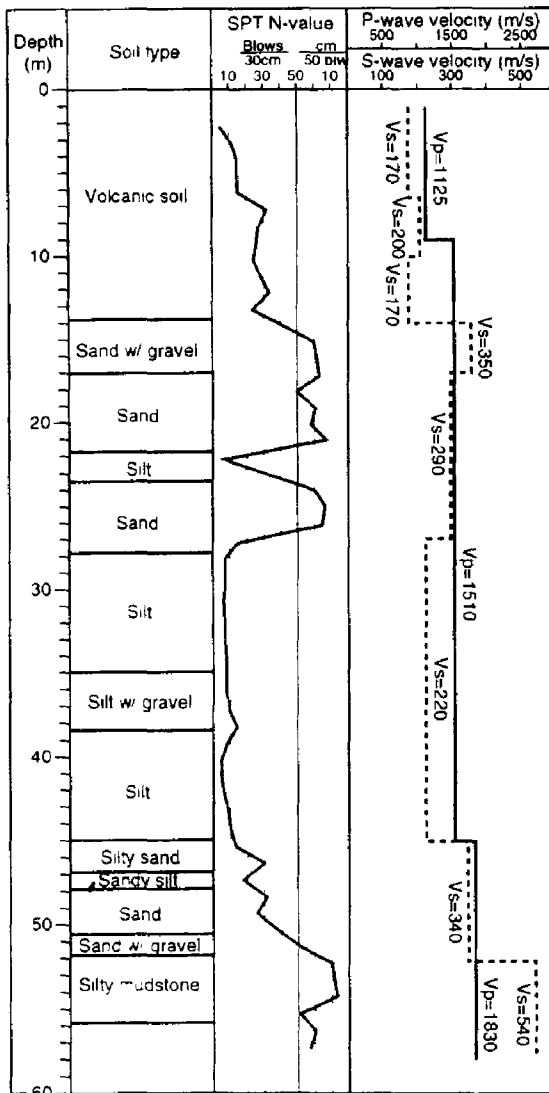
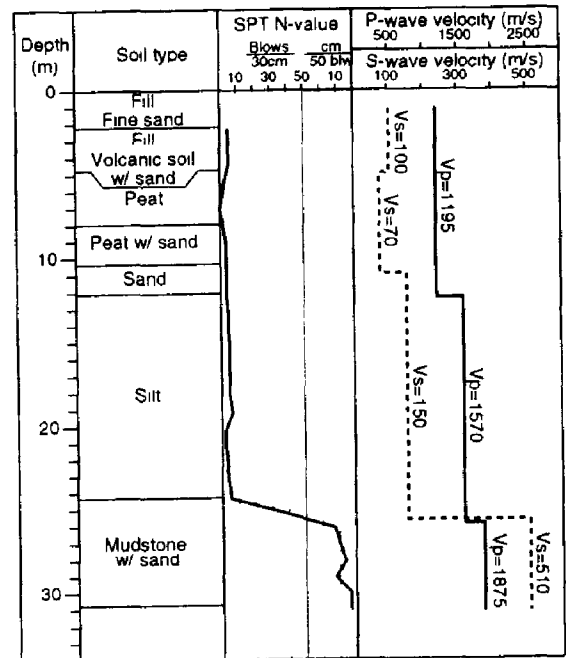
a) Pleistocene terrace

b) Filled valley

Fig.2 Typical Soil Profiles and Elastic Wave Velocities in Terrace and Valley²⁾
