DAMAGE TO STRUCTURES

Water Supply Lifelines

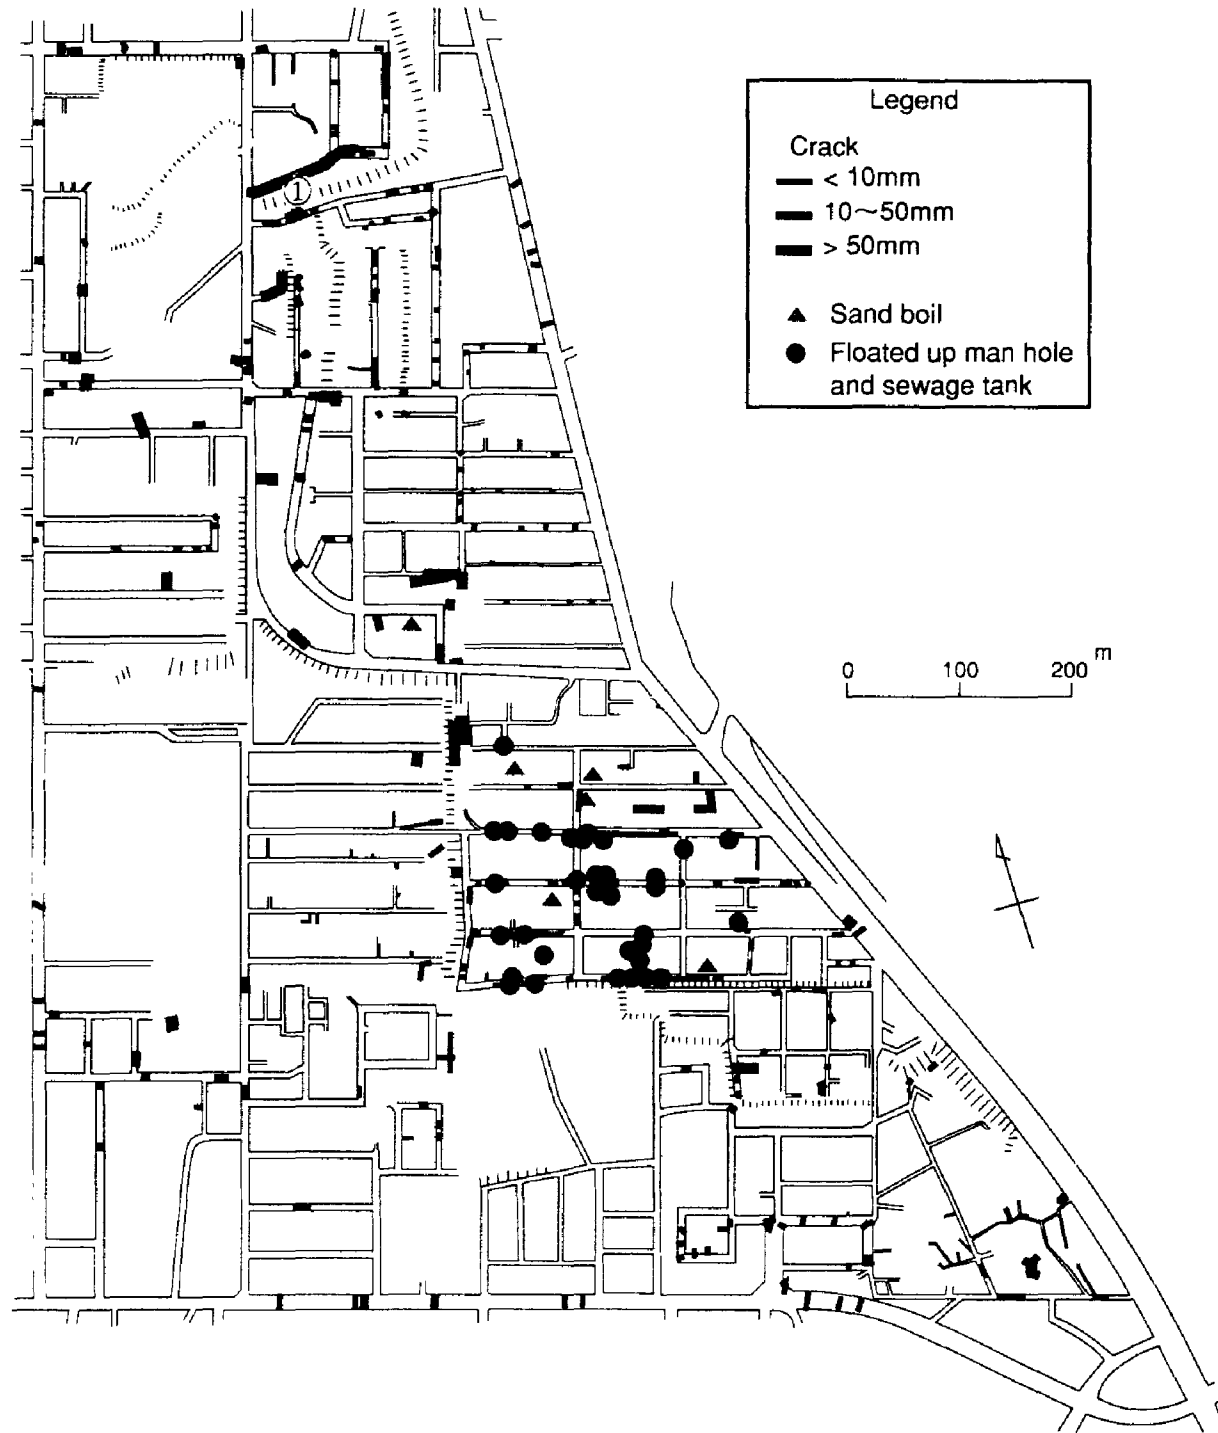
Fig.5 Map of Midorigaoka Showing Locations of Ground Failures and Floated up Manholes²⁾

Figure 5 shows distribution of ground failures in Midorigaoka. A slope with a height of 11 m collapsed at site ① in the figure. A wooden house slipped down the slope and two houses were crushed by the collapsed soil as shown in Photo 2. Liquefaction effects such as sand boils and floating up of manholes were observed as well as ground cracks. Manholes floated up 5 to 20 cm at many sites. Sand boils were observed at fewer locations than would be expected because of the frozen layer of ground at the surface estimated to be 50–100 cm thick at the time of the earthquake.

Underground pipelines and foundations of wooden houses settled differentially and were displaced laterally where the ground cracks were abundant. This implies that a large amount of permanent ground deformation occurred in these areas. The magnitudes of the vertical and horizontal ground displacements were estimated to be in the range of approximately 30 to 50 cm on the basis of widths of ground cracks and displacements of pipelines and foundations of the houses.

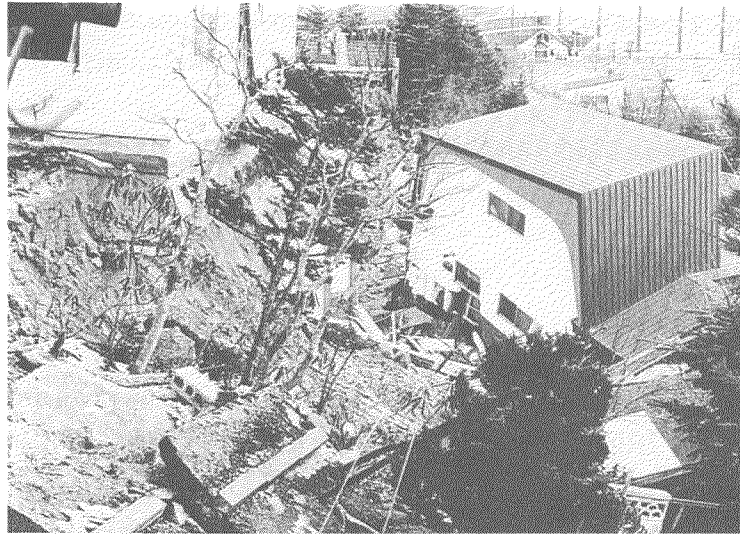
Photo 2 Slipping Down of a Houses due to Slope Failure
(Courtesy of Kiso-jiban Consultants Co.)

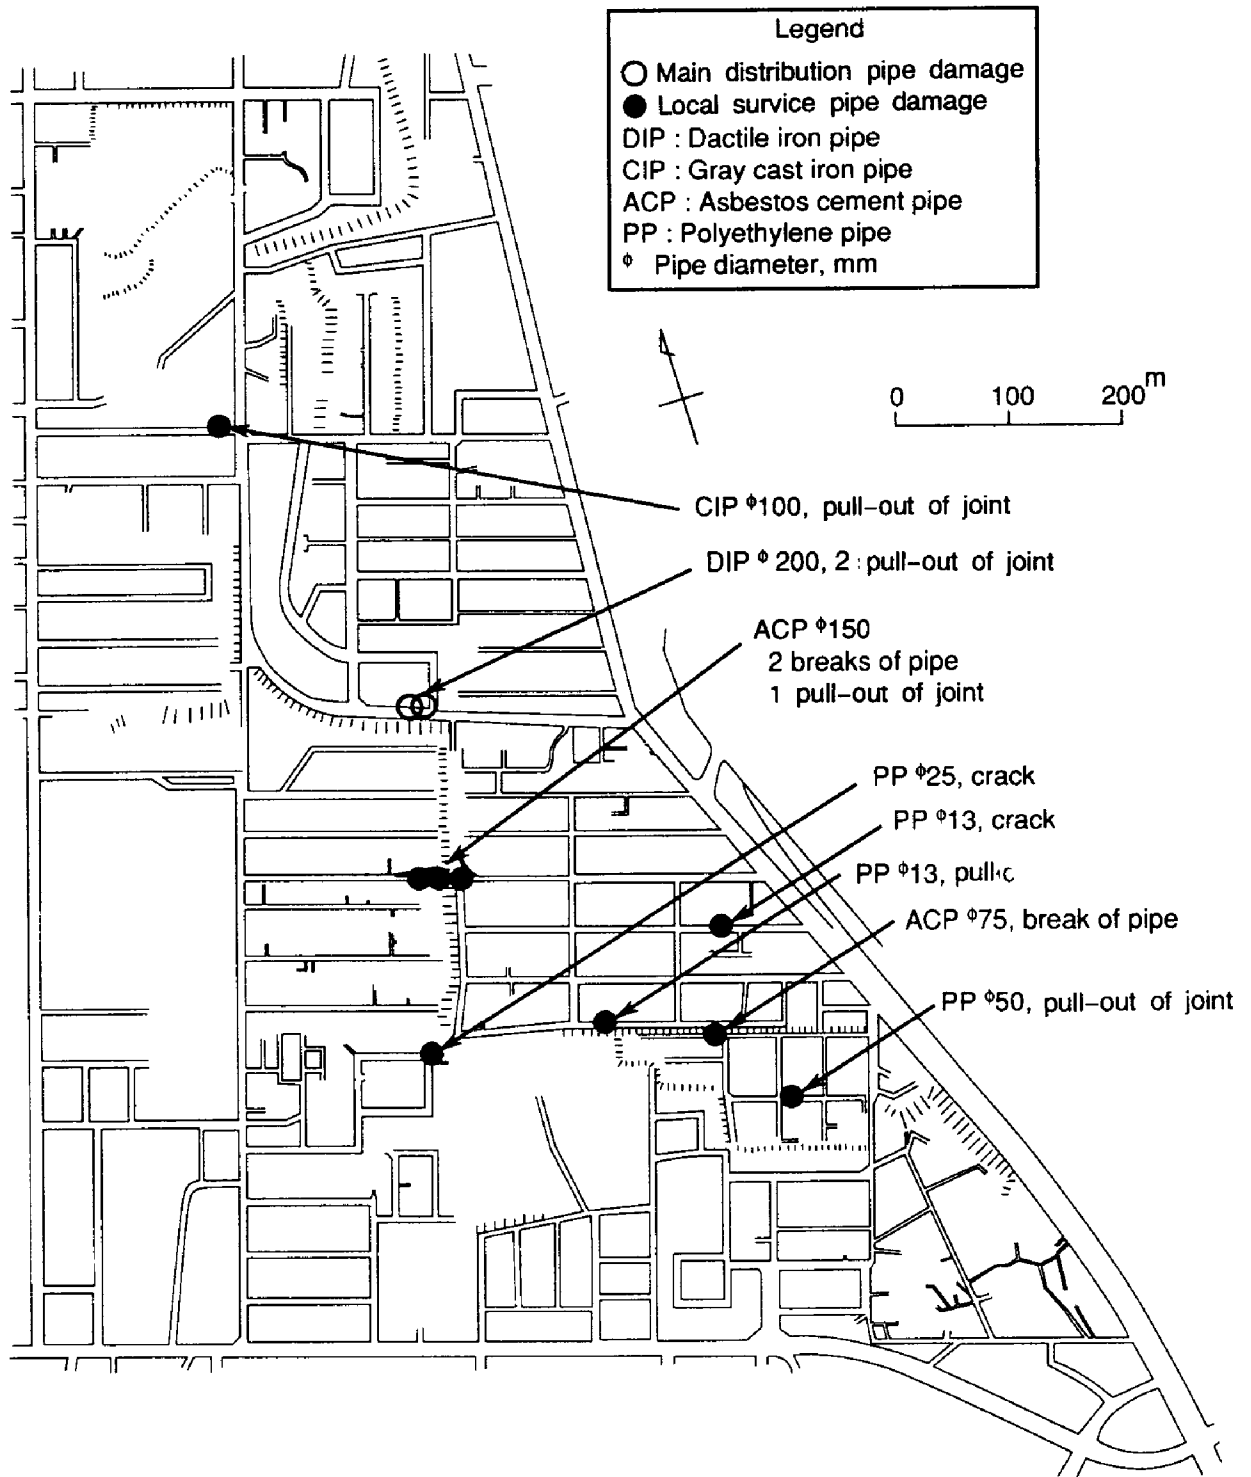
Fig.7 Map of Midorigaoka Showing Locations of Damage to Water Distribution and Service Pipelines

There was damage at 2 locations in the main water distribution system and at 9 locations in the local service system in Midorigaoka. This is approximately one-third of entire damage in Kushiro City to water supply system. Figure 7 shows the locations, types and diameter of damaged pipes, and damage modes of both main distribution and local pipelines. The pipe and joint damage occurred only in the areas of ground failures shown in Fig.5 in Midorigaoka.

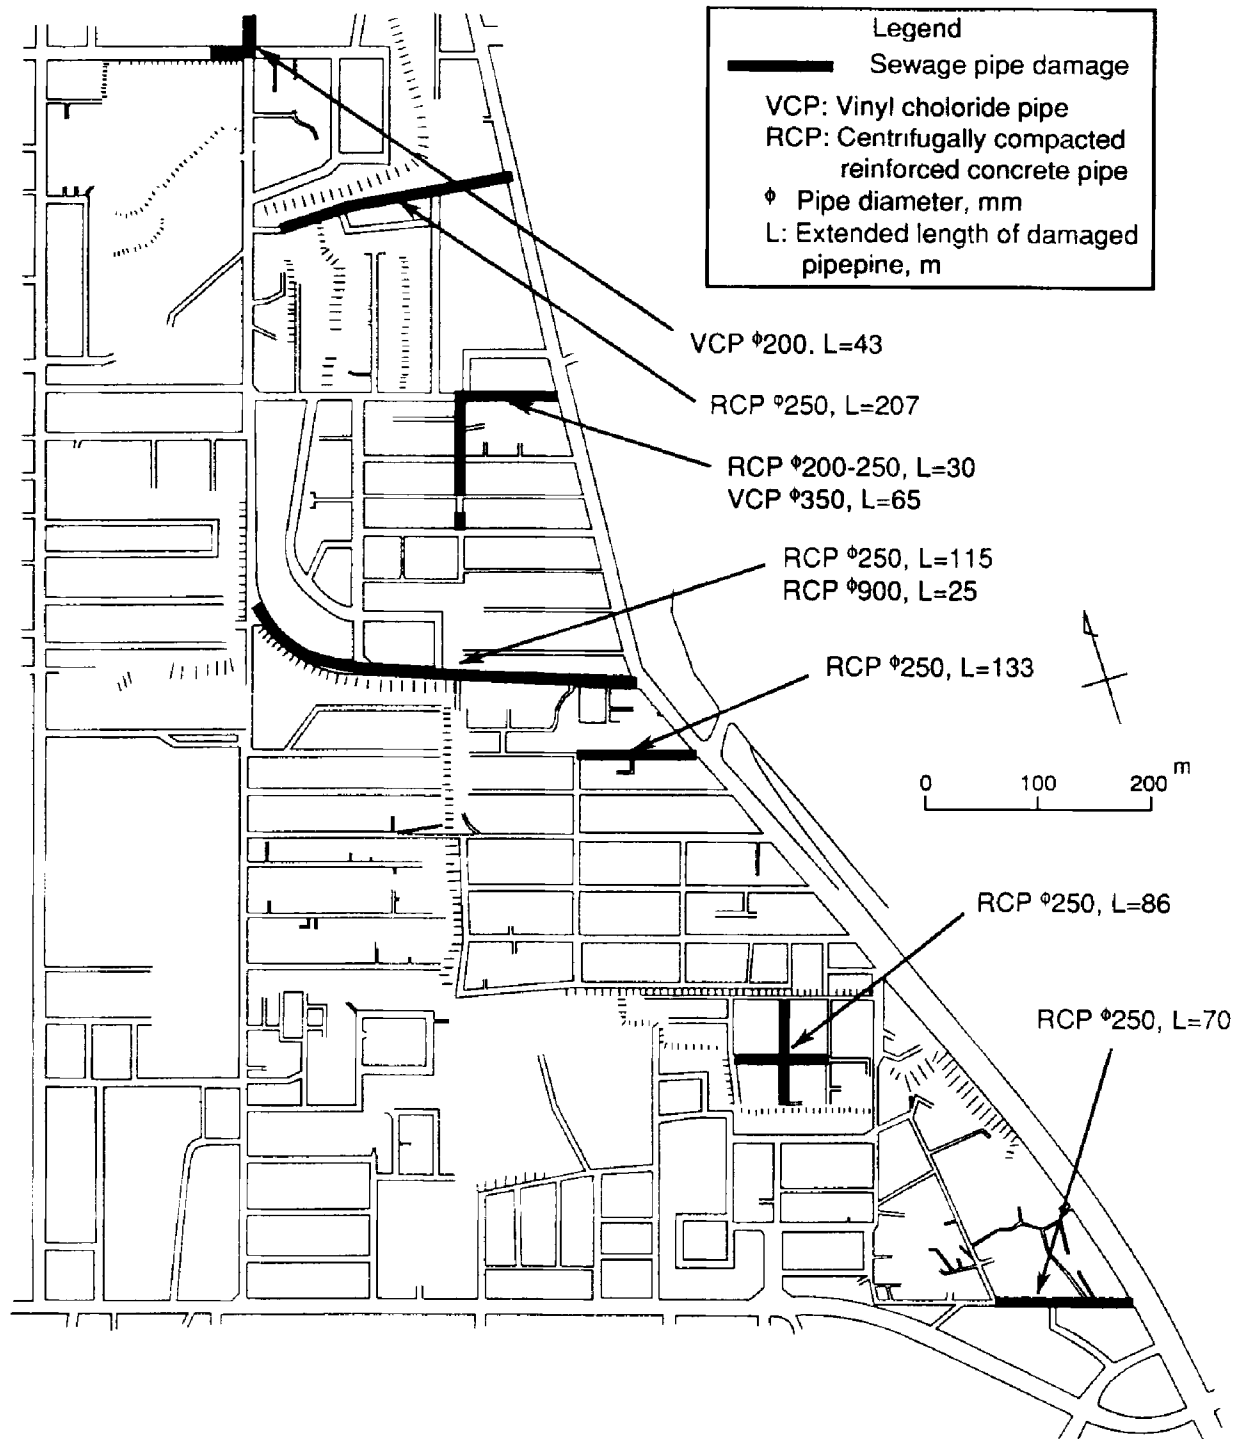
Fig.8 Map of Midorigaoka Showing Locations of Damage to Wastewater Pipelines

There are 947.5 km of wastewater pipelines in Kushiro City ranging in diameter from 200 to 1,000 mm. They consist of vinyl chloride pipes (VCP) and centrifugally compacted reinforced concrete pipes (RCP) with rubber joint. In total 47 sites, 7,744 m of the pipes, were damaged due to the earthquake. Figure 8 shows the locations, types, diameters and lengths of damaged pipes. At the damage locations the pipes buried at a depth of 3.4 m on average and supported by timber piles or macadam. Damage was primarily in the form of floating and settlement of the pipelines due to the displacement of the joints, round cracks of pipes and manholes, pull-out or break of joints, and floating of manholes as shown in Photos 3 and 4. The amount of both floating and settlement of pipelines were ranged from several cm to several ten cm.
