## **SUBSURFACE CONDITIONS IN MIDORIGAOKA**

## CONCLUDING REMARKS

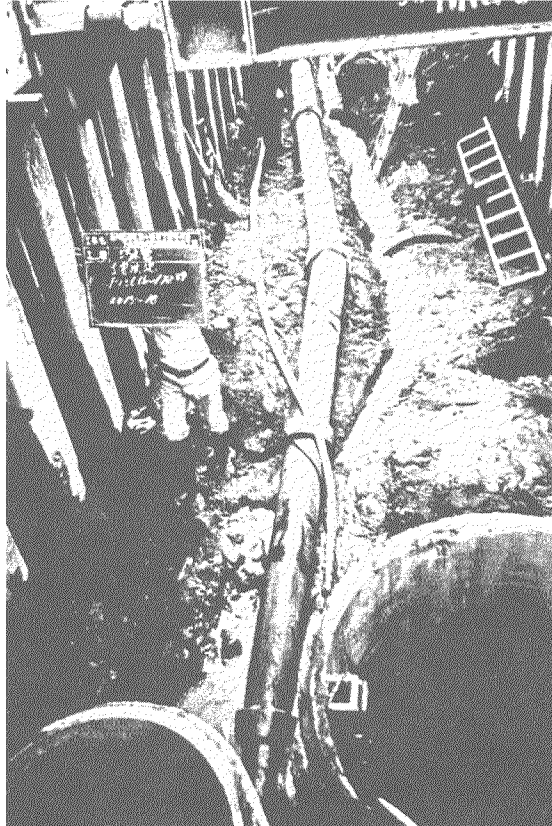
Photo 3 Deformation of a Wastewater Pipeline  
(Courtesy of Kushiro City Government)

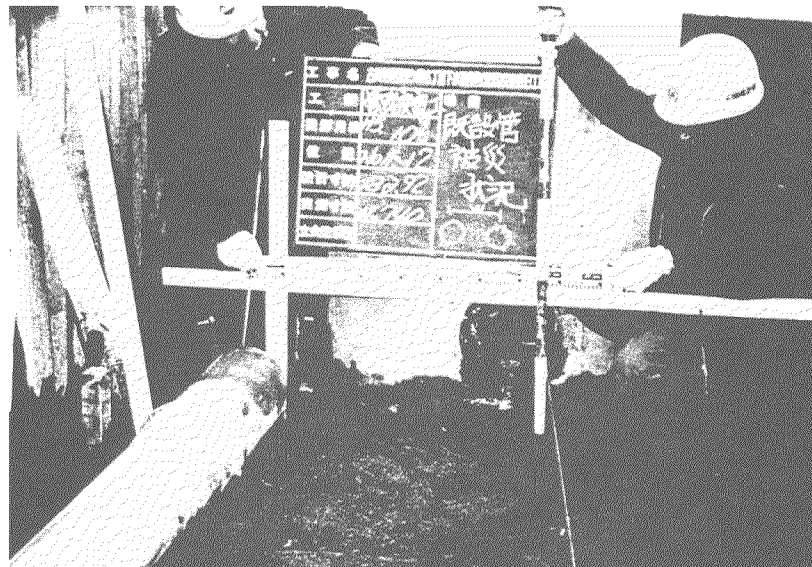
Photo 4 Rupture of Connection between Manhole and Pipe  
(Courtesy of Kushiro City Government)

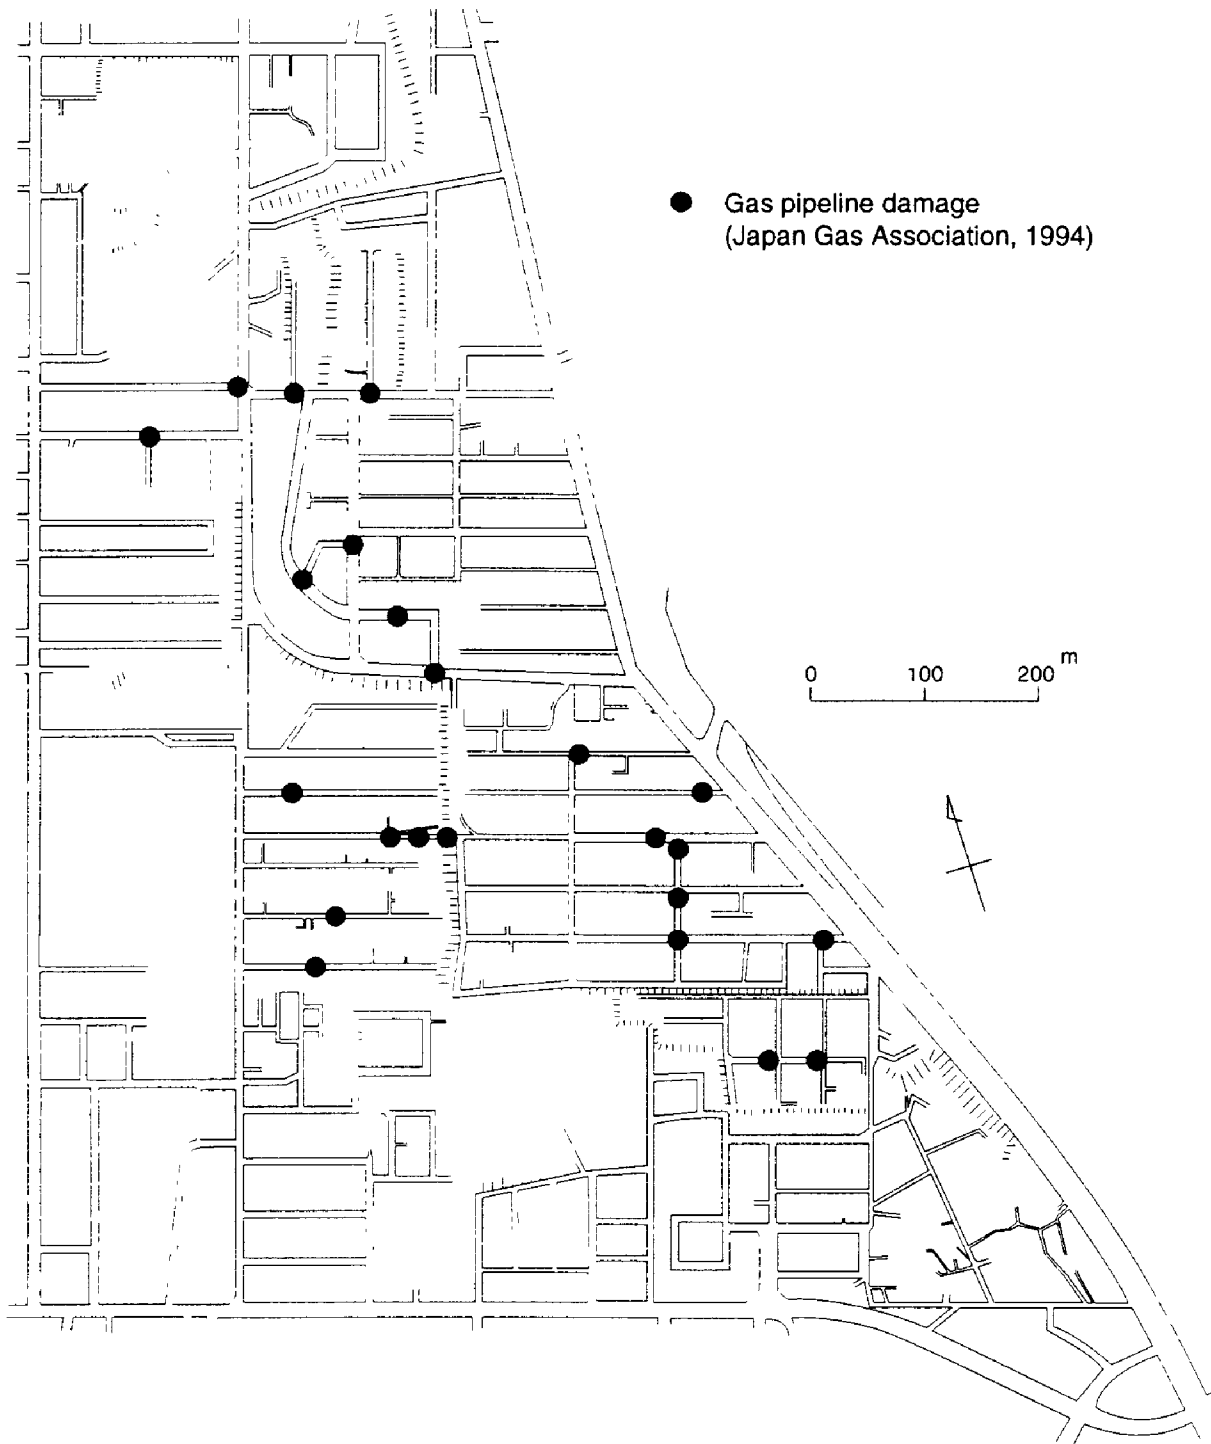
Fig.9 Map of Midorigaoka Showing Locations of Damage to High and Low Pressure Gas Distribution Systems

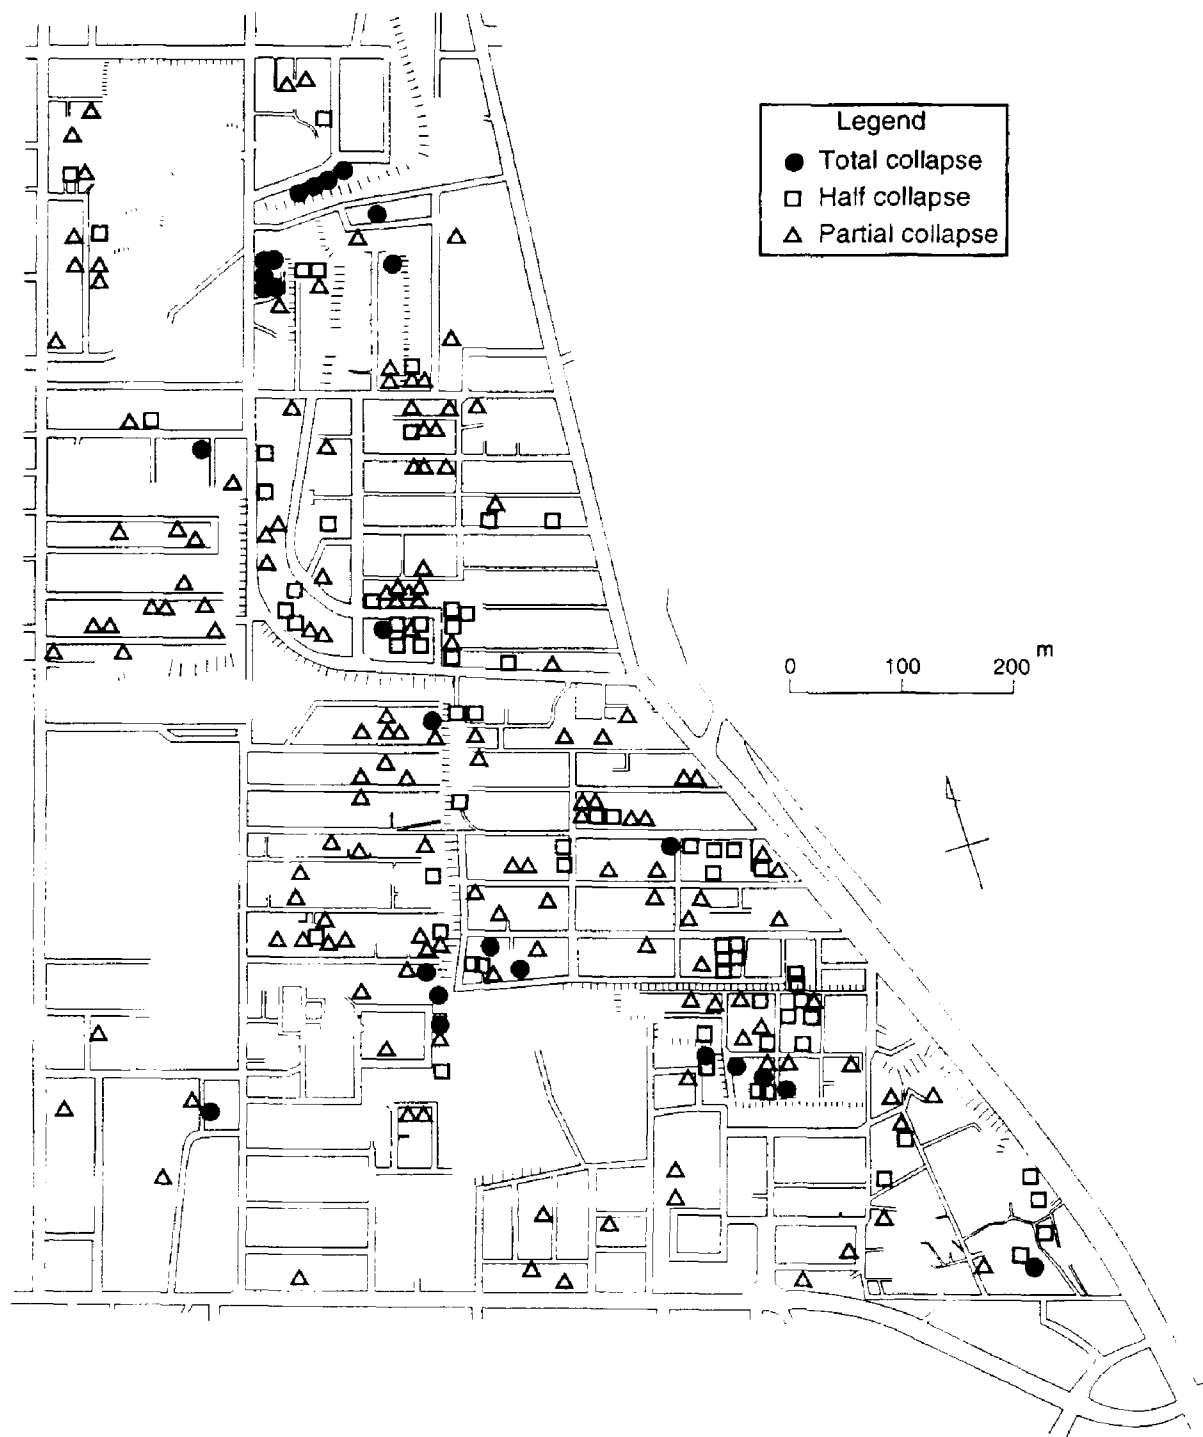
Fig.10 Map of Midorigaoka Showing Locations of Collapsed Houses

which were built in the last twenty years with some engineering design. These houses were significantly affected by the earthquake as shown in Fig. 10. Damage was primarily in the form of cracks of walls and foundation, broken chimneys, differential settlement and horizontal displacement of the foundation. Total collapse indicates damage to main structural members, but does not imply complete collapse of the structure. The most serious instances of damage occurred at site ① in Fig.5 where a slope failure occurred as previously shown in Photo 2.

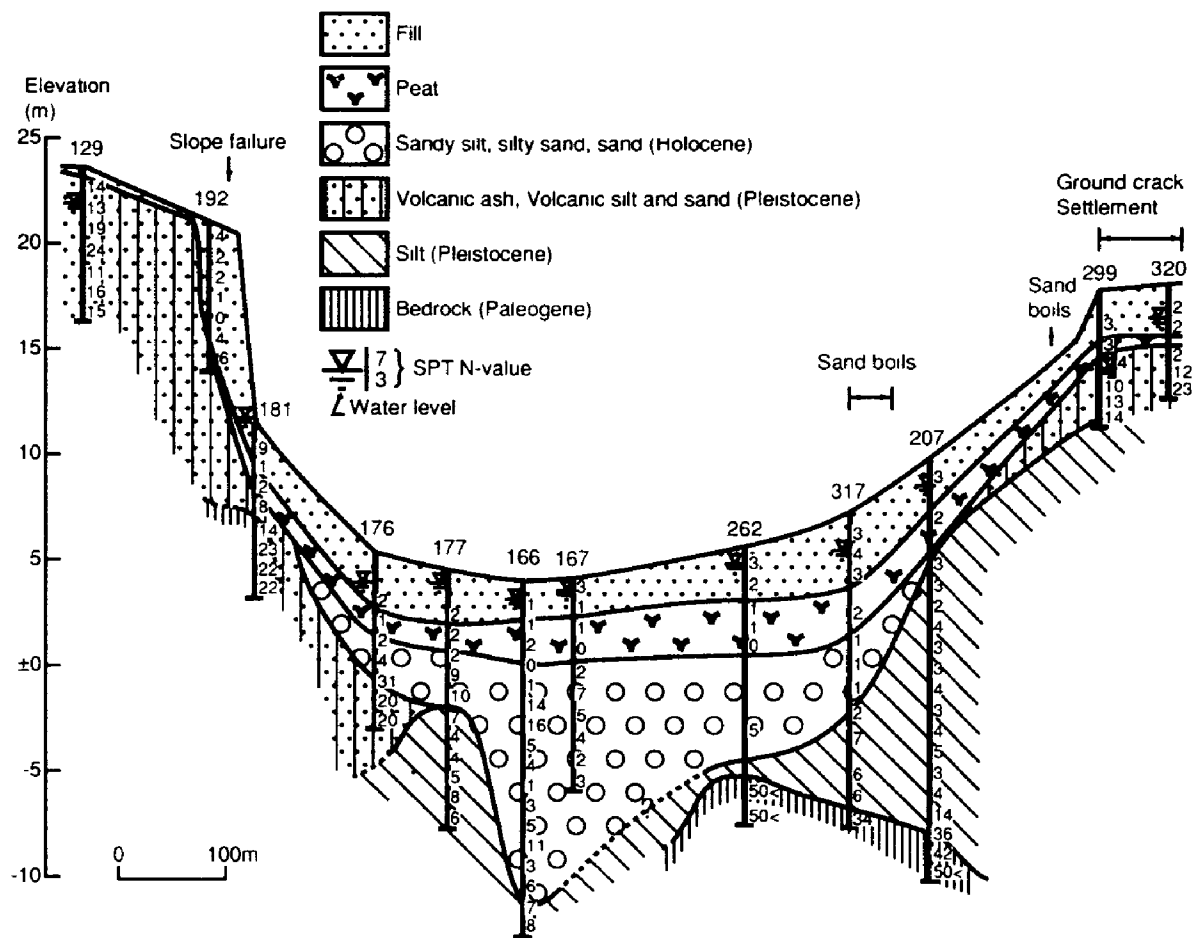
Many boring investigations and standard penetration tests have been performed to clarify the foundation conditions of wastewater utilities in Midorigaoka. On the basis of the boring information, a cross-section oriented in the north-south direction was developed as shown in Fig.11. Loose fill with SPT N-values less than 5 extends along the section with a thickness ranging from 1 to 9 m. The depth of the water table is shallow ranging from 0.3 to 2 m in the valley, whereas in the terrace it is several meters deep. Underlying the fills is very soft peat, which was originally at the bottom of the valley.

The slope failure described before (① in Fig.5) occurred where thickness of fill material is large and the slope is steep, as shown at the left side end of the figure. Sand boils were observed in the gentle slope of valley wall where 1- to 2-m thick fill overlies the water table. Major ground cracks and settlements occurred in the upper part of the slope with sand boils. This pattern of ground deformation implies that lateral movement toward the center of the valley occurred due to the liquefaction of loose fill. This agrees with the fact that grain size characteristics of sand boils was similar to the grain size of the volcanic ash used as fill in Midorigaoka.

Fig.11 Soil Profile along Cross-Section A-A' in Midorigaoka (see Fig.12 for location)

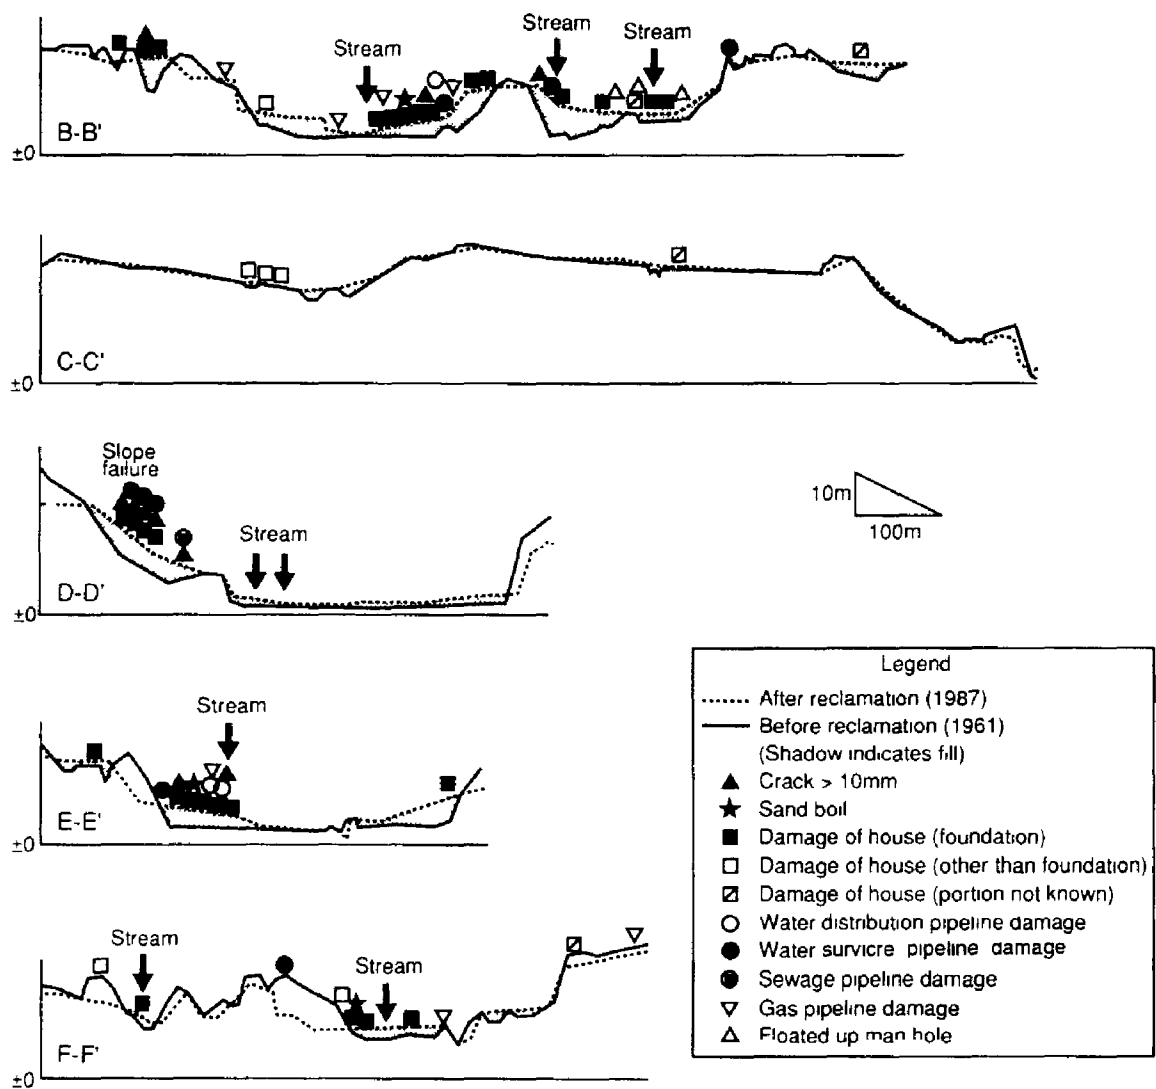
The typical examples of the photogrammetric analysis were shown in Fig. 13, in which the locations of streams before development and ground failures and damage to structures are plotted. In the figure, the damaged houses previously shown in Fig.10 are re-classified according to damage mode based on the record by the city government into three types: 1) damage in foundations; 2) damage other than that in foundation such as

Fig.13 Cross-Sections Showing Landform Changes due to Development (see Fig.12 for locations)

collapsed chimney and cracked exterior wall; and 3) portion of damage not reported. The majority of the damage in Midorigaoka was categorized as the type-1.

It can be seen from the figure that the heaviest concentration of structural damage was observed in the filled area where ground failures such as slope failure, ground cracks and sand boils were concentrated. The slope failure occurred at the boundary between the terrace and the valley where fill is thick and the slope of ground surface is steep as shown in section D-D', whereas liquefaction effects such as sand boils and floated up manholes occurred in the valley where fill is thick, slope is gentle and stream flowed down before the development. Ground cracks also occurred on both steep and gentle slopes in the filled area. Damage to pipelines and foundation of houses occurred in the locations of all ground failures, whereas structural damage was absent in the valley bottom where fills are flat and not so thick, as shown in section D-D'. The data imply that permanent ground deformation and/or movement associated with ground failures was the principal cause of the damage to structures. In contrast, damage other than that in foundation of house such as collapse of chimney and cracks of exterior walls, a few in number, did occur in all part of sections, in both filled and cut areas, which implies that primary cause of the damage was strong ground shaking.

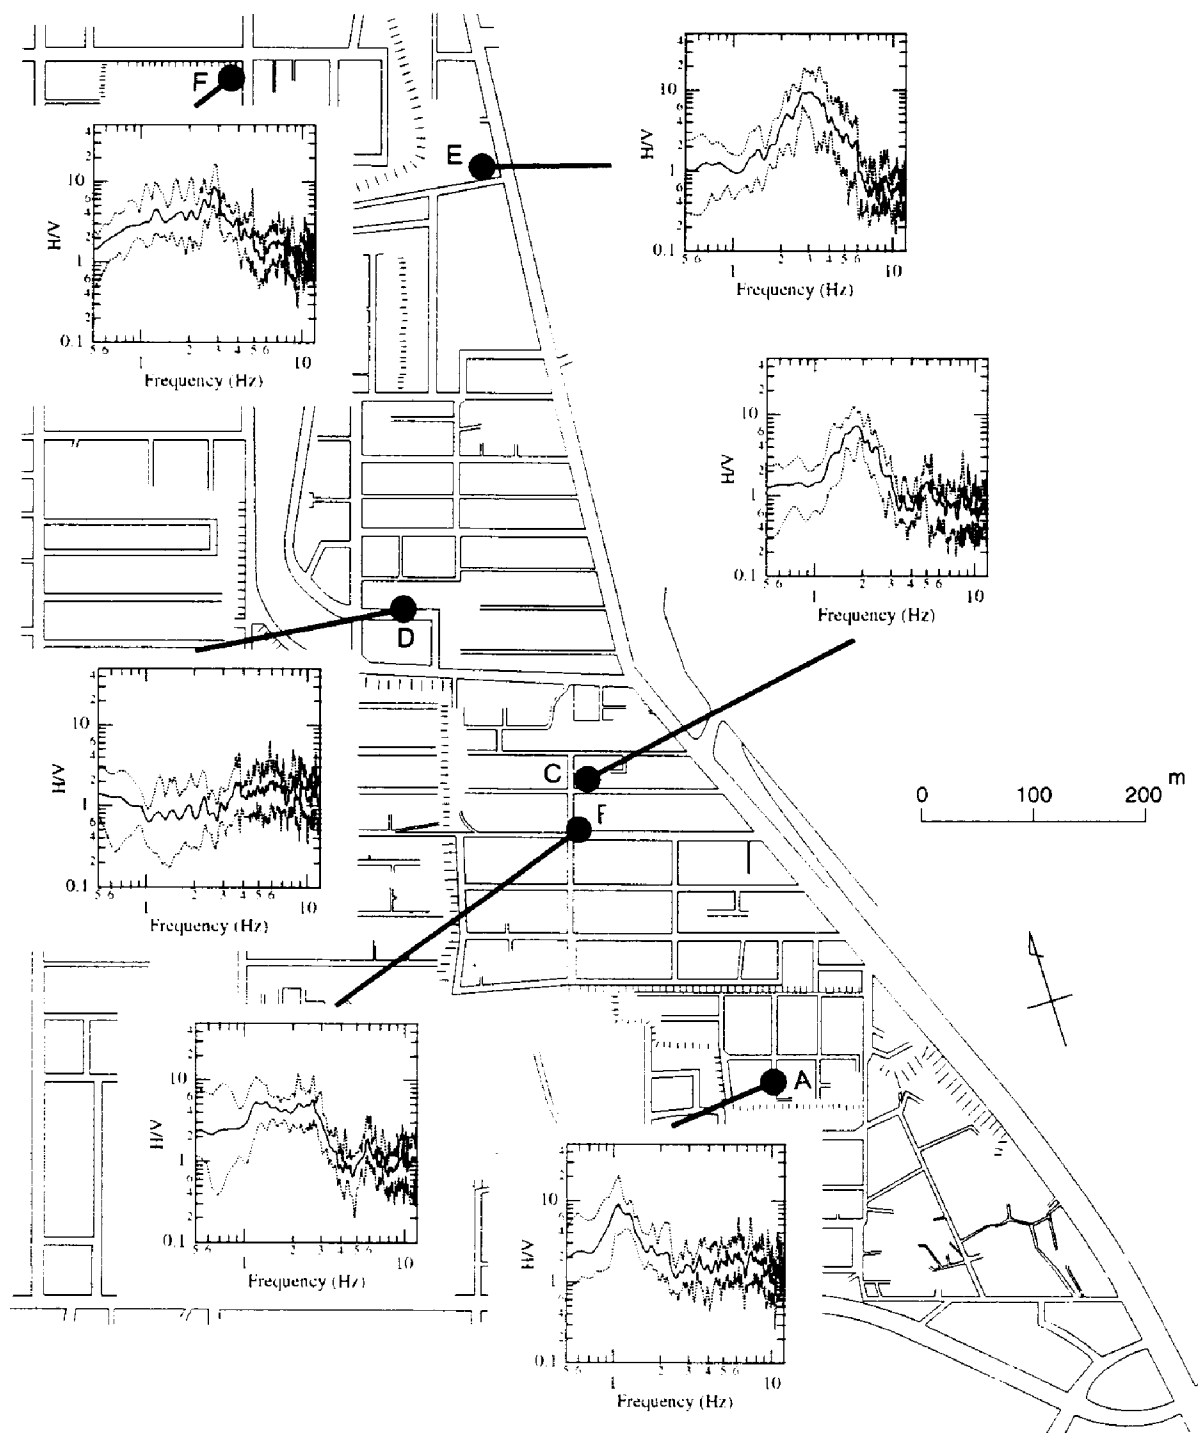
Microtremor measurements were made in Midorigaoka to determine response characteristics of different sites. Figure 14 shows spectrum ratio  $H/V$ , where  $H$  and  $V$  denote horizontal and vertical Fourier amplitude of microtremors. The solid line denotes the average spectrum and dotted lines at the top and at the bottom are envelopes of the measured spectrum. It is noted that large spectral values imply large contrast of stiffness between basin and surface deposit. Therefore, ground shaking is supposed to be larger as  $H/V$  value increases.

The predominant period at site A in Fig.14 is about 1 sec., which is the largest period in this area. Probably, there exist of thick silt layer beneath the volcanic ash. At site B, soil profile changes rapidly as seen in Fig.11, which may explain that peat is not absent at site B. Spectrum has clear peak at about 2 Hz at site C, which is 2 times as large as that as site A. It agrees with the observation that bed rock is shallow and impedance ratio between surface layer and bedrock is large here. The same discussion can be made at site E. On the other hand, the location of bedrock is not known and there exists thick and soft silt layer at site D. This explains no clear peak in the spectrum at this site. In summary, the difference in stiffness and thickness of the deposits may control predominant periods. Direct correlation were not seen, however, between the predominant periods and occurrence of ground failures.

Fig.14 Result of Microtremor Measurements
