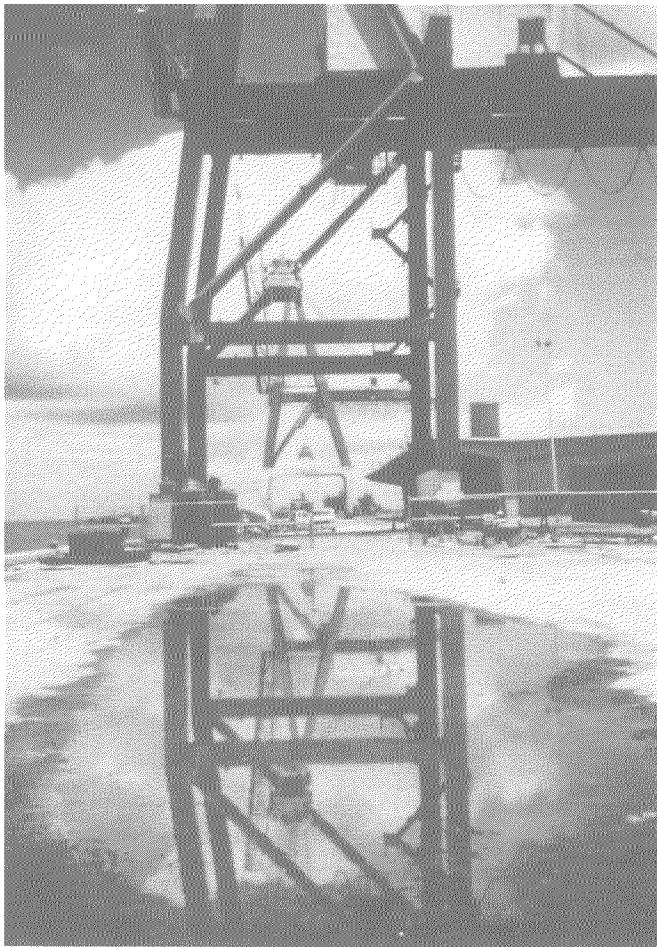
Figure 6: Settlements of up to 18 inches disrupted the surface drainage at the commercial port facilities

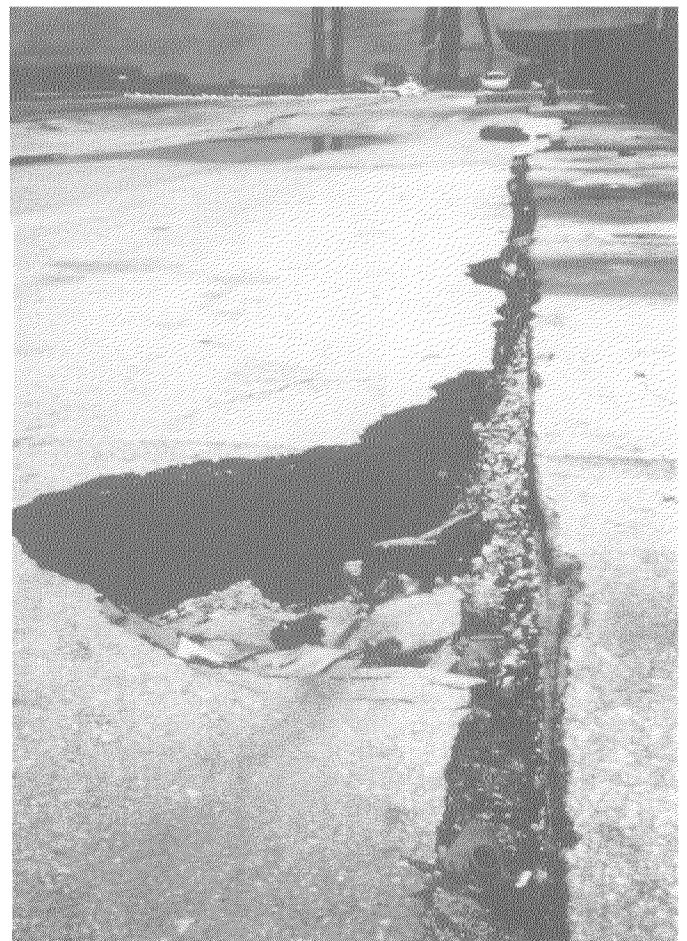
Figure 7: Lateral movement and cracking of the pavement, commercial port facilities
