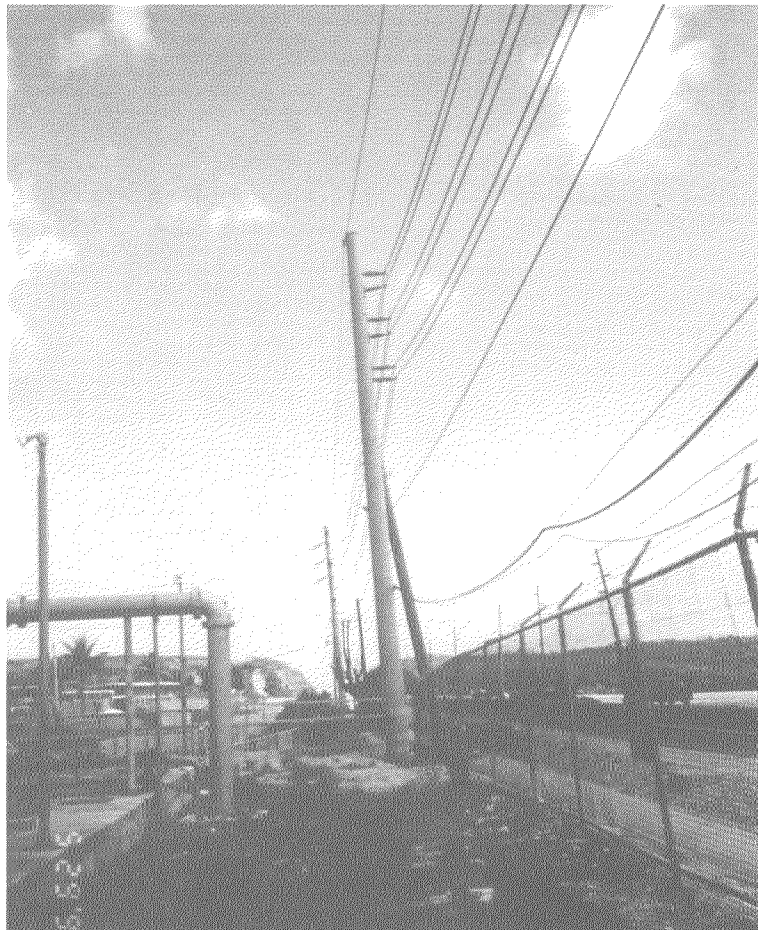
Figure 11: Leaning of the power poles caused by lateral spreading at the Piti Electric Power Plant
