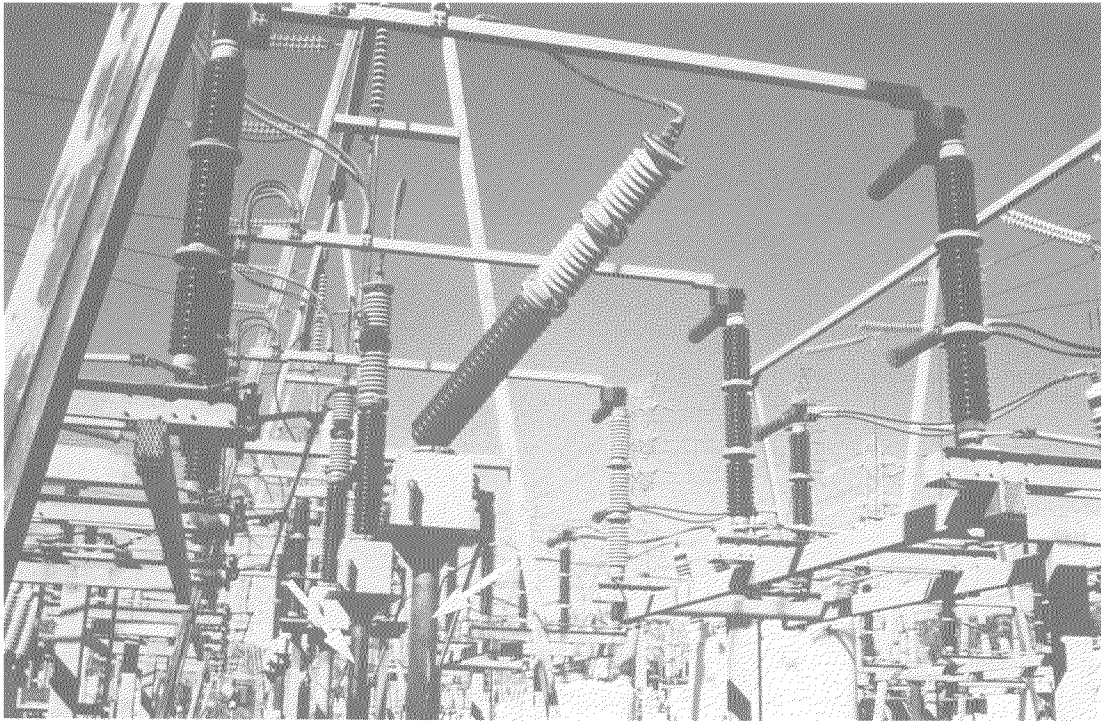
Fig. 6 Discoloration of Support Columns Indicates That Two CVTs Have Failed.

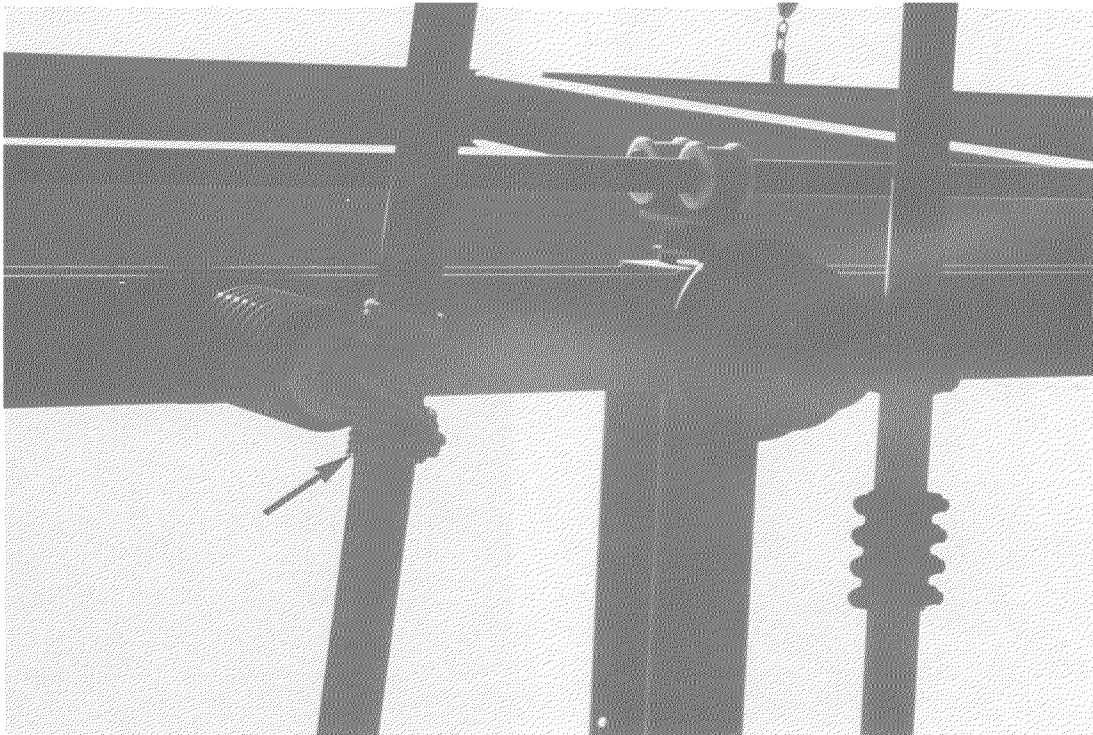
Fig. 7 Rope Used As Temporary Replacement for Damage Hardware
