Damage to Water Pipes During the 1994 Northridge Earthquake

This paper presents damage to pipes of a water supply network system under the control of the Department of Water and Power of City of Los Angeles (LADWP). Site investigation was conducted at San Fernando Valley where the damage to trunk lines, distribution pipes and service pipes were concentrated.

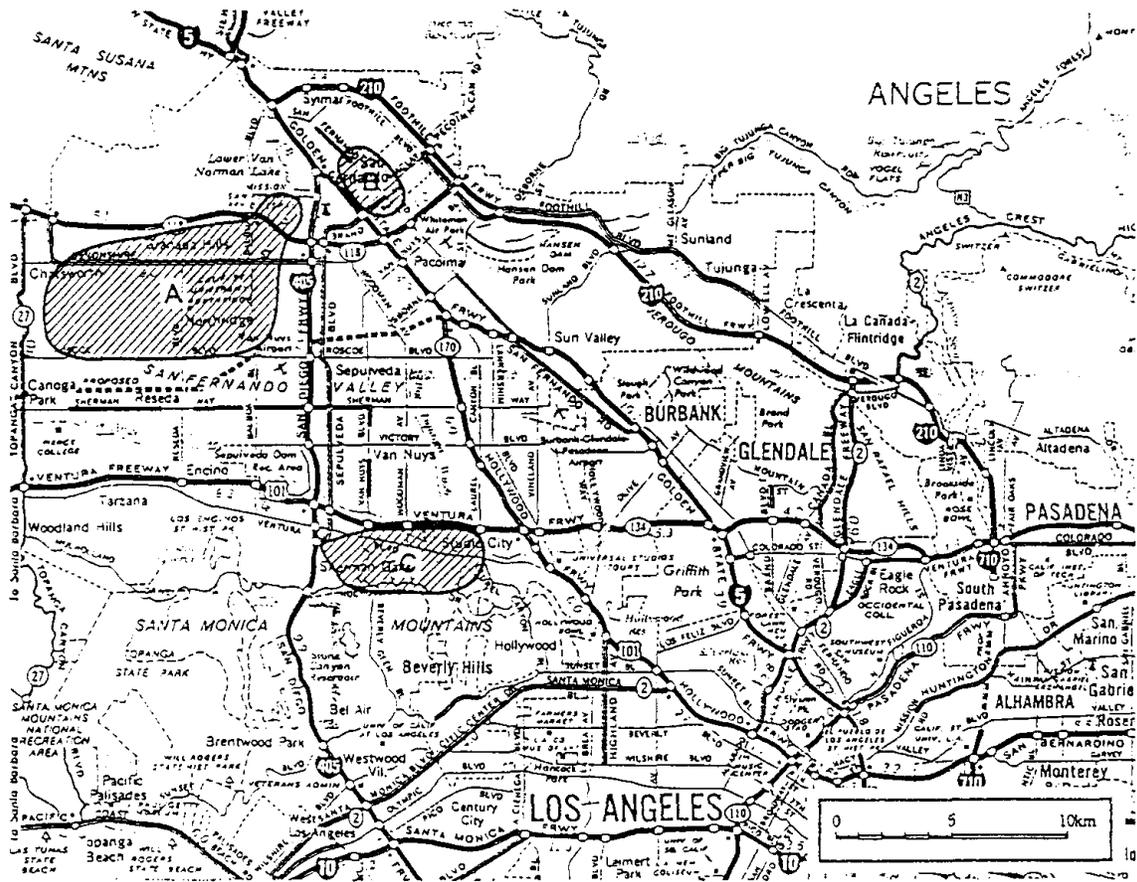
Figure 3 Concentrated Areas of Damage to Distribution and Service Pipes

Approximately 65 % of 1,670 breaks of the pipes were occurred in the West Valley district and 35 % of that in the East Valley district [3][4]. And most of the damage were concentrated in three areas as shown in Fig.3. About 800 breaks were reported within area A, and 60 in area B, and 360 in area C. The number of the damage to the trunk lines were accumulated to 16 including damage to Granada trunk line at Balboa Blvd.

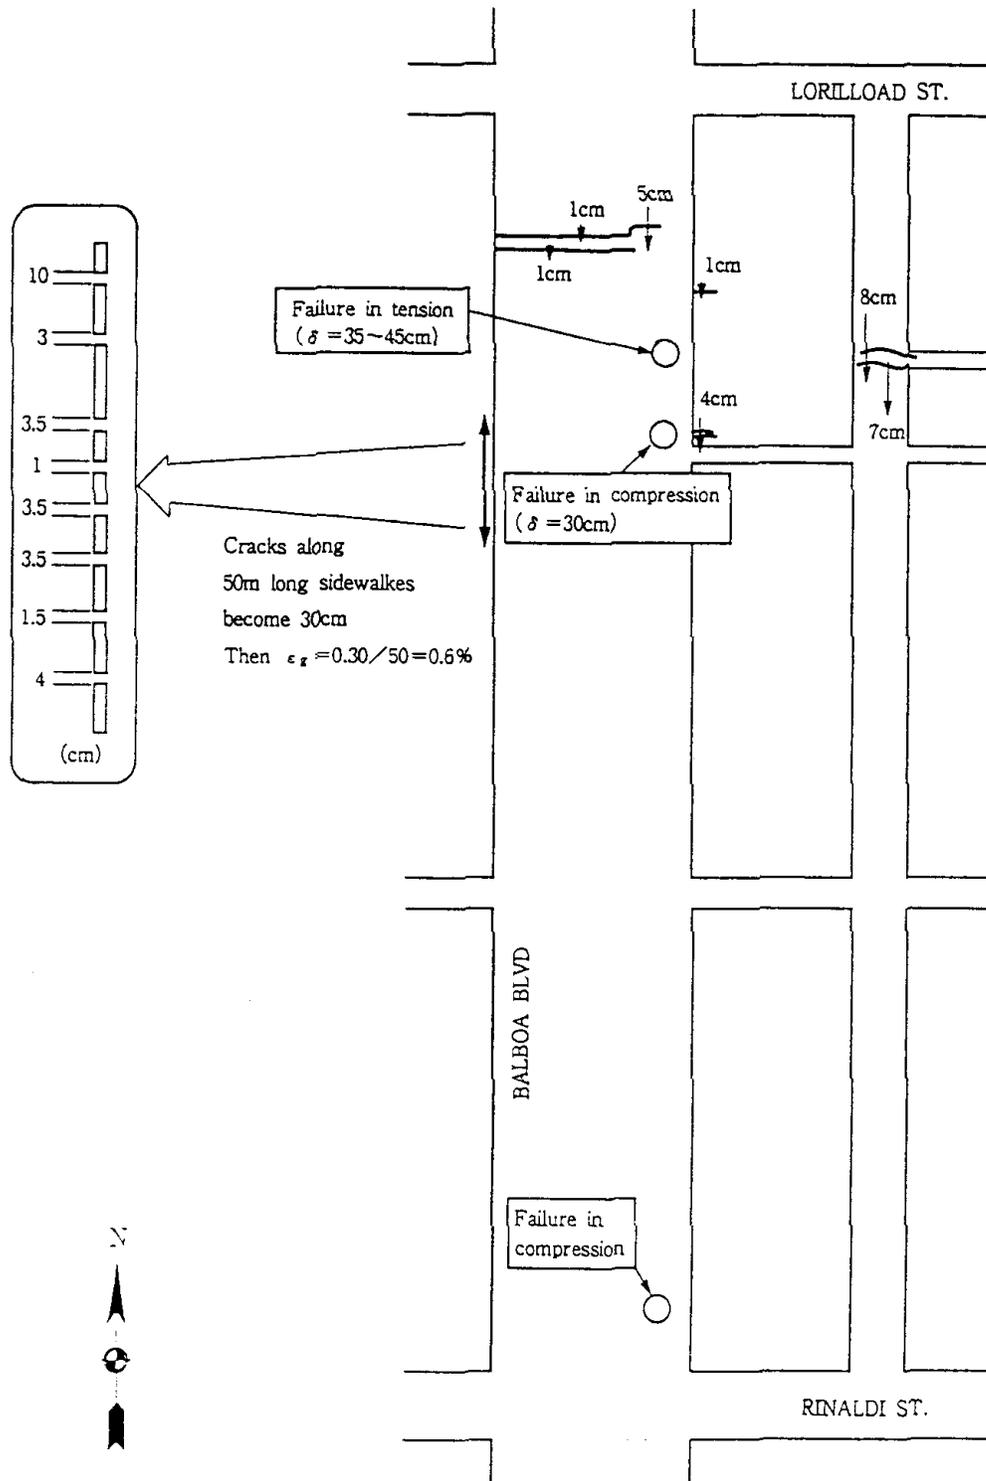
Figure 5 Damage to Trunk Lines at Balboa Blvd. and Permanent Ground displacements

Six breaks were occurred to Roscoe trunk line as shown in Fig.4, which was constructed in 1918 and the diameter ranges from 35 to 42 in. The pipes of Roscoe trunk line were connected with rivets both in the circumferential and the longitudinal seams. Some of the damage can be considered as effects of ground deformation as Fig.5 shows cracks near the points on Roscoe St. where the damage were occurred.

Granada and Rinaldi trunk lines were broken in compression and tension at Balboa Blvd. The different kinds of failures of the two trunk lines were occurred at points whose distance was from 80 to 100 ft as shown in Fig.5. Photo 1 shows a compressed welded bell joint taken from Granada trunk line and the length of compression is estimated approximately 1 ft. The distance of the pipes failed in tension was about from 12 to 15 ft apart from each other. Another compressive collapse was reported at a point close to the intersection of Balboa Blvd. and Rinaldi St.
