A VULNERABILITY STUDY OF THE HOSPITAL DR HORACIO E. ODUBER, ARUBA

The Pan American Organization of Health (POH) has requested us to make a study to evaluate in a qualitative way the functional and structural vulnerability of the Hospital Dr Horacio E. Oduber, located in the L.G. Smith Boulevard, Oranjestad, Aruba, to the eventual occurrence of earthquakes, hurricanes, tsunamis, floods and/or landslides.

In order to undertake this study, an inspection visit was carried out during the lapse November 30th through December 2nd, 2000, with the purpose of making a general recognition of the buildings of the hospital complex. Likewise, information about the original structural project and geotechnical reports of the area of interest were requested, but they were not available. It must be pointed out that lack of adequate information will cast uncertainty in the forecast of structure behavior.

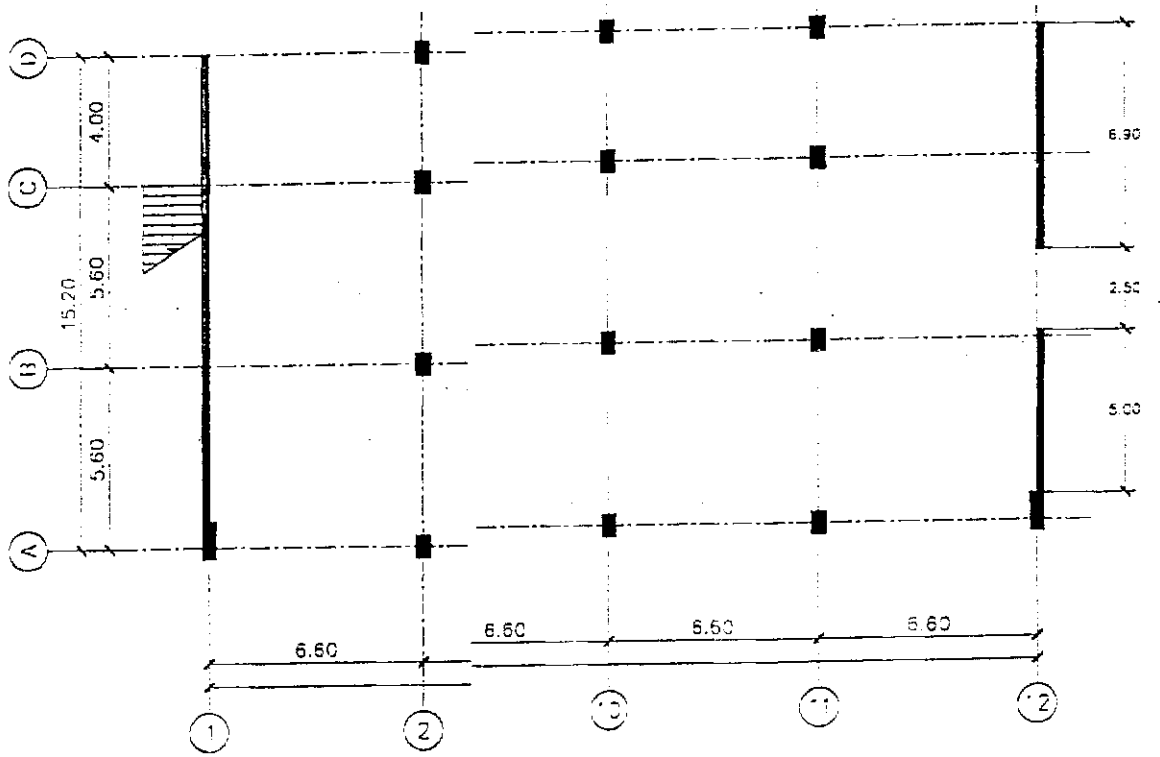
It is a reinforced concrete structure of 6 levels in a rectangular plan with flat plates 20 cm of thick. In the transversal direction, it has 12 resistance lines with 4 columns each one plus 2 walls 20 cm thick and in the longitudinal direction has 4 resistance lines with 12 columns each one (Figure 8).

The columns are rectangular varying with height dimension as verified in site; for example, the columns of the axis A have in the ground level dimensions of 46 x 64 cm and in the level 5, 45 x 51 cm.

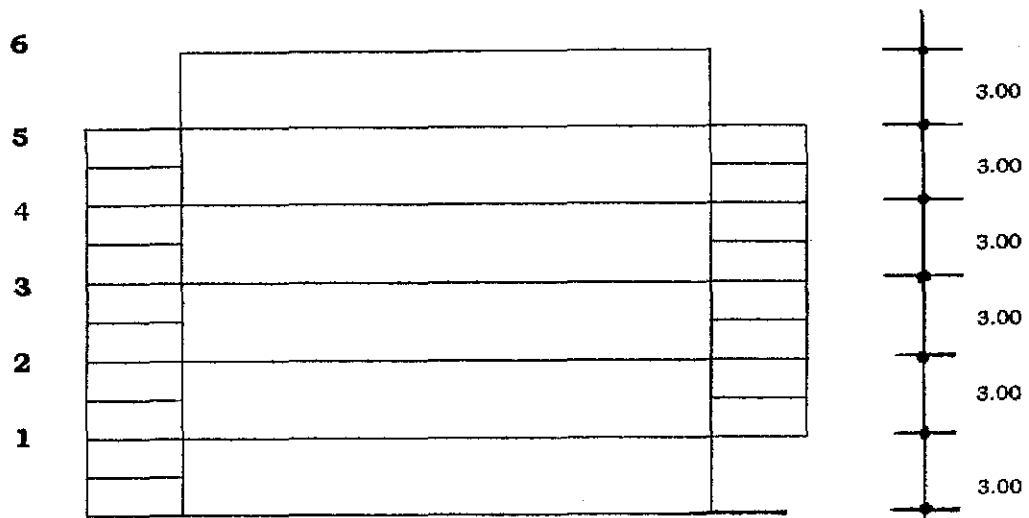
FIGURE 9 Elevation view of Main Building

Figure 9 shows the building elevation, in which one can see that the level 6 has a smaller area (also see Photos 3 and 6).
