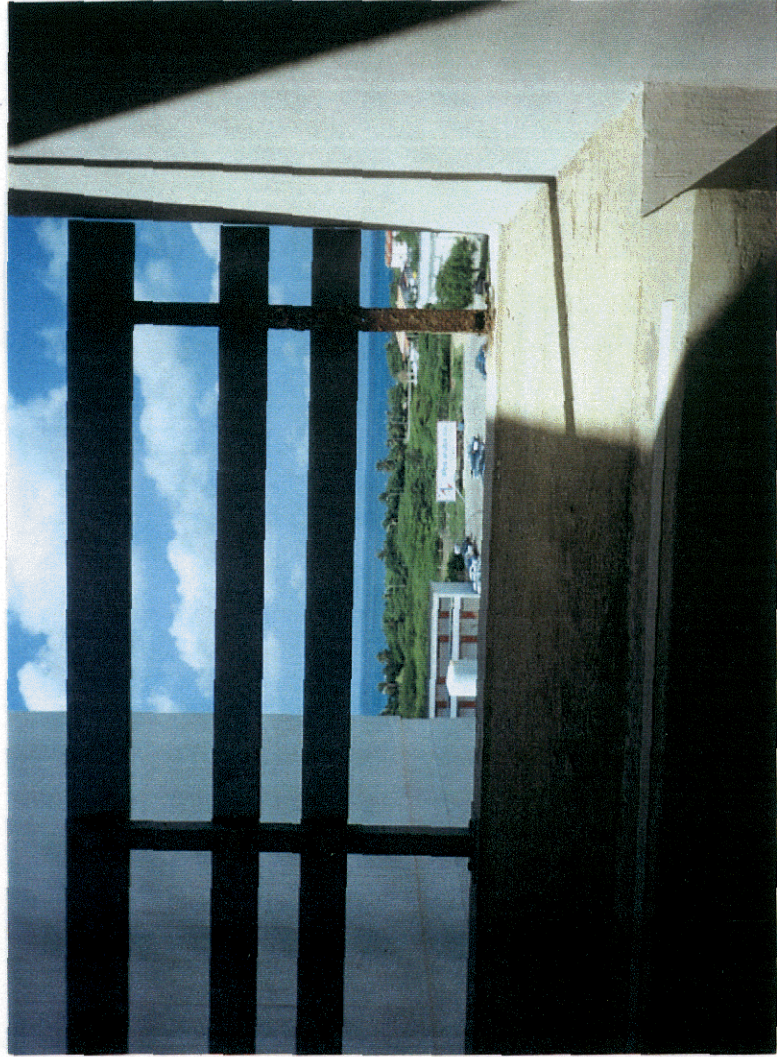
PHOTO 15 Corrosion spots on fence in the emergency stairway

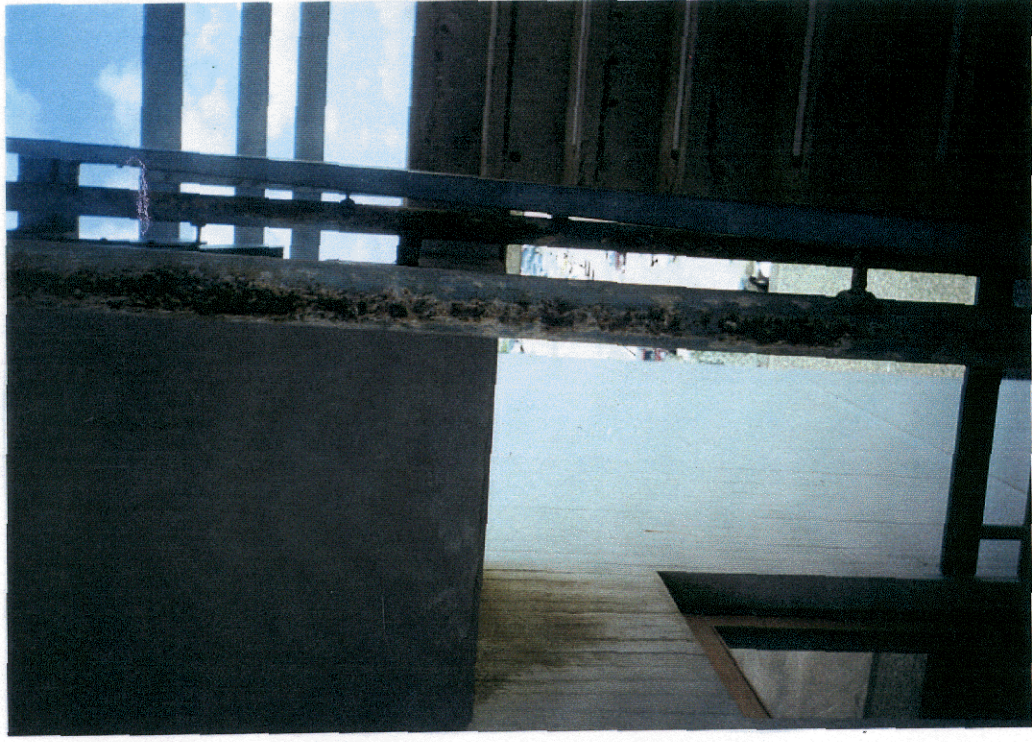
PHOTO 16 Corrosion spots along the steel column in the emergency stairway
