## **B.- INSTALLATIONS OF THE MAIN HOSPITAL OF SAINT VINCENT, W.I**

### **B.1.- GENERAL DESCRIPTION**

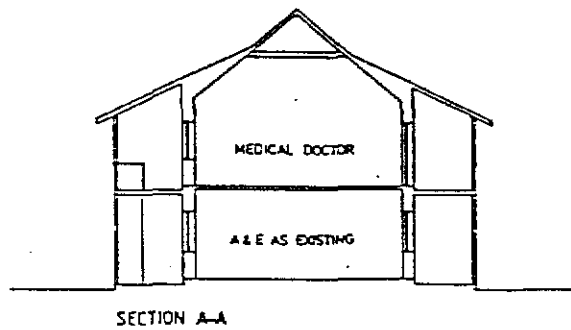
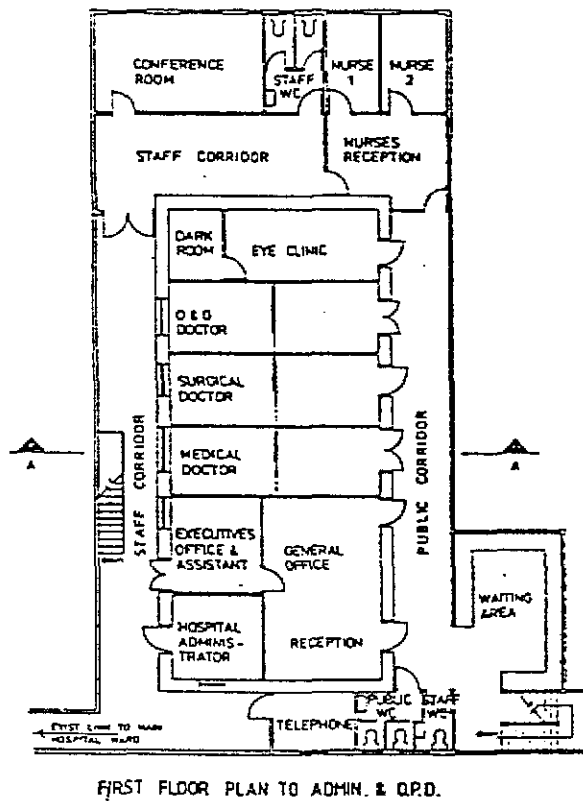
FIGURE B6 LAYOUT MADE BY TVA IN APRIL 1987, OF THE TOP FLOOR AND CROSS SECTION OF BUILDING A

The detailed map made by TVA in April 1987 of the top floor and cross section of Building A is reproduced in Figure B.6.

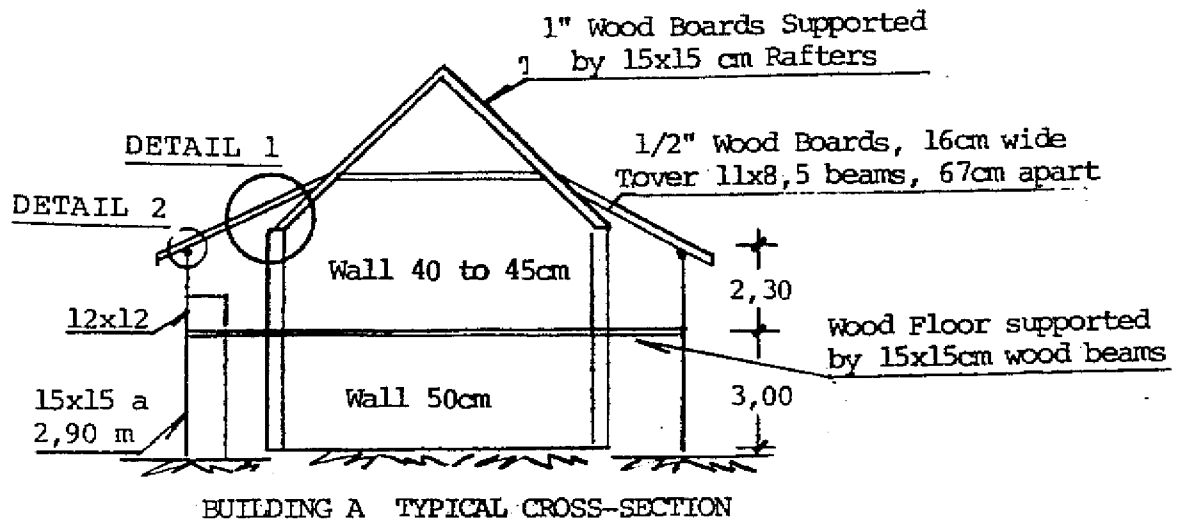
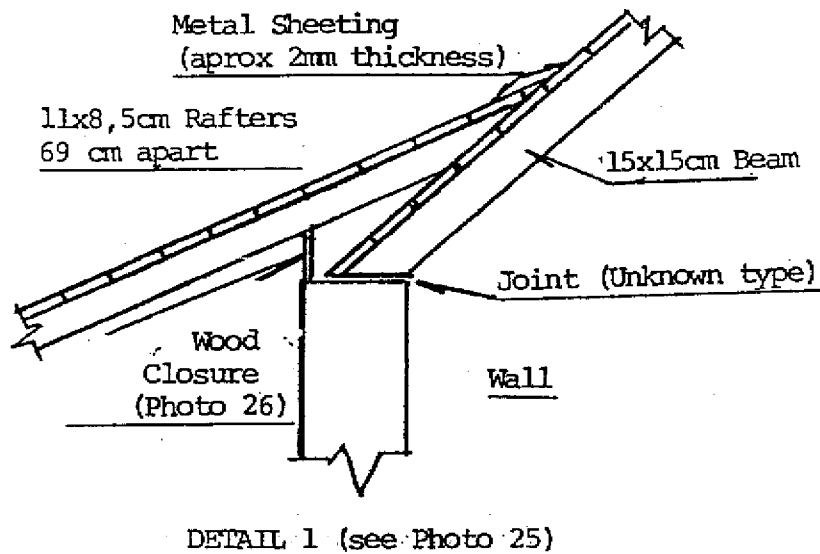
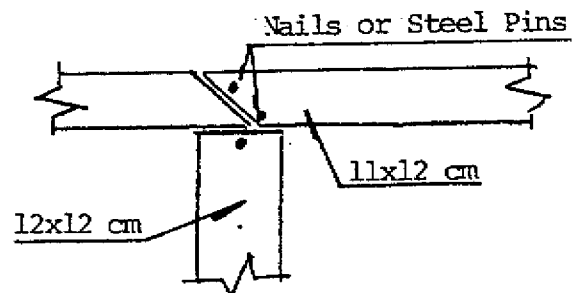
**FIGURE B7 DETAILS OF THE ROOF ELEMENTS OF BUILDING A**

The banister elements, with diagonalized members, confer bracing in the frame's longitudinal direction (12 x 12 cm columns) that support the corridors' roof (see Figure B.7).

The joints of the horizontal elements, with the columns that support the roof, deserve to be strengthened to absorb the tensile forces transmitted by wind suction (Photo 31).

Note: Steel sheeting is nailed to the wood roof by aligned nails similar to those shown in Photos 39 & 40, 25cm apart. They fall into line every 90 cm approximately. At gable-ends separation is halved

DETAIL 2 (see Photos 26 & 31)

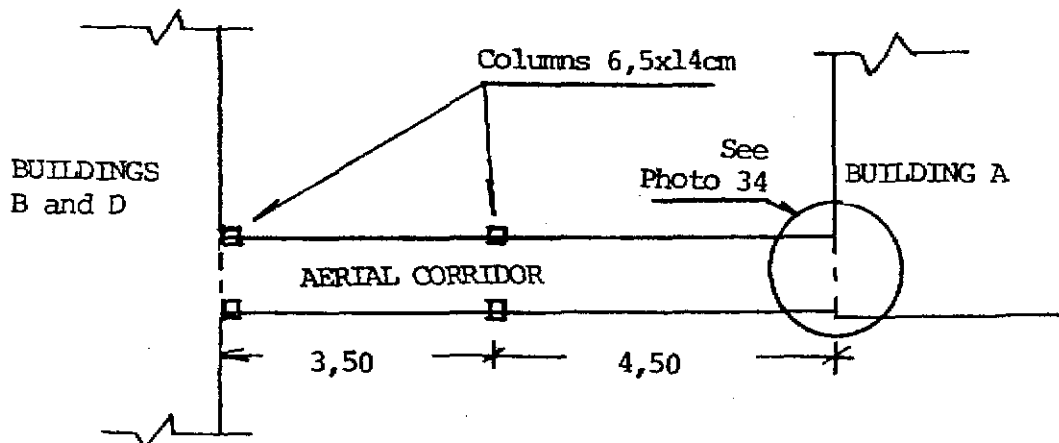
FIGURE B.8 LAYOUT OF THE AERIAL CORRIDOR BETWEEN BUILDINGS A AND B-D

The aerial corridor, that goes from Building A to Building B-D, level 2 (Photo 33), is 8 m long and 1 m wide with internal metallic members at roof level. This corridor is supported by four 6,5 x 14 cm columns, very slender, layed in the way illustrated Figure B.8. The support at Building A's facade (Photo 34) requires to be improved, for example with a metal corbel support.

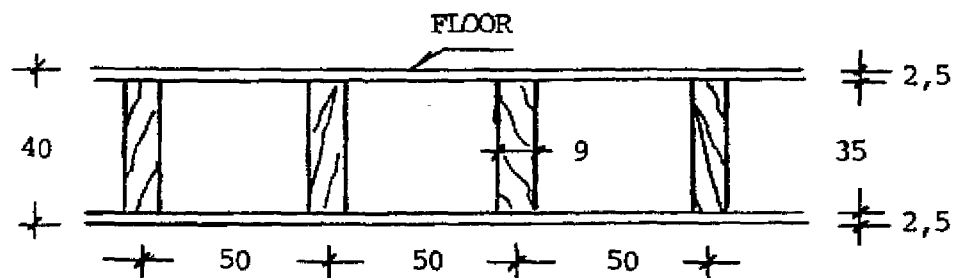
FIGURE B.9 CROSS-SECTION OF THE WOODEN SLAB

The floor-slabs are made of wood. In building B details of such can be observed, they being constituted by a wooden section shaped as a box, just as it is schematically indicated in Figure B.9. This floor is directly supported on the masonry walls. It is possible that the floor-slab of Building A is similar to the recently described.

In Building C, the floor-slab of the area corresponding to the Main Laboratory, is wooden; underneath which, the Pharmacy is found. This slab does not seem to be in good conditions and for the reasons given later on, it deserves to be changed.

Taking into consideration the fire hazard and what has been said in Section B.2.4, it is advised to improve and/or reinforce all the floor-slab, for example placing a reinforced concrete slab. It is also advised to anchor to the walls those equipments susceptible to tipping over, that in case of breackage or spill could limit the operation of the services in Building C.

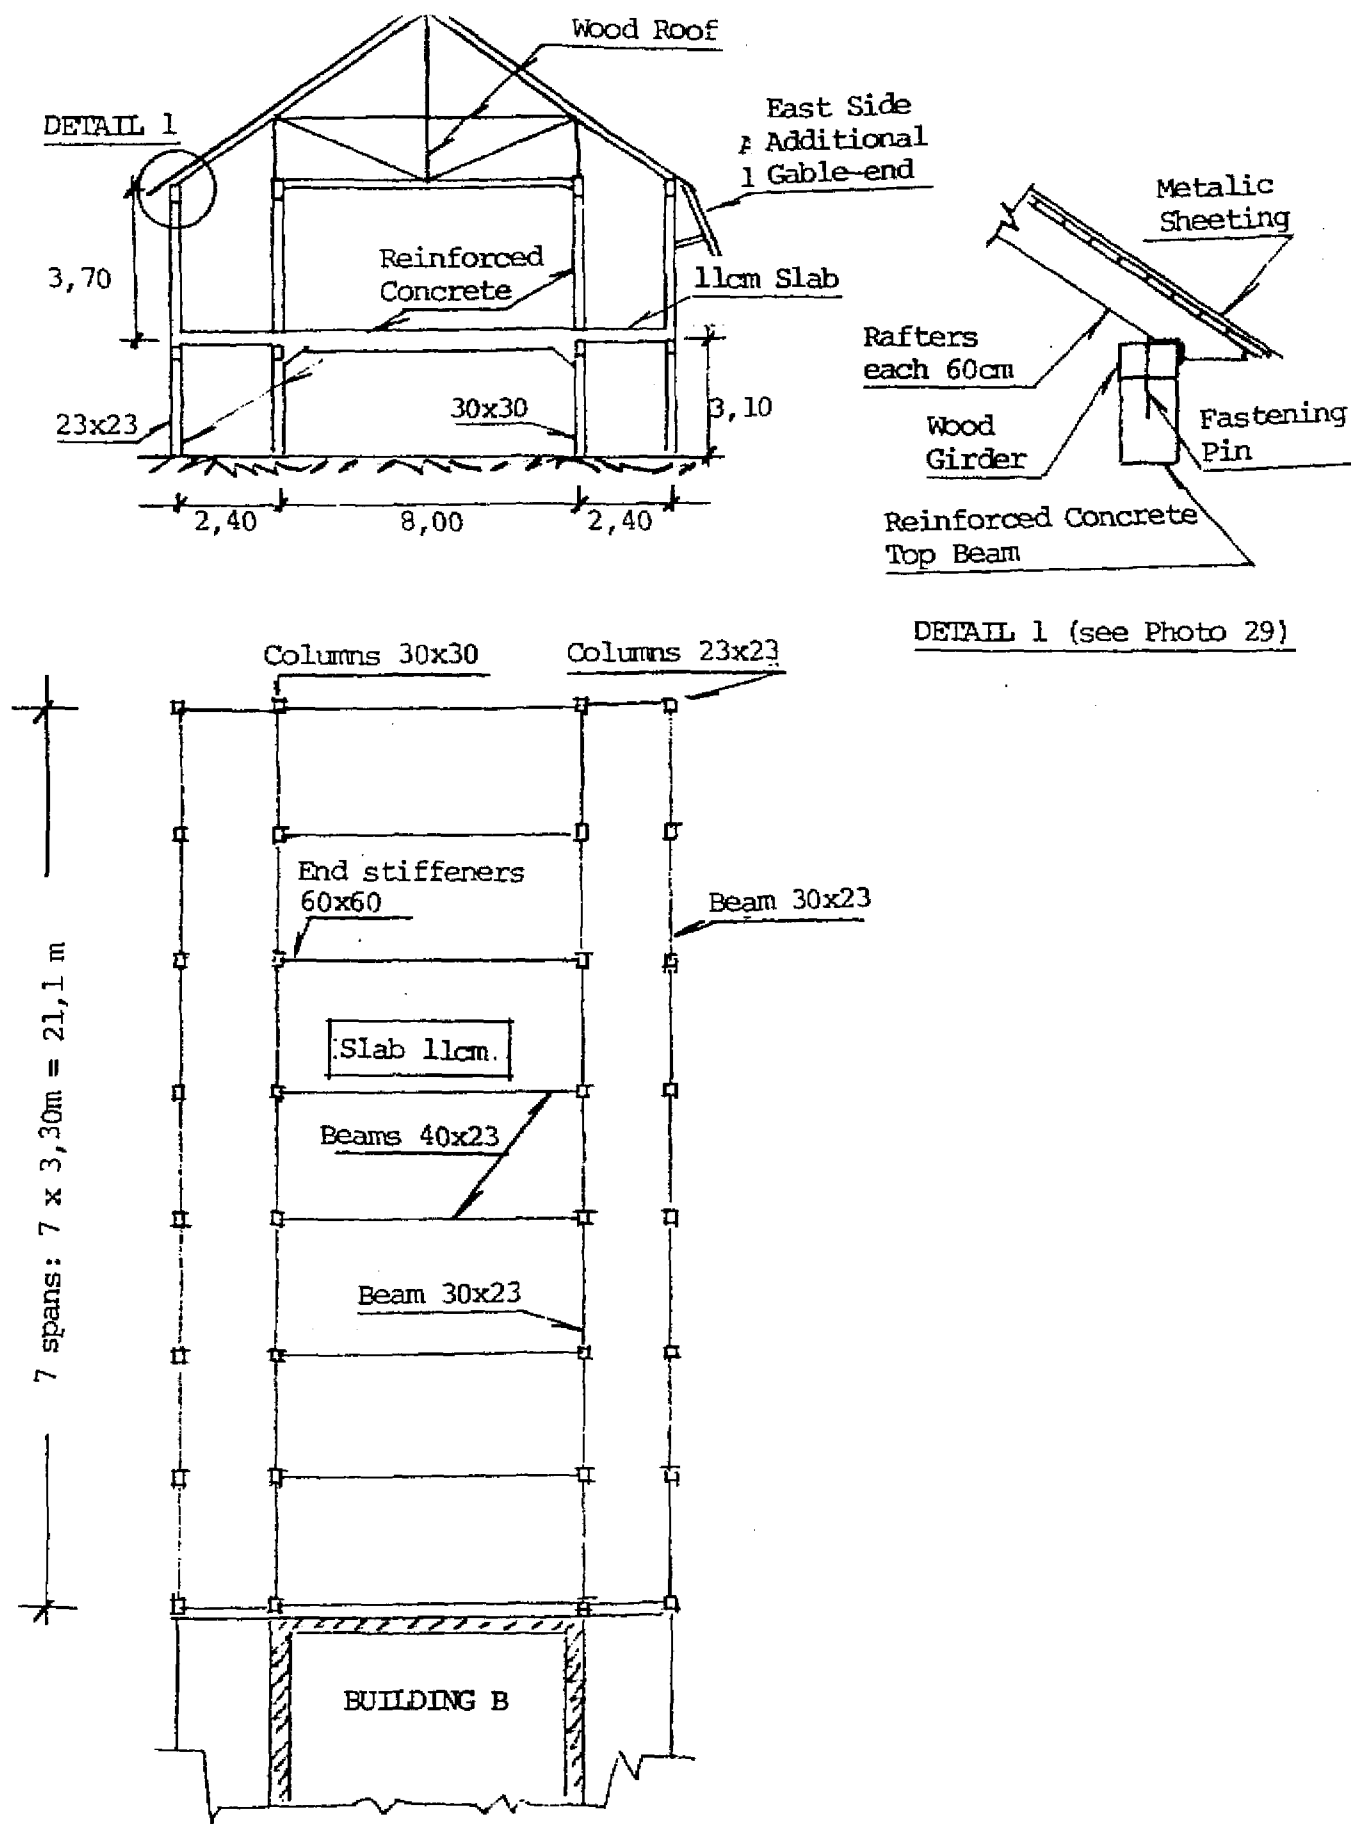
FIGURE B10 PLAN AND APPROXIMATED CROSS-SECTION OF BUILDING D

It is a two levels reinforced concrete building, with light roof, reinforced concrete slab and rectangular plan, placed back-to-back to the Northern face and giving continuity to Building B (see Figure B.10).

With an adequate structural configuration, the central span is about 8 m long, covered by beams in transverse direction with variable transition sections of about 60 cm, continuing on each side along the corridors; the slab rests on top of

the transverse beams and 30 x 23 cm longitudinal beams. The peripheric columns are of 23 x 23 cm and the internal 30 x 23 cm with the greatest side in the transverse direction.

The wooden roofing details were not inspected due to the presence of a hanging false roof placed more than 3 m high.

The connection bolt given in Detail 1 of Figure B.10 (Photo 29) could only be found every 2 to 2,5 m, with a diameter of about 3/4" (2,8 cm<sup>2</sup>) For the foreseen suctions of 62,1 Kg/cm<sup>2</sup> (see Table C.1, Section C.2.2) the expected forces would reach of a maximum:

$$2,5 \times 62,1 \times 2,40 / (2 \times \cos 32) = 220 \text{ (kg)}$$

which are relatively small forces.

This bolts were not identified in the Eastern facade side, side in which there is an additional gable-end to limit the rain water entrance to the corridor, according to what is indicated in the cross-section of Figure B.10.

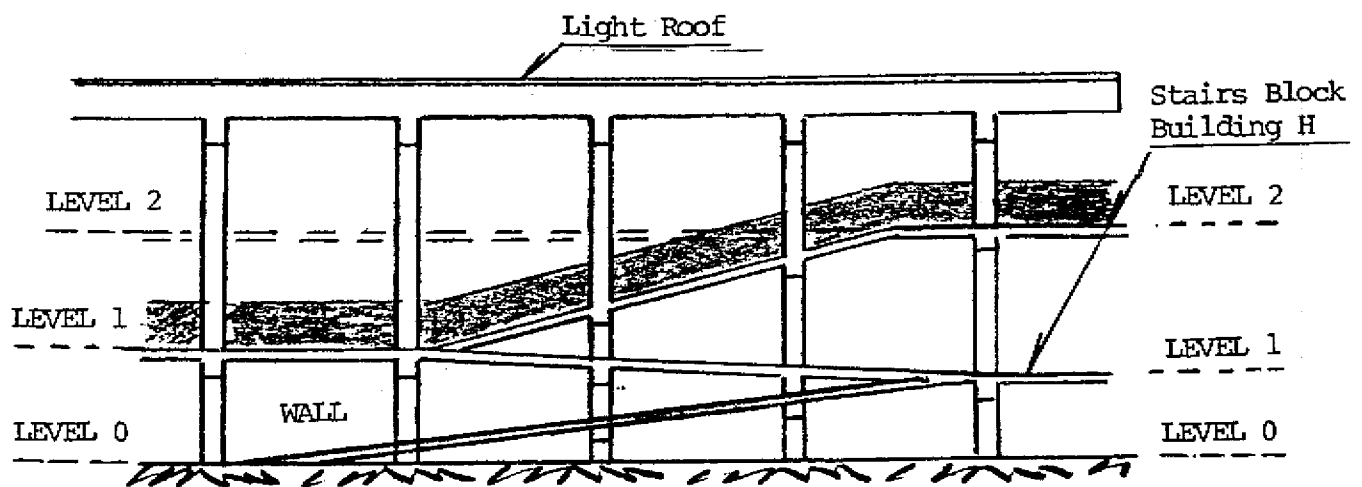
**FIGURE B.11 SKETCH OF BUILDING I (REINFORCED CONCRETE MONOFRAME)**

More than a building, structure I is composed of a reinforced concrete frame(also called monoframe) with five columns that connect, by means of ramps and horizontal sections, Buildings G, E, B, J and H. In Figure B.11 an approximate sketch of this structure is given, that typically has columns of 50 cm in the plan of the figure times a width of 35 to 37 cm. The top beam has a height of about 80 to

90 cm, providing rigidity and stability to the system in its own plan; the roof is made of wood covered with metallic sheets.

On the frame's perpendicular plan and at each side of the frame, a group of cantilever beams are found; they support the horizontal corridors in each level, as well as the ramps that allow displacement from one corridor to another. The stability normal to the frame is reached through the interaction with the neighbouring buildings and the wall placed at the lower level.

Such interaction, with visible joints of less than 1 cm of separation, surely will be a source of collision between the adjacent slabs with which minor local damages are expected; no specially vulnerable situations were found in this structure.
