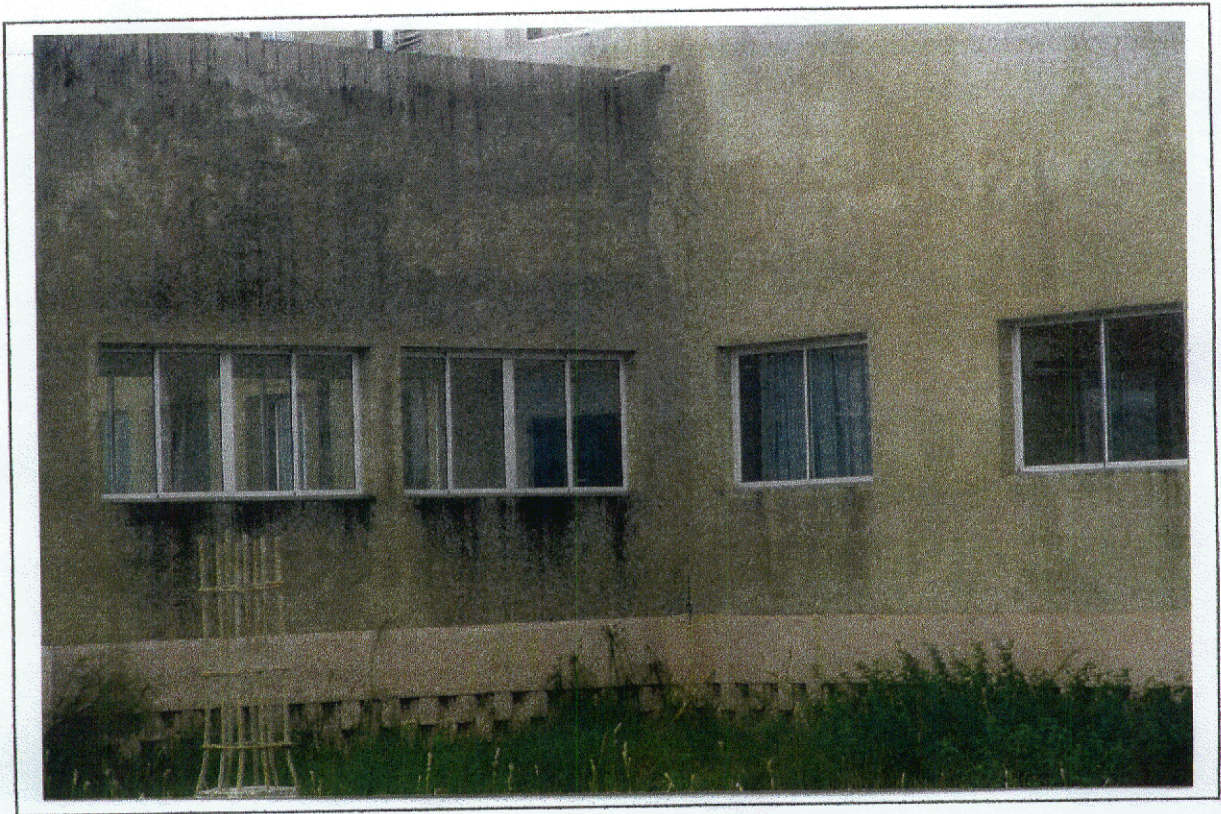
Photo 21 - External wall of the Hospital

Note the crack at the corner.

It would have been preferable to have a separation joint at this corner location.

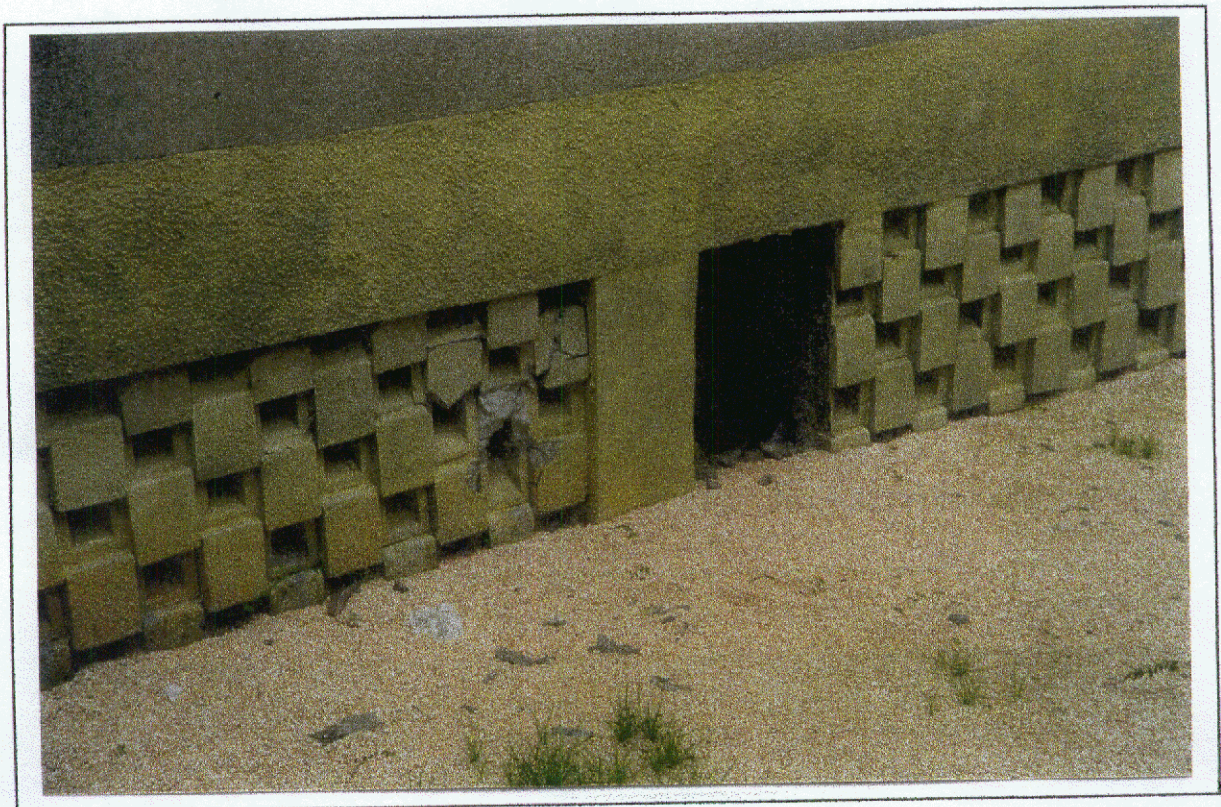
Photo 22 - Informal entrance to the underside of the lowest floor of the Hospital
Conditions for maintenance repair and replacement of services are too difficult.
