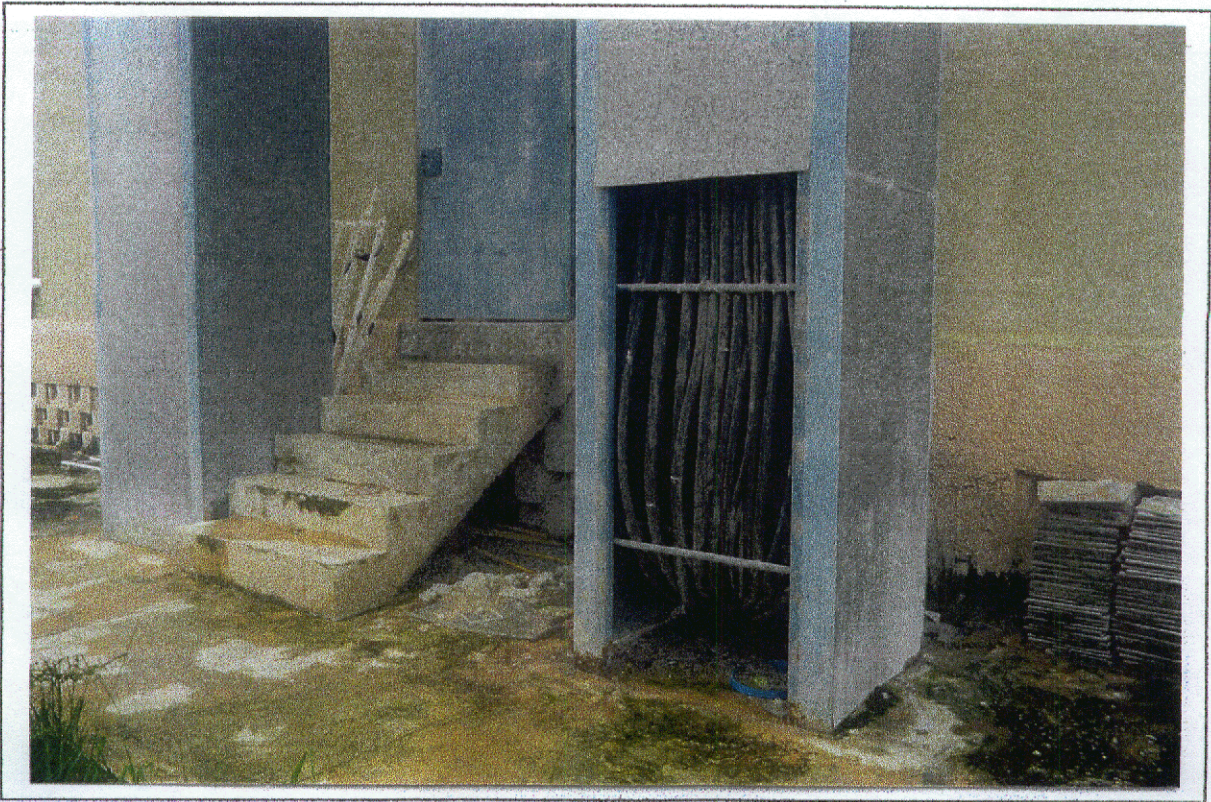
**Photo 23 - Electrical Cable Duct**

**Metal panels (covers) removed by sub-hurricane winds**

**This contributes to debris which could lead to collateral damage of adjacent facilities.**

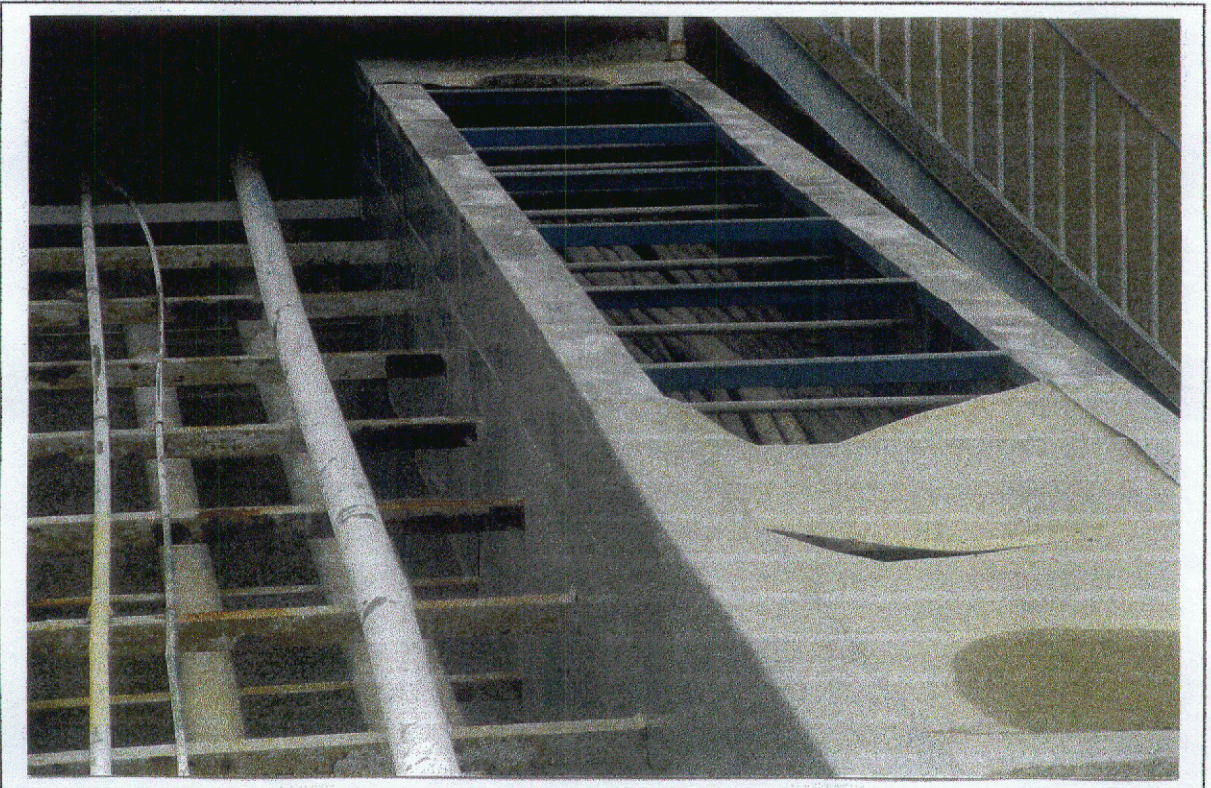
**Photo 24 - Electrical Cable Duct**

**Metal panels (covers) removed by sub-hurricane winds**

**This contributes to debris which could lead to collateral damage of adjacent facilities.**
