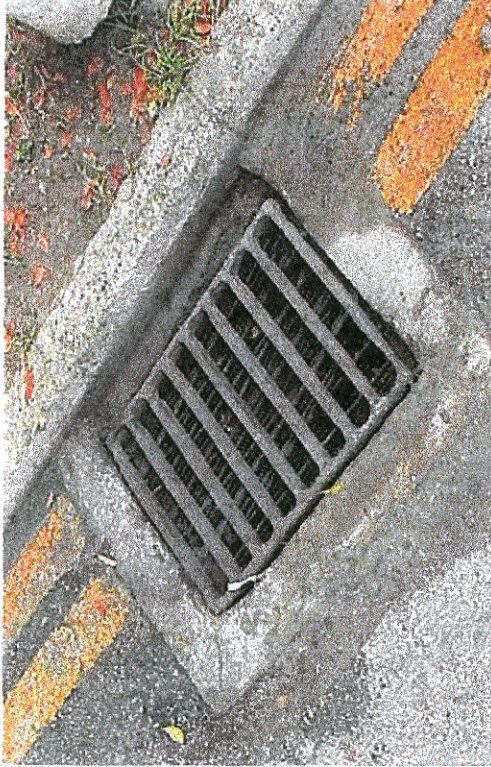
**Photo 41.** One-way avenue to the East of the site. A drainage grille combined with a fine mesh to collect debris is used for stormwater drainage.

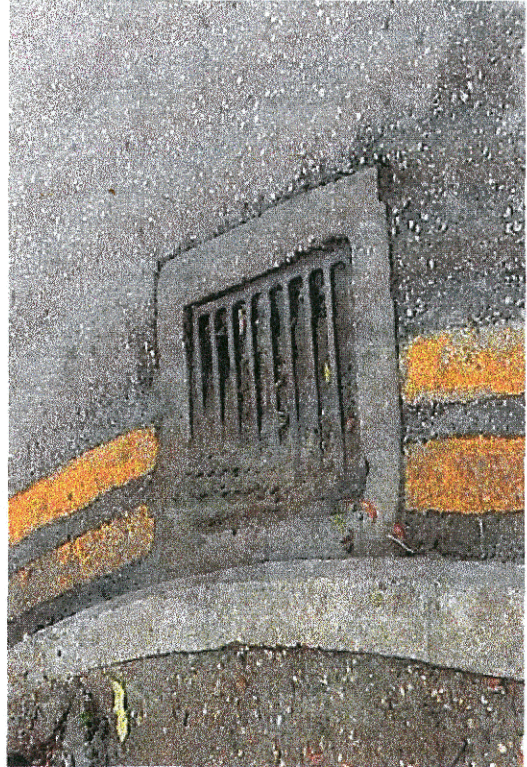
**Photo 42.** Drainage grille with mesh blocked with silt.
