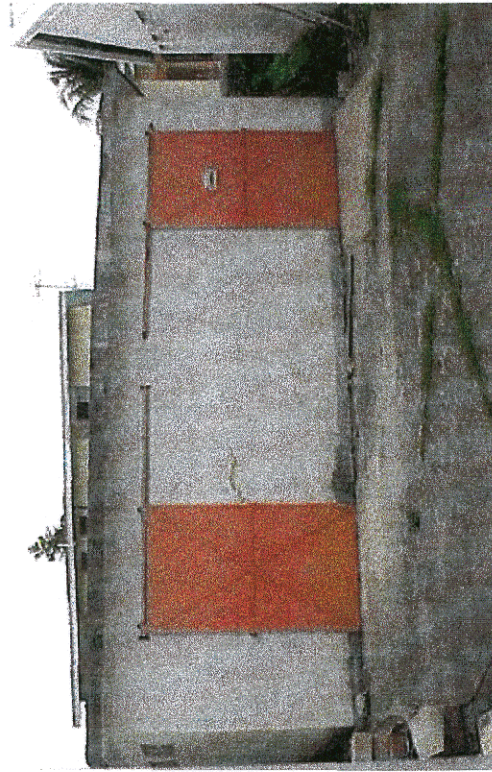
**Photo 5.** The Inflammable Store, between Physiotherapy and the Maintenance Store.

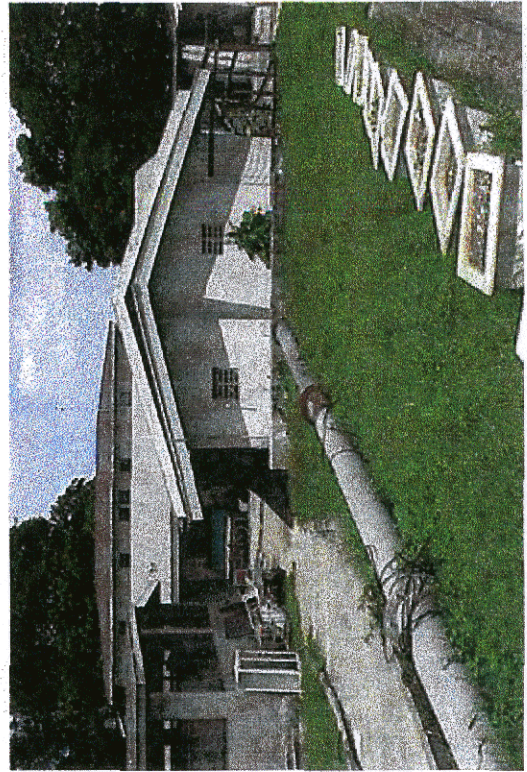
**Photo 6.** Workshop #1 as seen from the North-East.

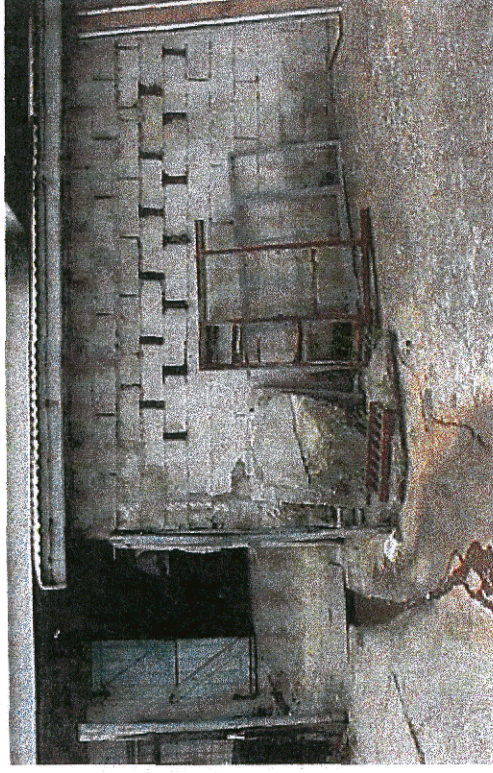
**Photo 7.** Small shed on the North end of Workshop #1. The workmanship of the horizontal courses of the mortar joints between blocks is poor.

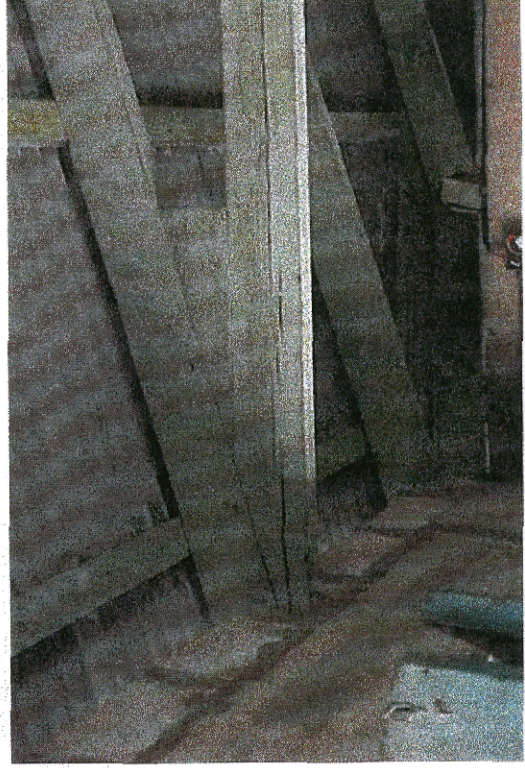
**Photo 8.** Splitting of the timber along the grain at the support of a roof truss in Workshop #1.
