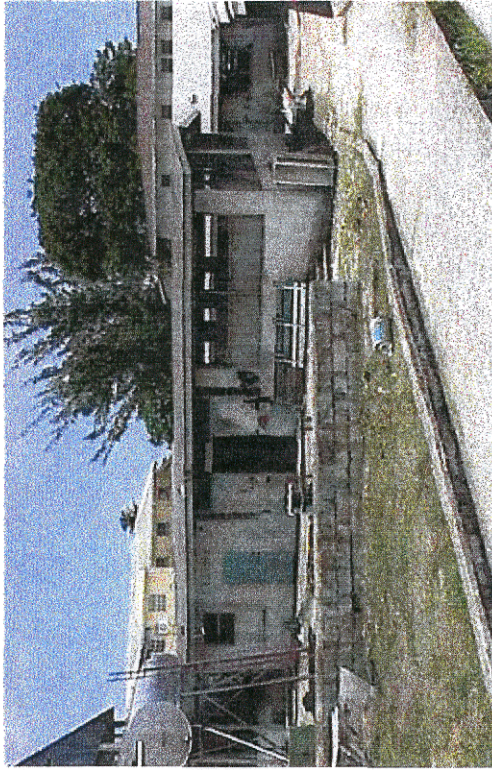
**Photo 9.** A view of Workshop #2 from the East. Flooding of both workshops due to stormwater flow behind this building from the Boiler House area has been reported.

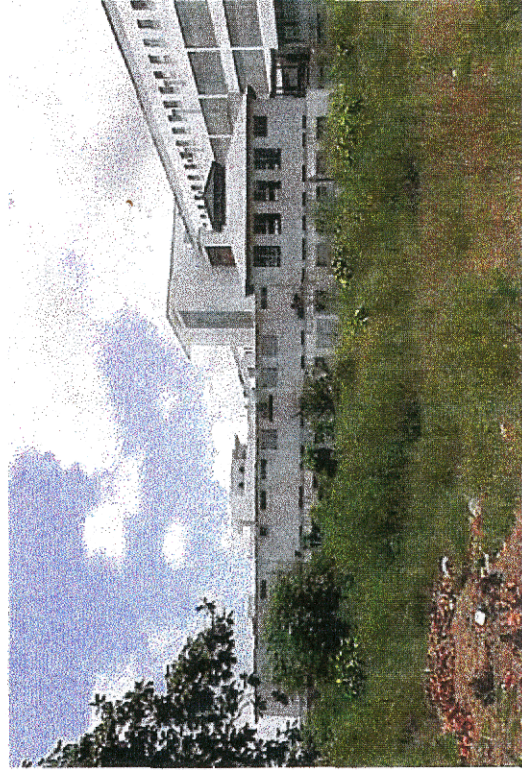
**Photo 10.** The Physiotherapy Department and Chapel, as seen from River Road to the South.

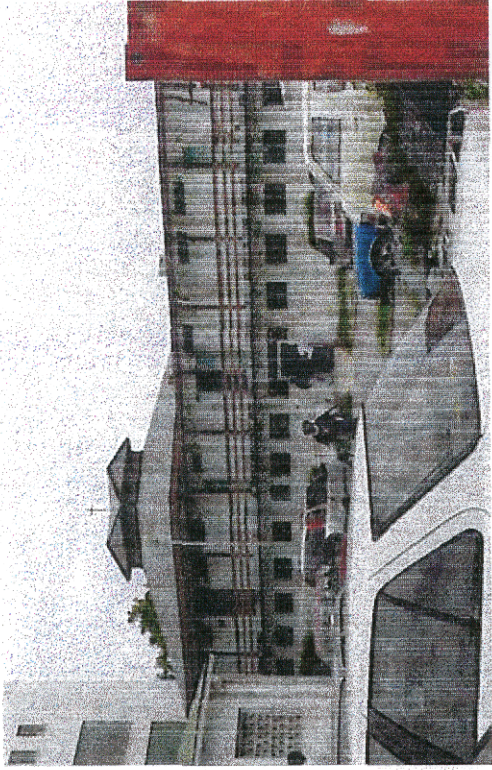
**Photo 11.** A view of the entrance of the Physiotherapy Department.

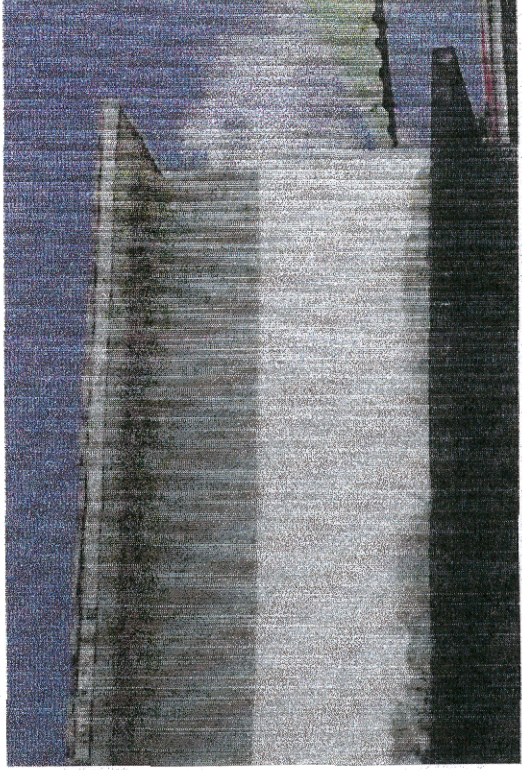
**Photo 12.** A long, diagonal crack at the upper North-East corner of the Physiotherapy Department. This crack continues along the East perimeter wall at the same level.
