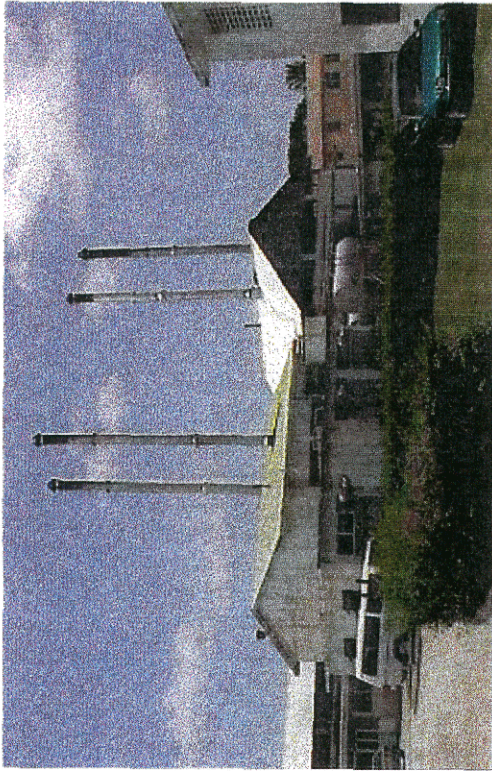
Photo 13. The Boiler House, as seen from the North.

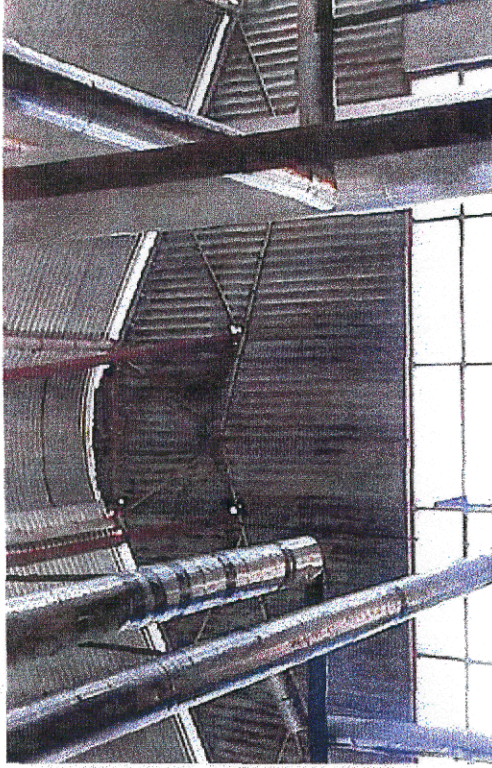
Photo 15. The roof of the Boiler House has been reported to be leaking.

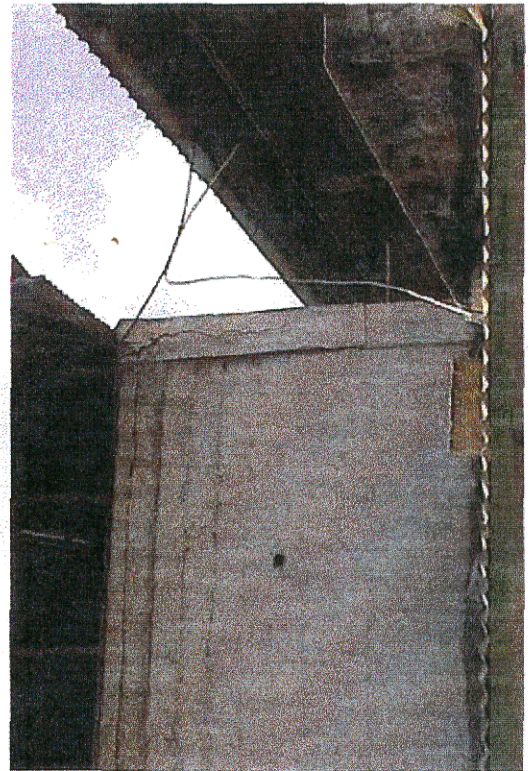
Photo 14. A long vertical crack in the Southern corner column of the Boiler House.

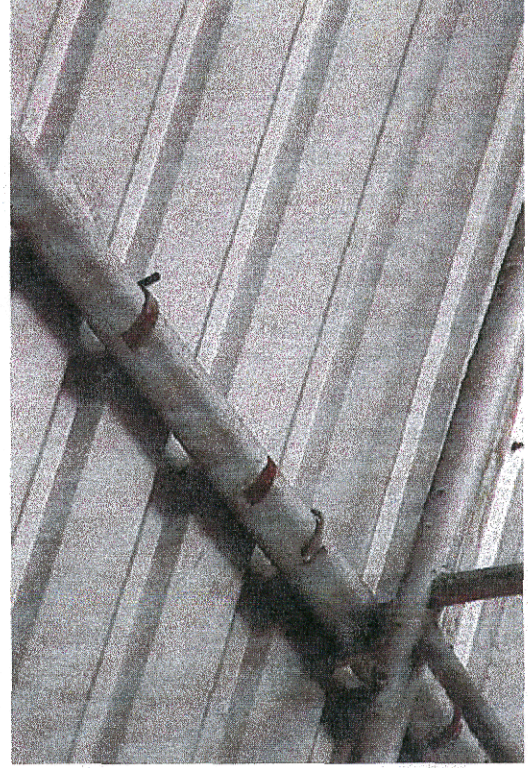
Photo 16. The hooked bolt detail used in both the Boiler House and the Laundry House to tie the roof sheets to the purlins. This detail is inadequate for hurricane resistance.
