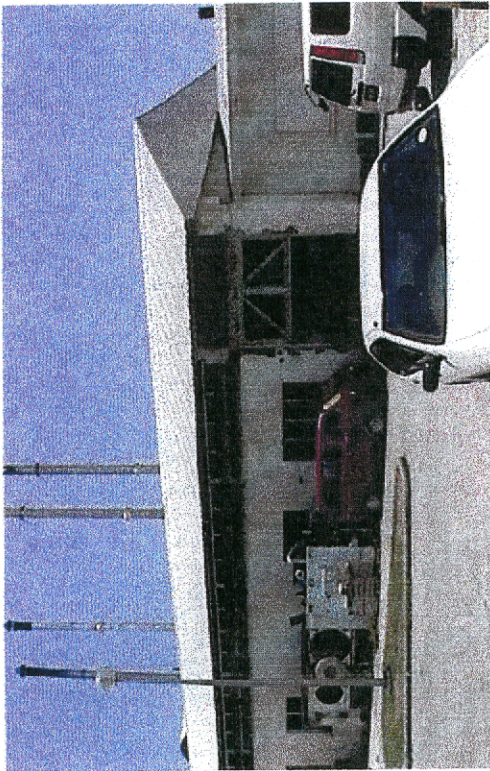
**Photo 17.** A partial view of the Laundry House from the West.

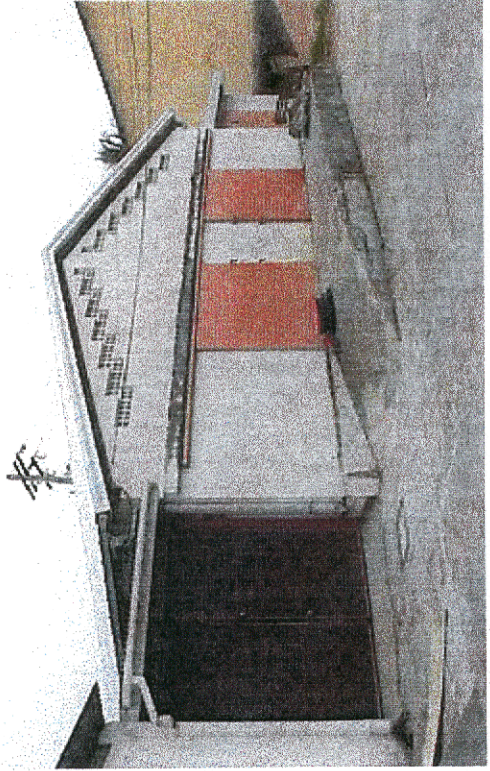
**Photo 19.** The Maintenance Store as seen from the North-West. The gate closes off the covered link between this building and the Linen Supply Store.

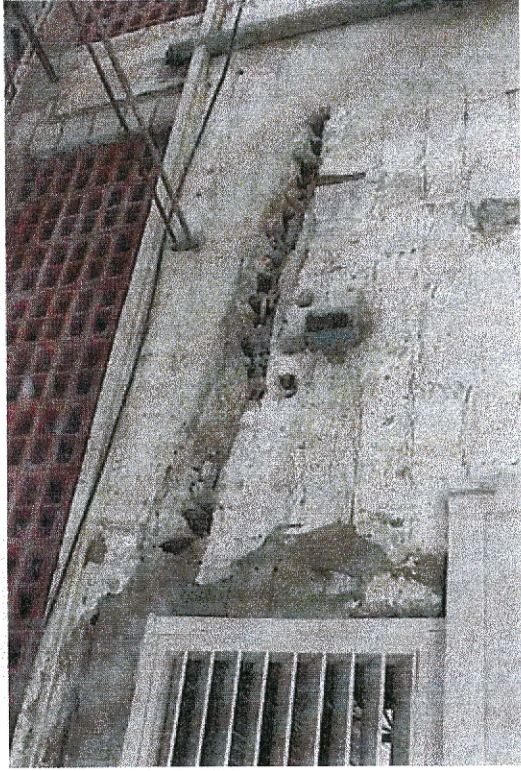
**Photo 18.** Extensive damage to blockwork in the East wall of the Laundry House.

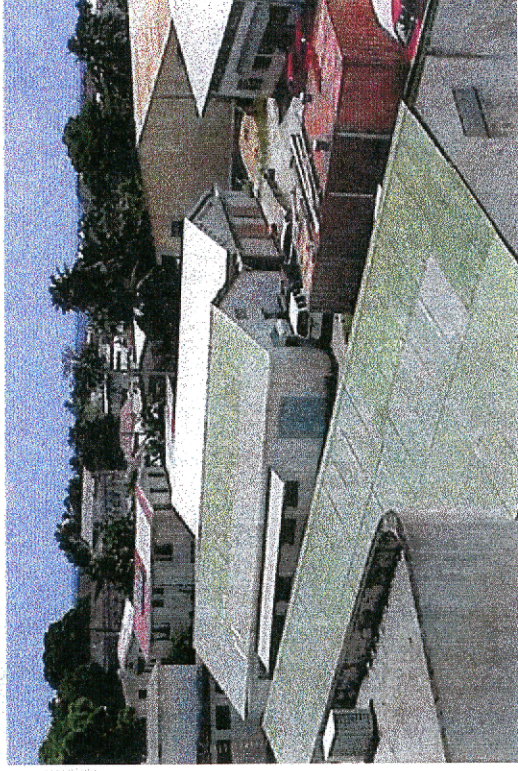
**Photo 20.** The close proximity of the Linen Supply Store and the Maintenance Store, coupled with the covered link, makes them appear to make up one building.
