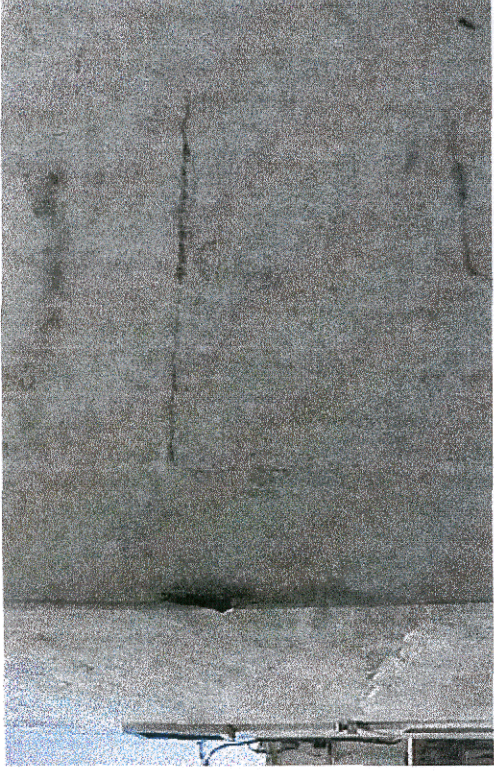
**Photo 35.** An example of junction cracking in the walls. The interface of structural elements and the infill clay brick wall is clearly delineated by these cracks.

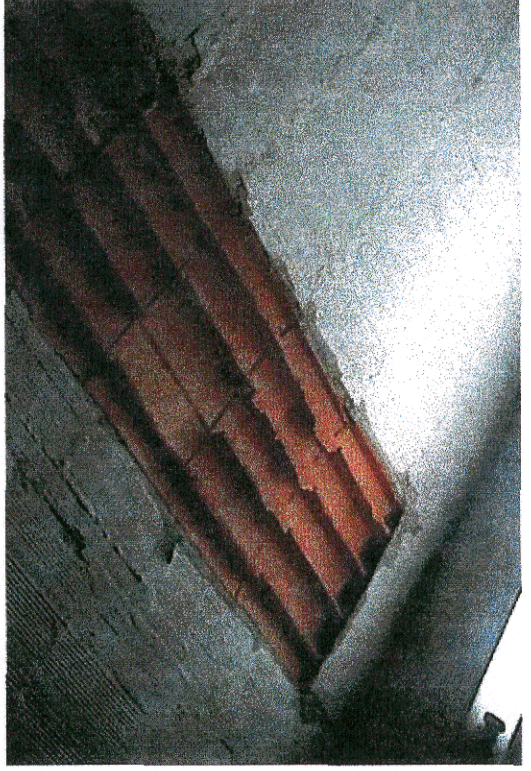
**Photo 36.** Damage to the soffit of an SB Slab in the South Block. The brittle nature of fired clay results in the unexpected collapse of broken portions of clay 'pots'.
