Appendix E

Sketches
for
Short-Term Measures
to
Mitigate Damage
due to
Hurricanes

NOTES		SCALE: Not To Scale
-	Bridgetown, Barbados	DATE: Aug 98
	Roof Details at Eaves, Ridges & Gable Ends	JOB No: CEP/20432
	CONSULTING ENGINEERS PARTNERSHIP LTD	SKETCH No: 3

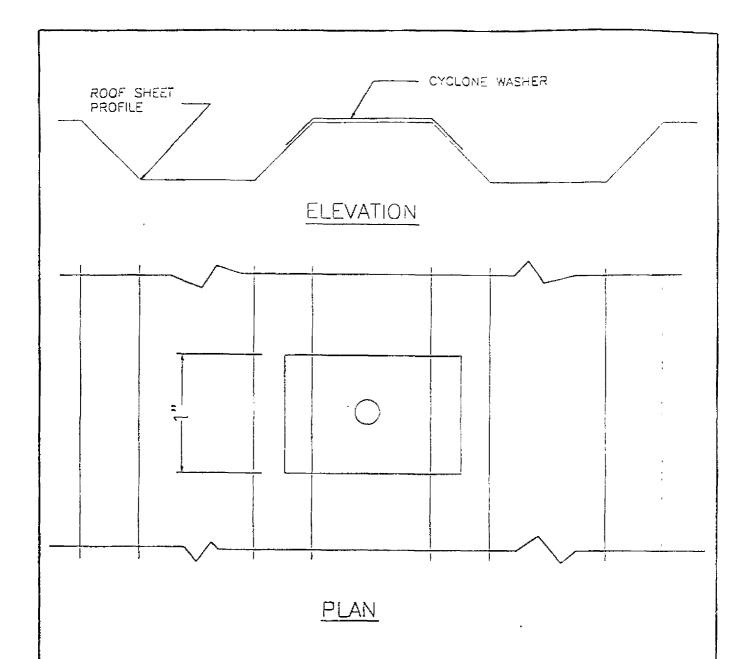
SHEETING FIXINGS TO BE AT EVERY CORRUGATION ON THE THREE NEAREST PURLINS AT ALL EAVES, RIDGES AND GABLE-ENDS.

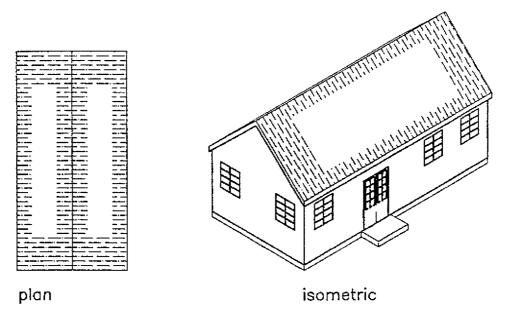
gable roof

The more vulnerable areas of roofs
