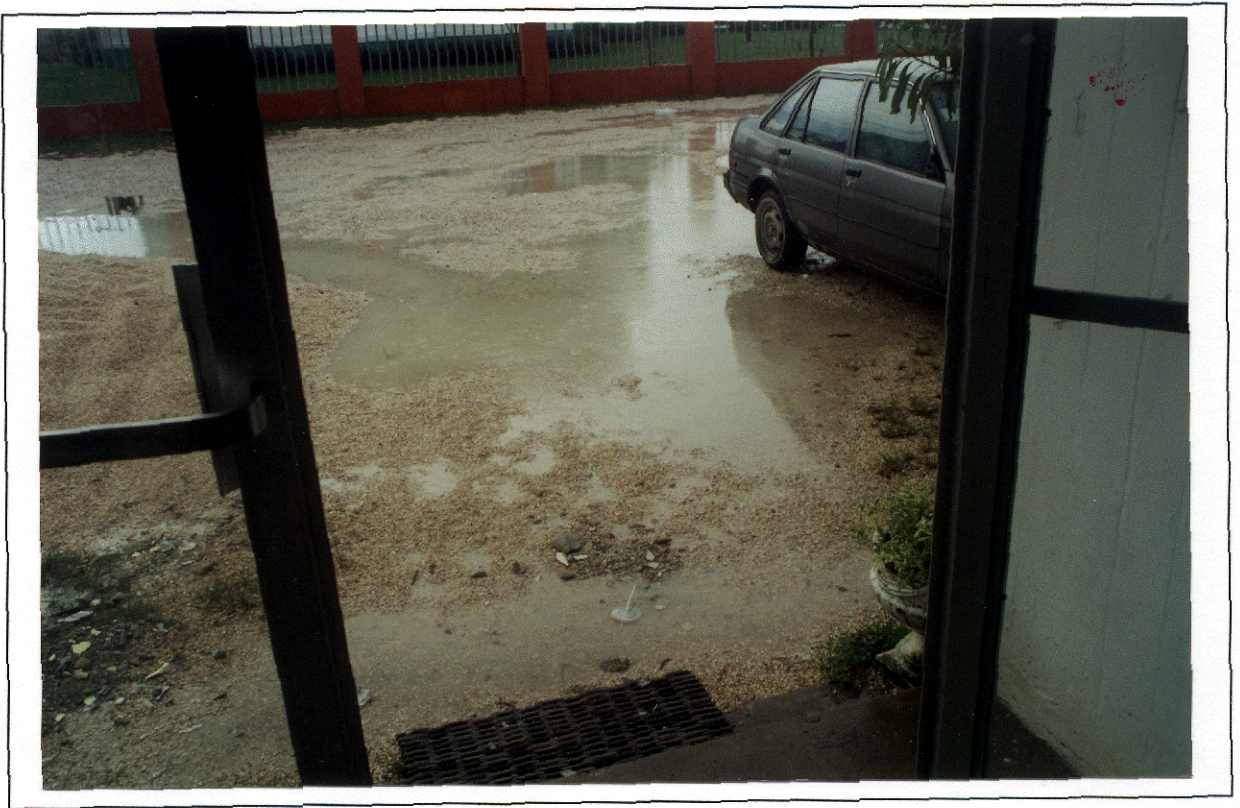
Photo 7 - Main entrance
Low-lying and poorly drained

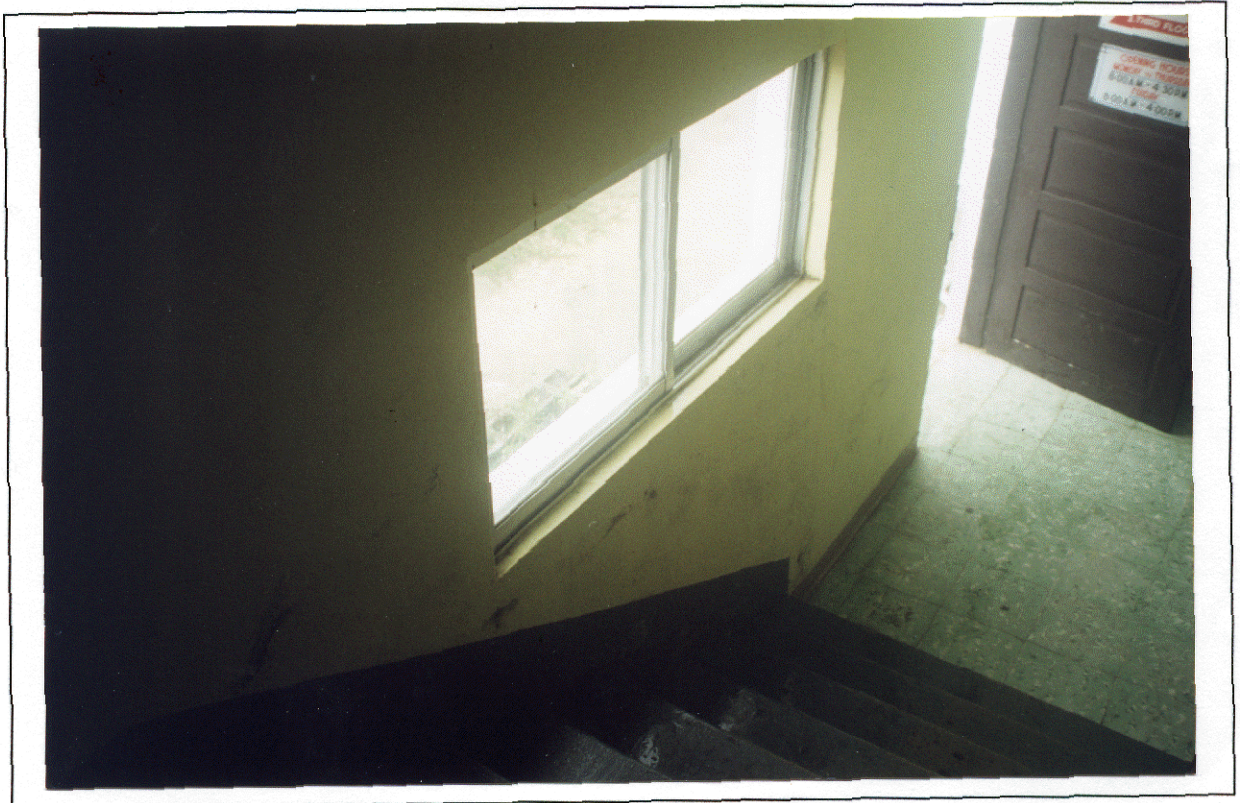
Photo 8 - Side entrance
Wind-driven rain leaks through the windows
