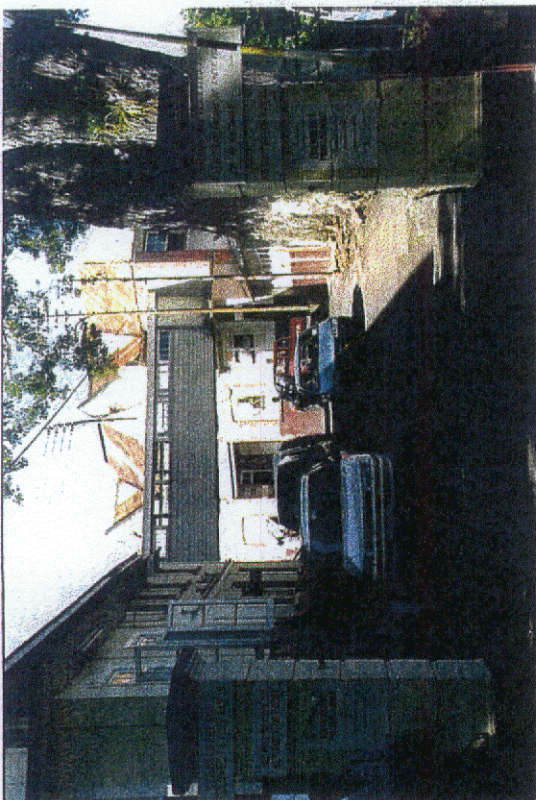
Photo 9: Official entrance to hospital. Note narrow driveway. Bridge in background.

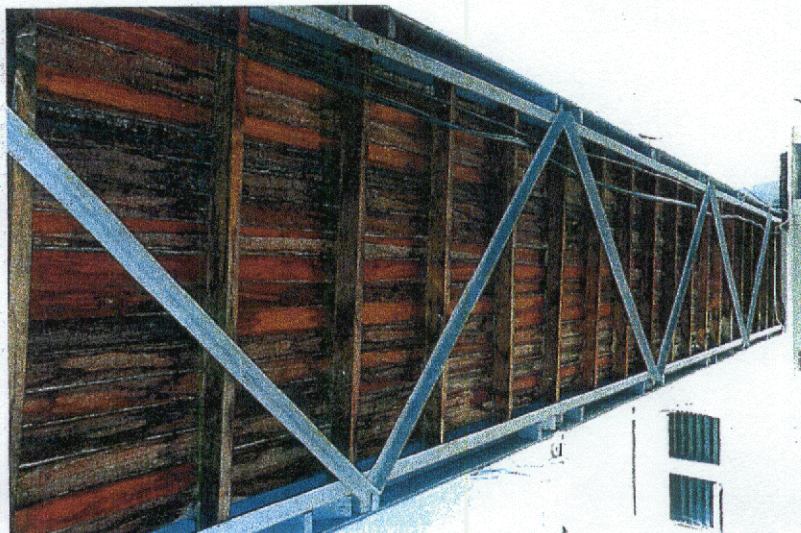
**Photo 10:** Underside of bridge. Steel truss similar to that shown here is recommended at eaves level for horizontal stability.

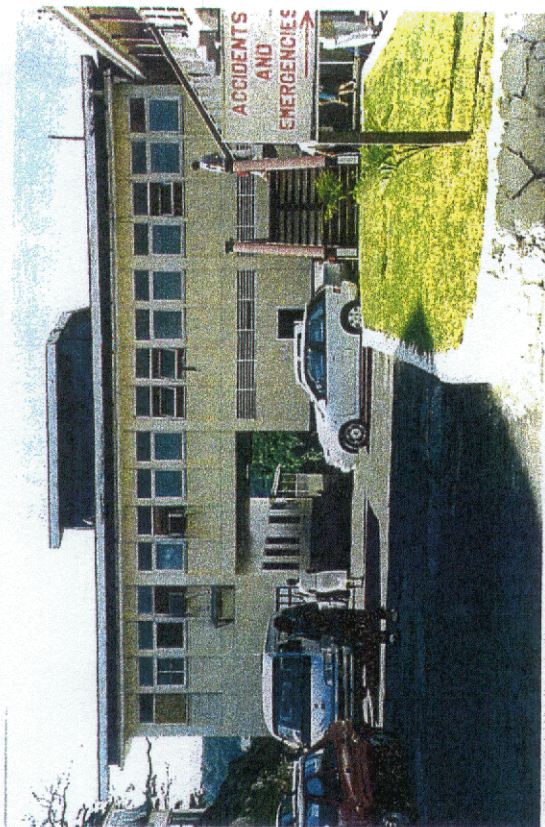
Photo 11: Front view of operating theatre. Note limited parking area in hospital yard.

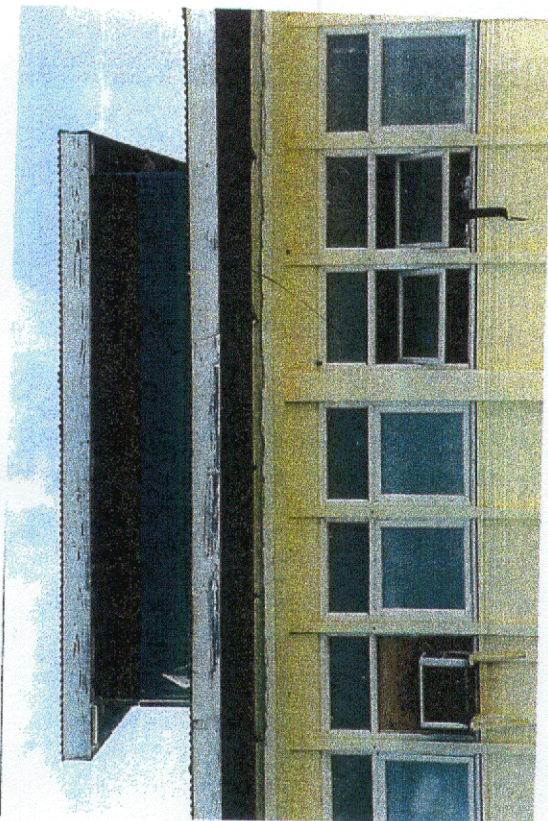
**Photo 12:** Close-up of operating theatre windows. Timber roof protects out-of-use air-conditioning equipment housed on reinforced concrete sub-roof.
