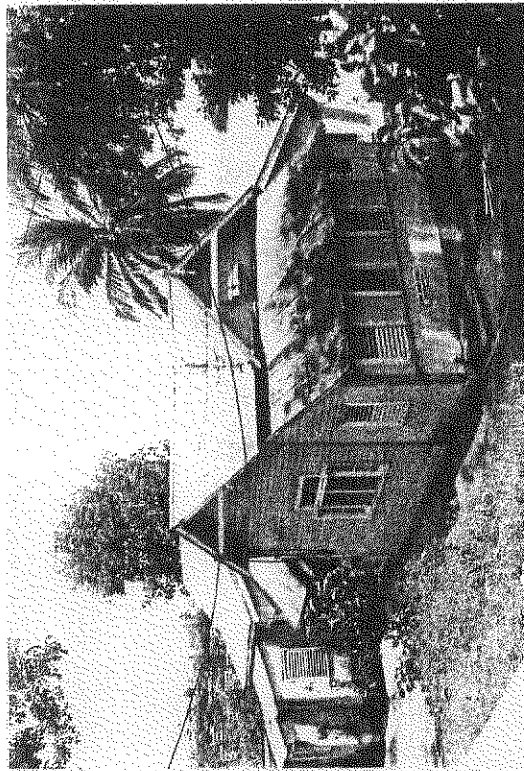
9. Former doctor's residence on the north-west side of the site.

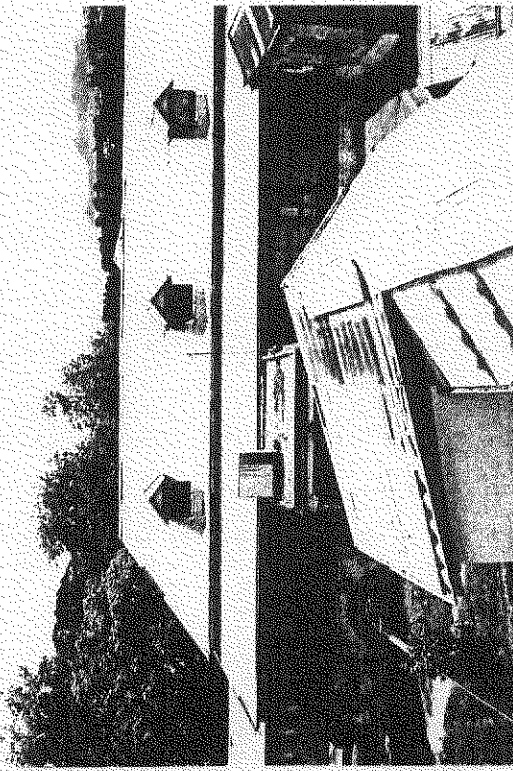
10. A view of one end of the L-Block. Note the steeply sloped hipped roof - good for hurricane resistance.

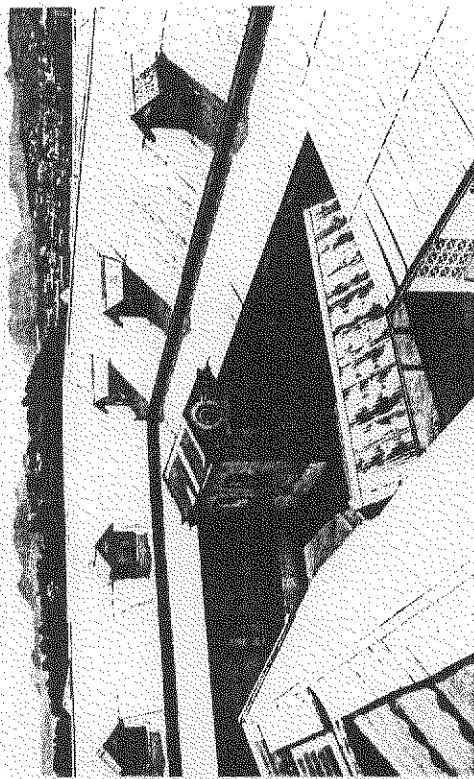
11. Another view of the L-Block. Note the dormer windows.

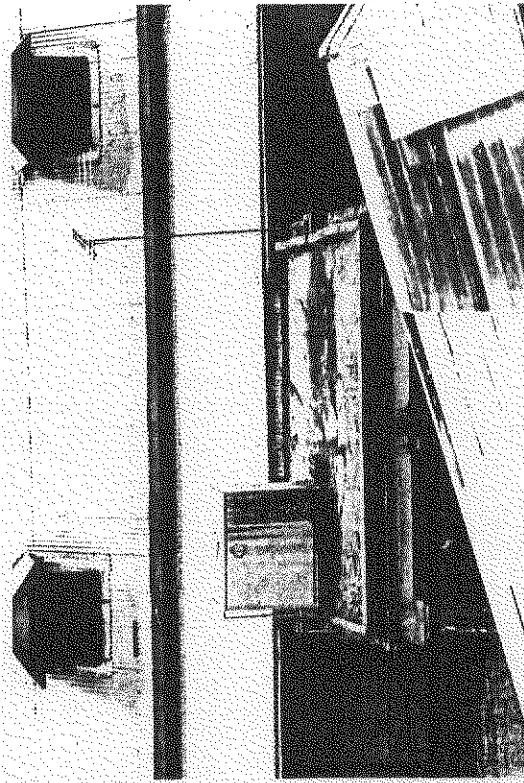
12. Further evidence of lack of maintenance - grass growing on a verandah roof on the L-Block. Note also the rusting corrugated sheets on the kitchen roof in the foreground.

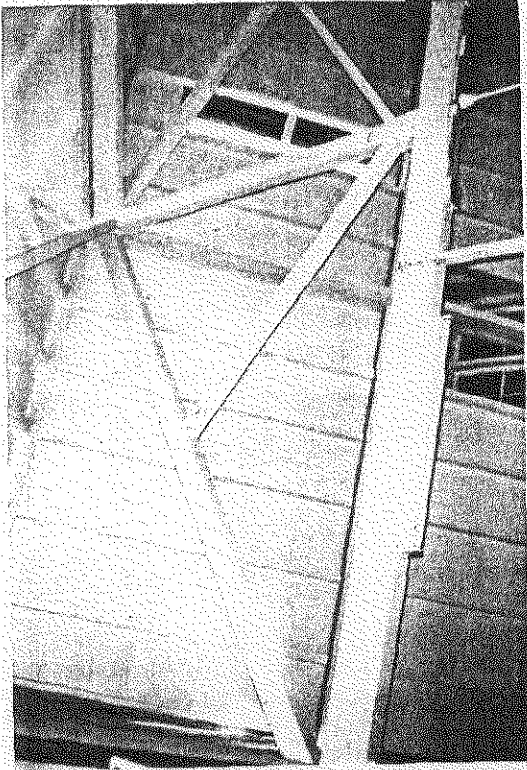
13. Typical roof truss and ancillary structure inside the L-Block.

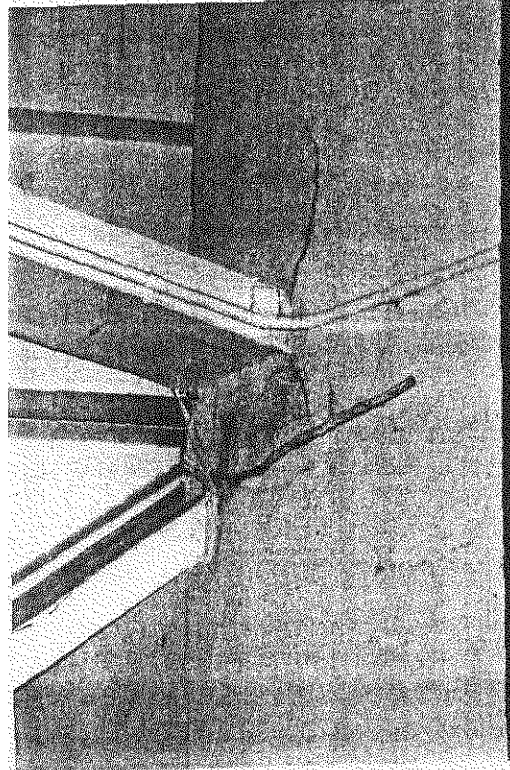
14. Close up of wall supporting roof truss. Several of the trusses exhibit these horizontal/diagonal cracks in the wall at the ends.

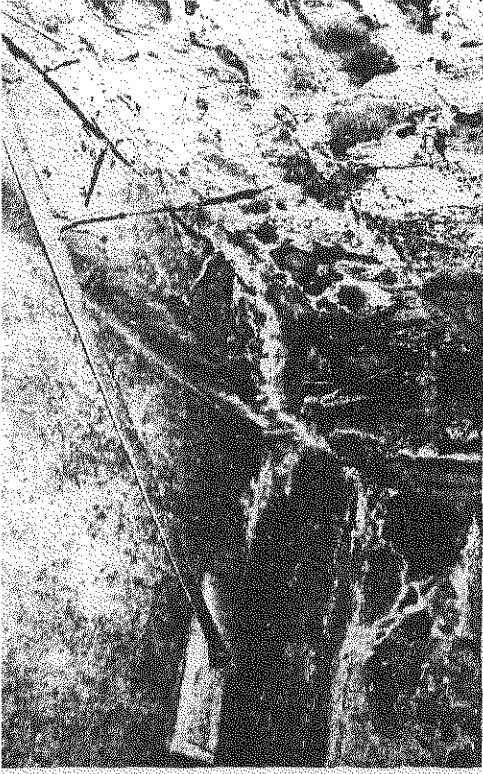
15. The underside of one of the newer additions on the north side of the L-Block. The walls are cracked and covered with efflorescence. The beam reinforcement is exposed and rusting.

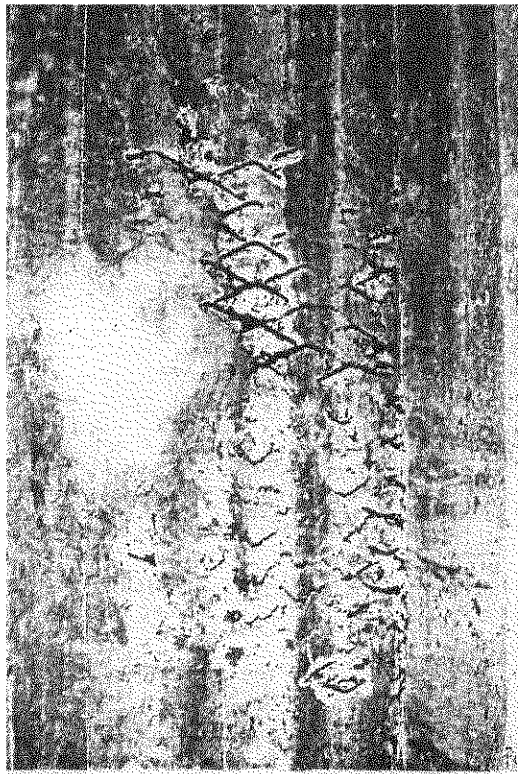
16. More inadequately covered and exposed reinforcement at the soffit of the floor slab. The repair attempt is inadequate.
