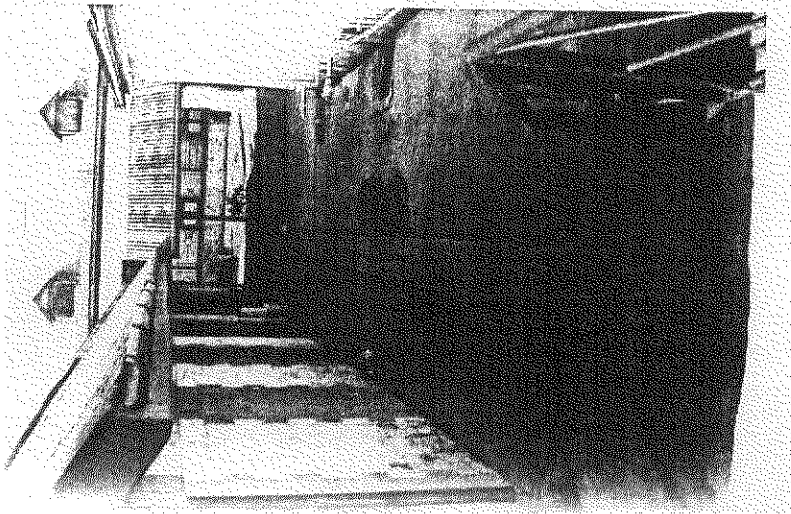
41. Stormwater drains inside the compound. Note broken gutter on kitchen roof.

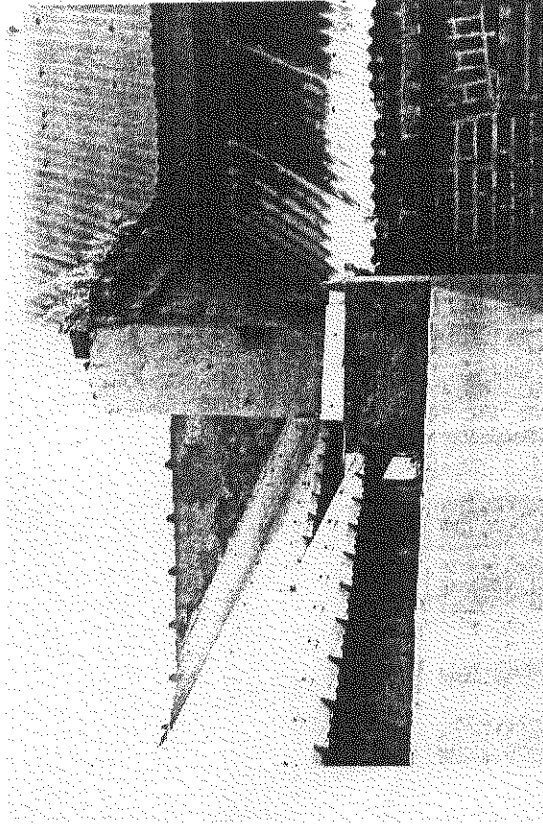
42. Main stormwater outfall

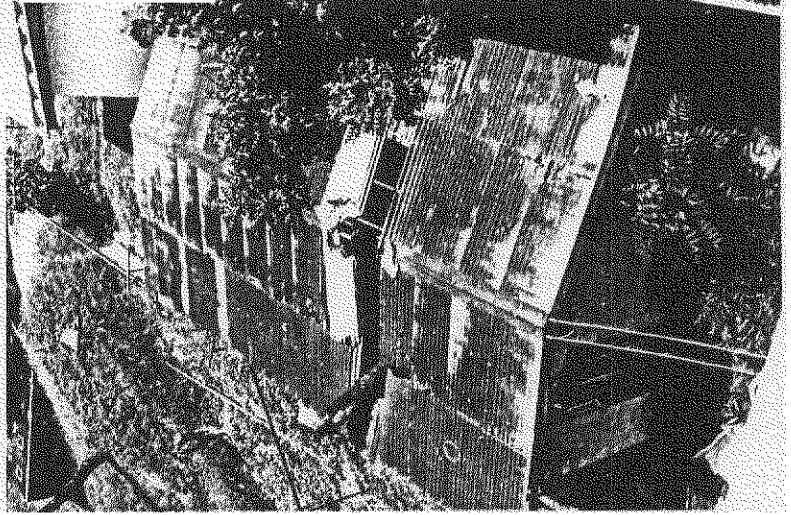
43. Good cyclone washer fixings on the new maternity wing adjacent the L-Block.

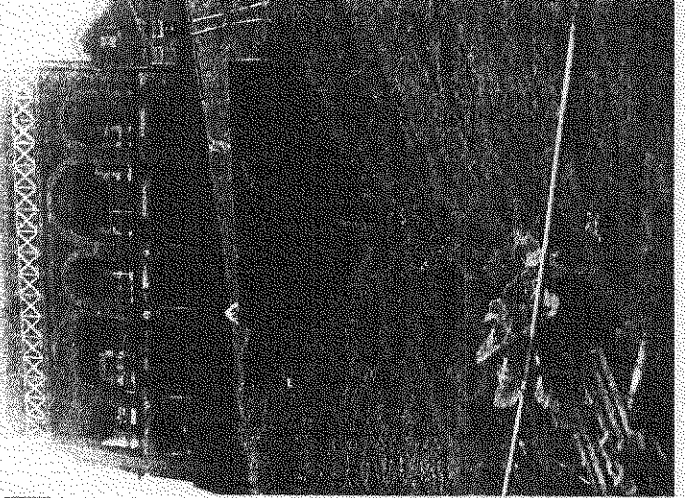
44. Derelict buildings provide ready sources of flying debris.
