2.18 Grays Farm I Health Centre

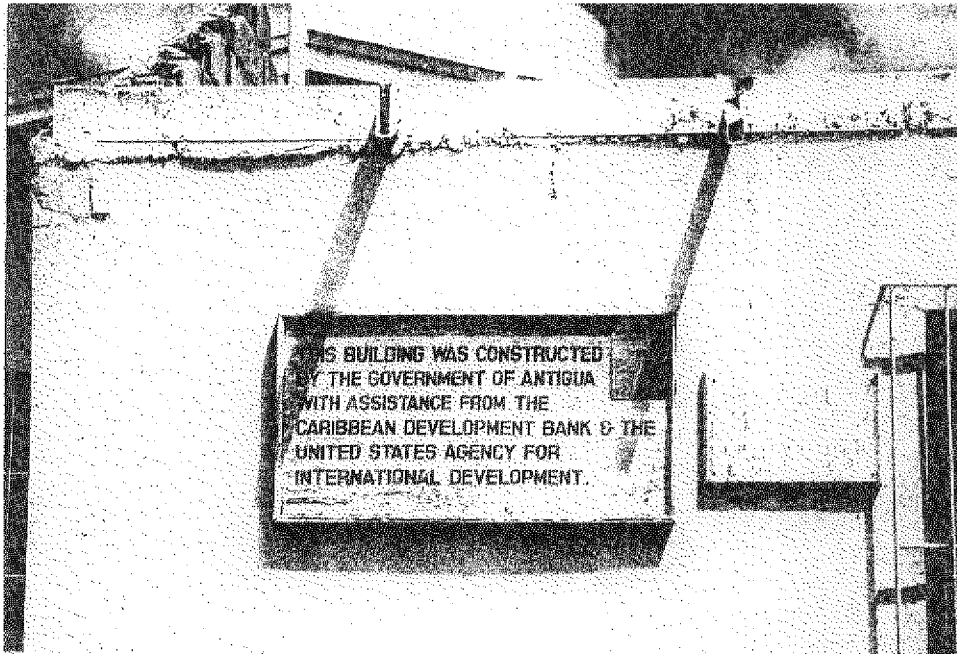
- This building consists of a major new addition to a small nineteenth century structure (date stone 1830). The nineteenth century part fared better than the newer addition.

. Grays Farm I - there are problems even in the best regulated families.

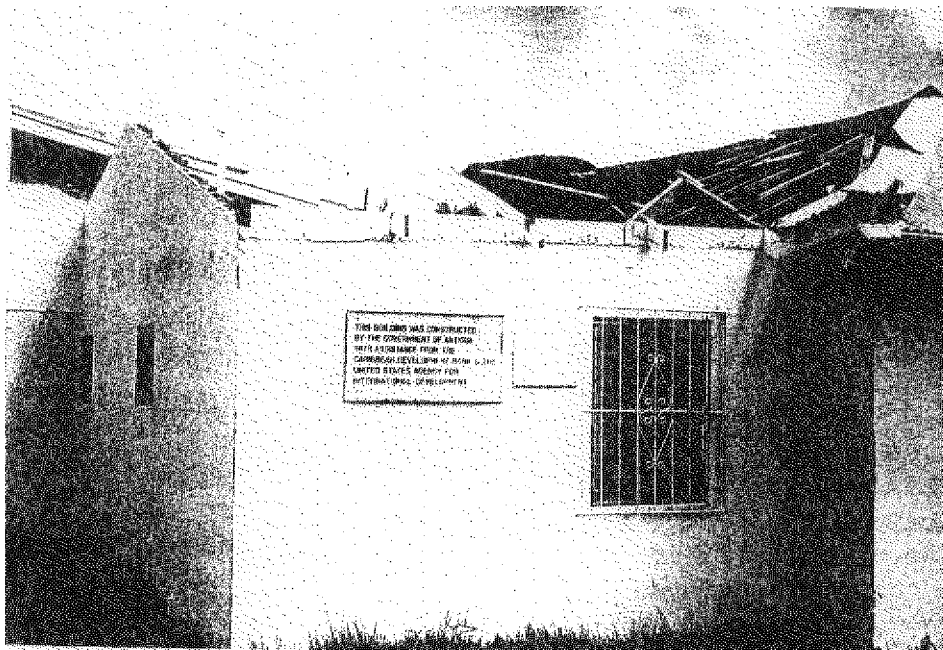
- There was major damage to the roof structures and covering
- Some of the roof rafters split longitudinally from the point of the eaves fixing.
- A lot of internal water damage to:
 - plywood ceilings
 - thermo-plastic floor tiles
 - doors
 - cupboards
- The external doors cannot now close properly
- Several of the glass louvre blades were broken (perhaps about 2 dozen)
- Fencing was destroyed on two sides of the property

Grays Farm I - destruction of roof and splitting of rafters.

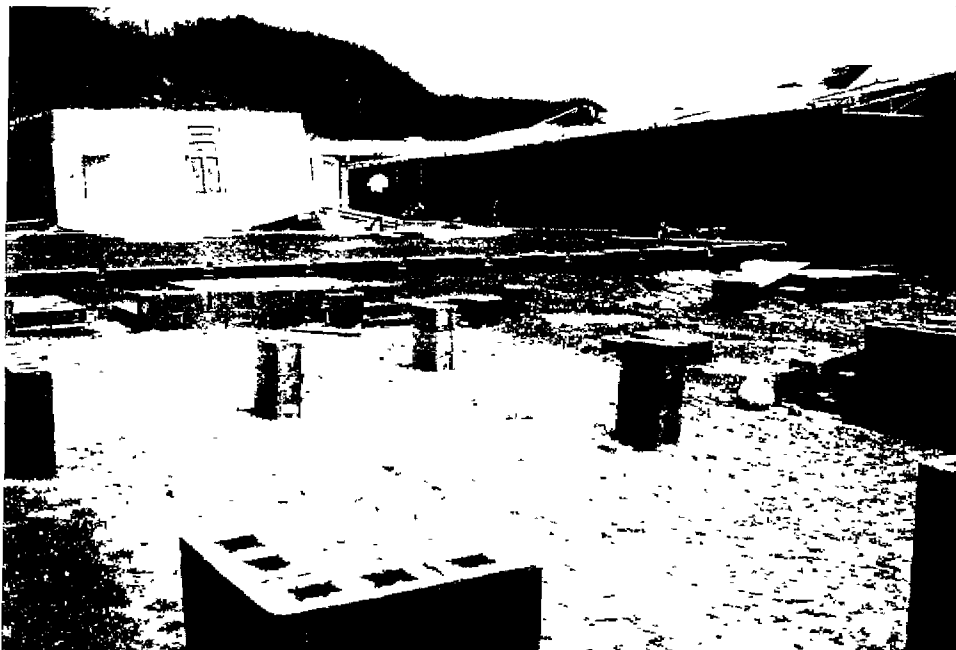
- Several of the classrooms have been completely demolished by Luis.

- The quality of the construction was worse than bad.
- There was no attempt to anchor prefabricated timber classrooms to their foundation piers.
- There was no attempt to reinforce the masonry foundation piers.
- There was no attempt to provide footings of any depth or size whatsoever for the piers.

Five Islands - total lack of standards.

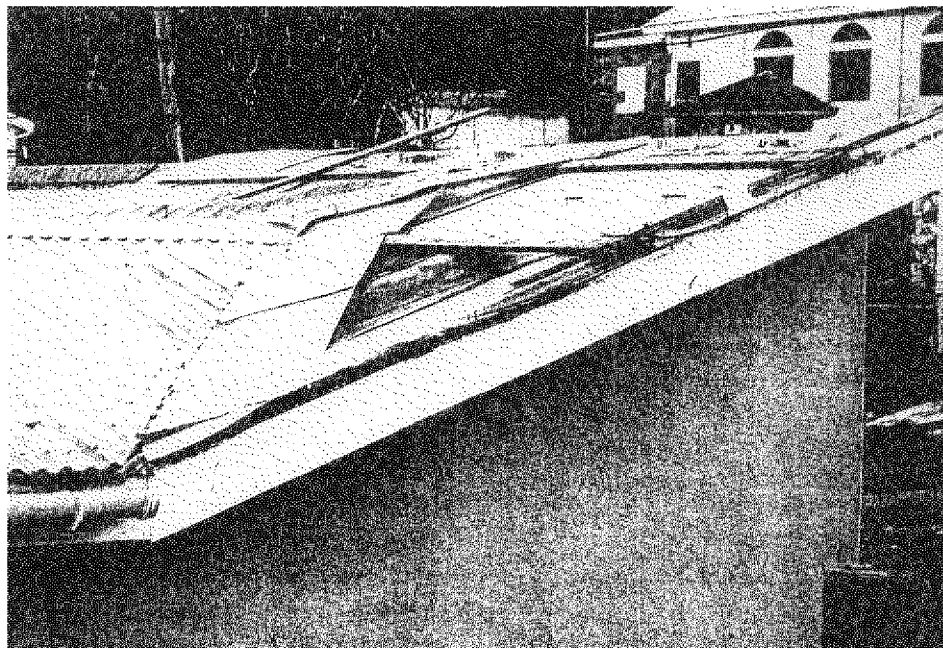
- There was a lot of damage, principally to the roof. Roof sheeting was lost in three main areas and some of the roof structure was damaged.
- Some of the windows were broken.

Bolans - the greater vulnerability is usually at the edges.

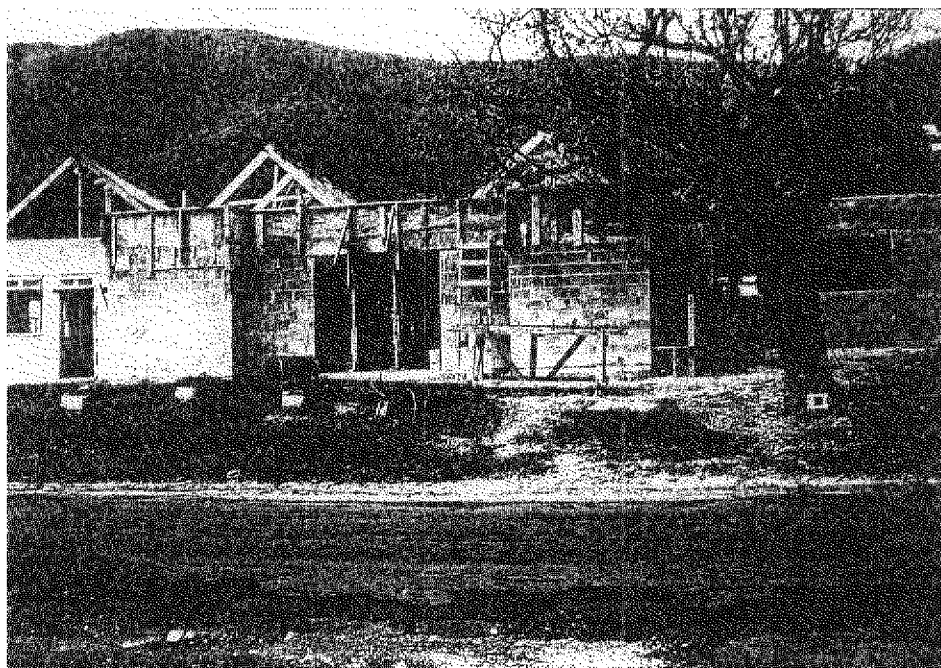
- It was not evident that much damage was caused to the works under construction
- There was some minor loss of asphalt shingles
- The holding-down of rafters (under construction) is provided by steel bars bent over the rafters at the eaves.

Johnson's Point - still to be tested.
