### **2.23 Old Road Clinic**

### **2.24 John Hughes**

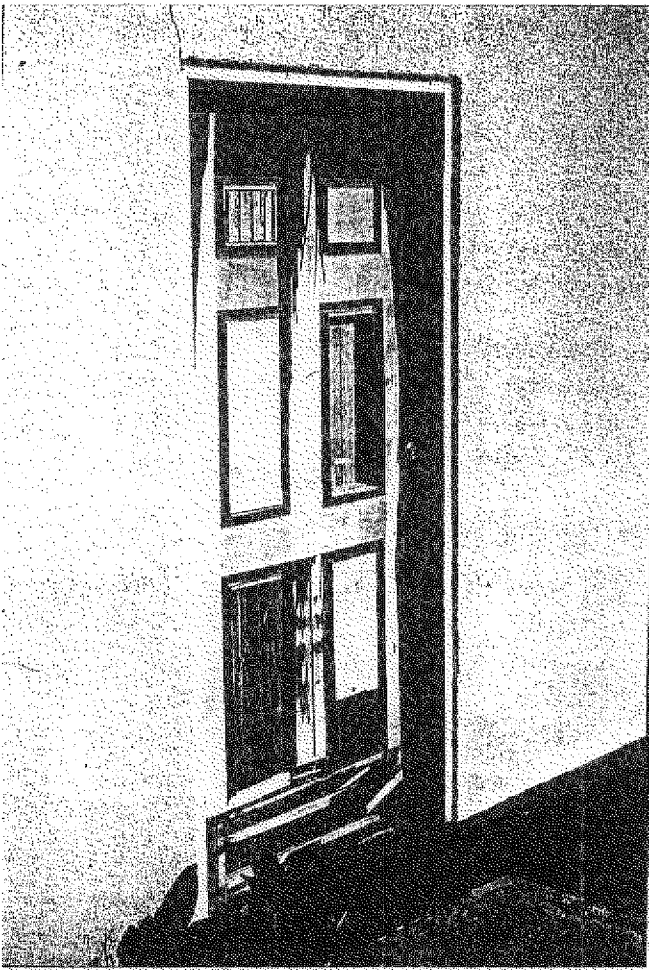
- The external doors were damaged but were probably in a bad state of repair before Luis

Old Road - deterioration and resulting damage was commonplace with external doors.

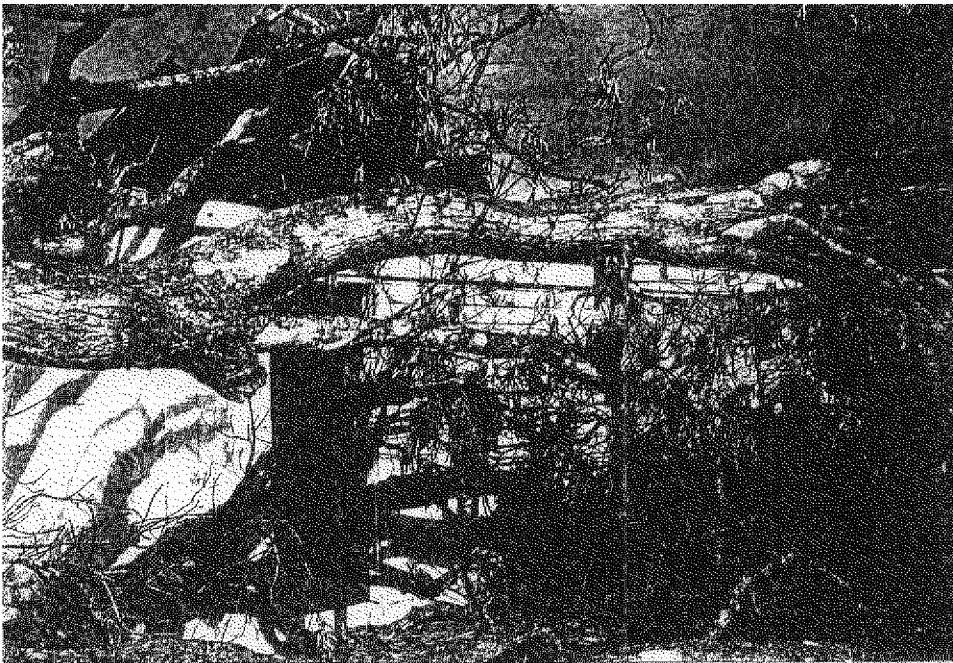
- A large tree caused substantial damage by falling on to the roof.
- There was also wind damage to roof sheeting.
- The entrance canopy lost one of its supports due, in part, to wood rot.
- The unreinforced masonry supports for the water tank collapsed completely

John Hughes - nearby trees can be a hazard.
