## **2.27 Bendals Clinic**

## **2.28 Liberta Clinic**

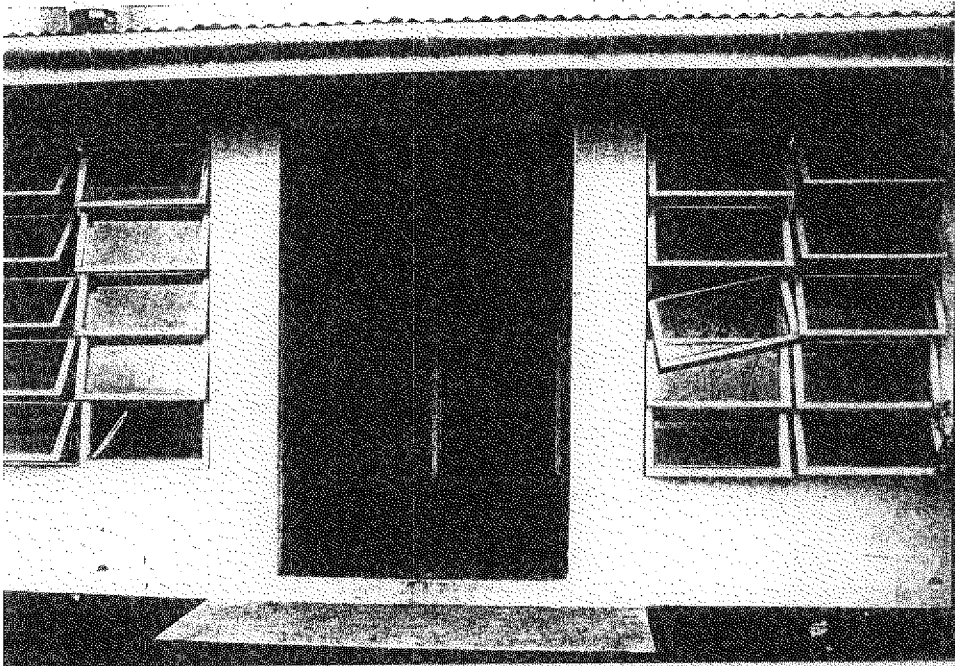
- Windows were broken before Luis
- There is only one exit from the lower floor - dangerous in a fire

- Liberta - the sole means of egress.

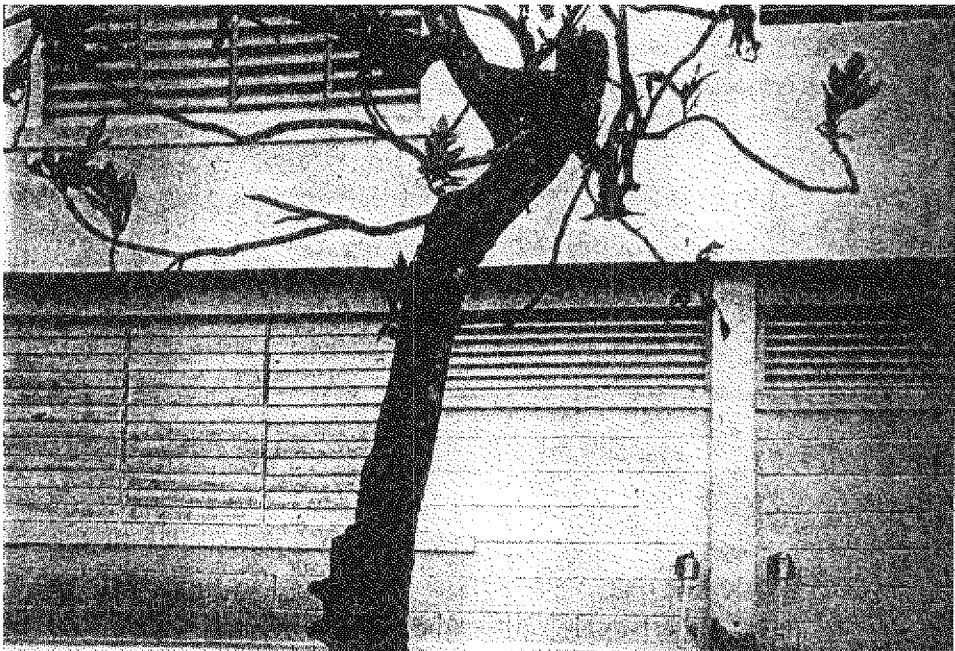
- Unshuttered windows were of aluminium and timber louvres which were not damaged.
- No damage was observed to the structure.

Bendals - secure fenestration.
