## 2.29 Cobb's Cross Clinic

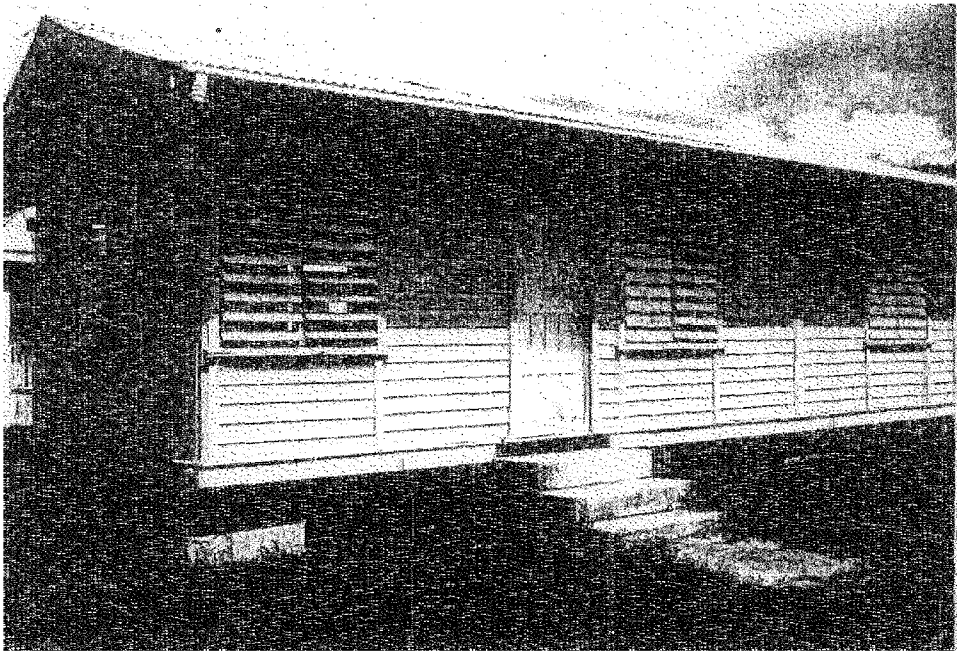
\* Cobb's Cross - post-Hugo, well-anchored, light-weight construction.

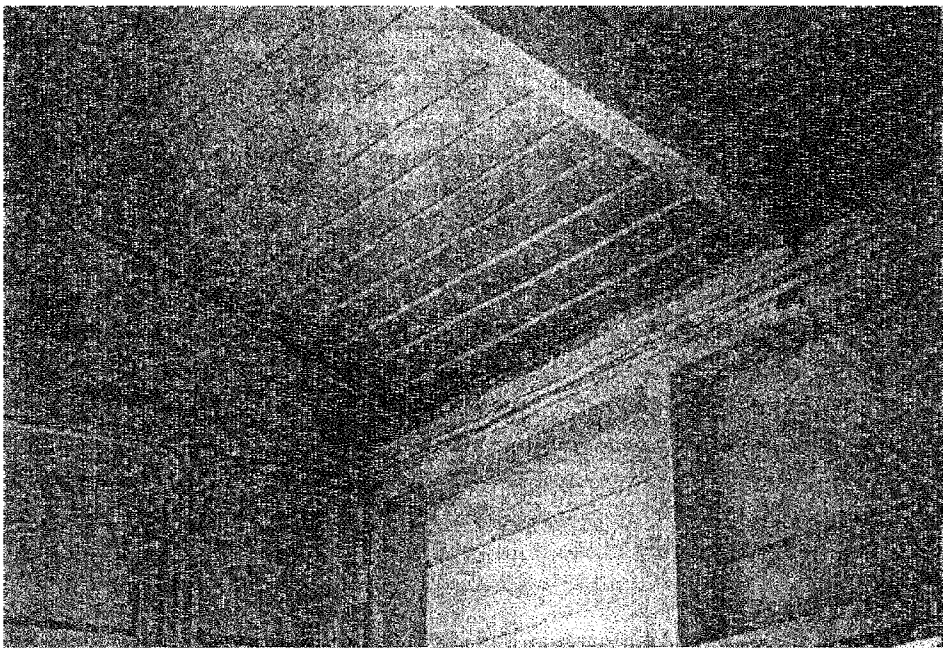
Cobb's Cross - note hurricane straps.
