Health Services Facilities - Antigua

Holberton General Hospital - Rehabilitation Building

3.3 Laundry

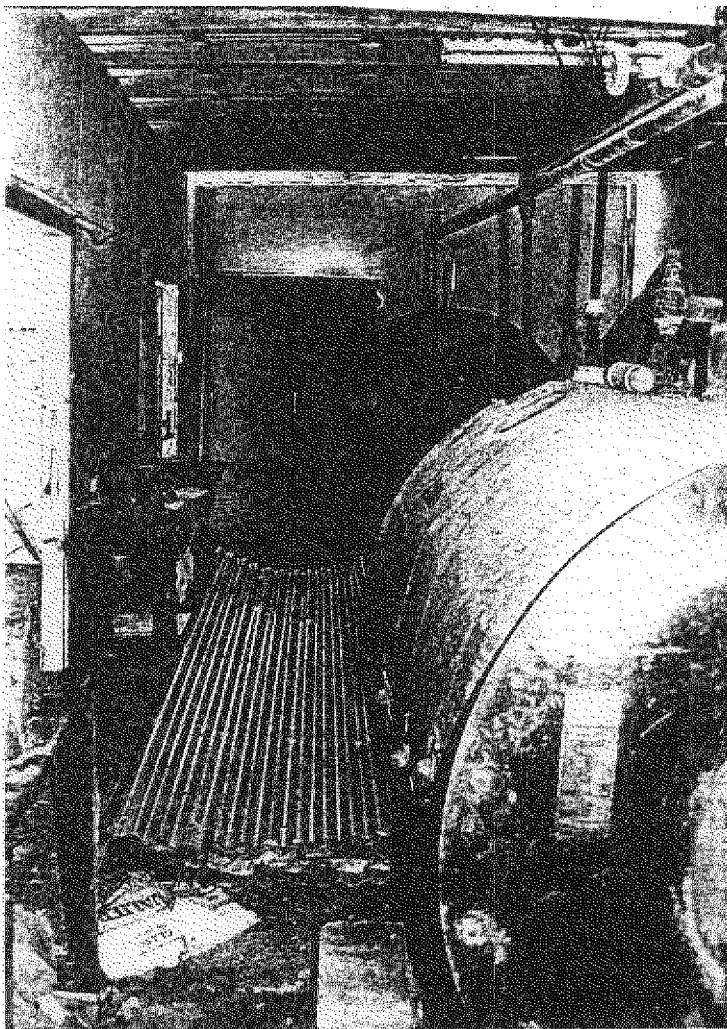
Photo HL-1: Boiler Room.

The building is a single storey masonry building approximately 73ft x 16ft. Attached at south is a 12' x 10' sewing room and on the northern end forming an 'L' is a 12' x 30' boiler room (photo H-L-1). In the corner enclosed by the boiler room and the laundry was an unfinished covered clothes air-drying area.

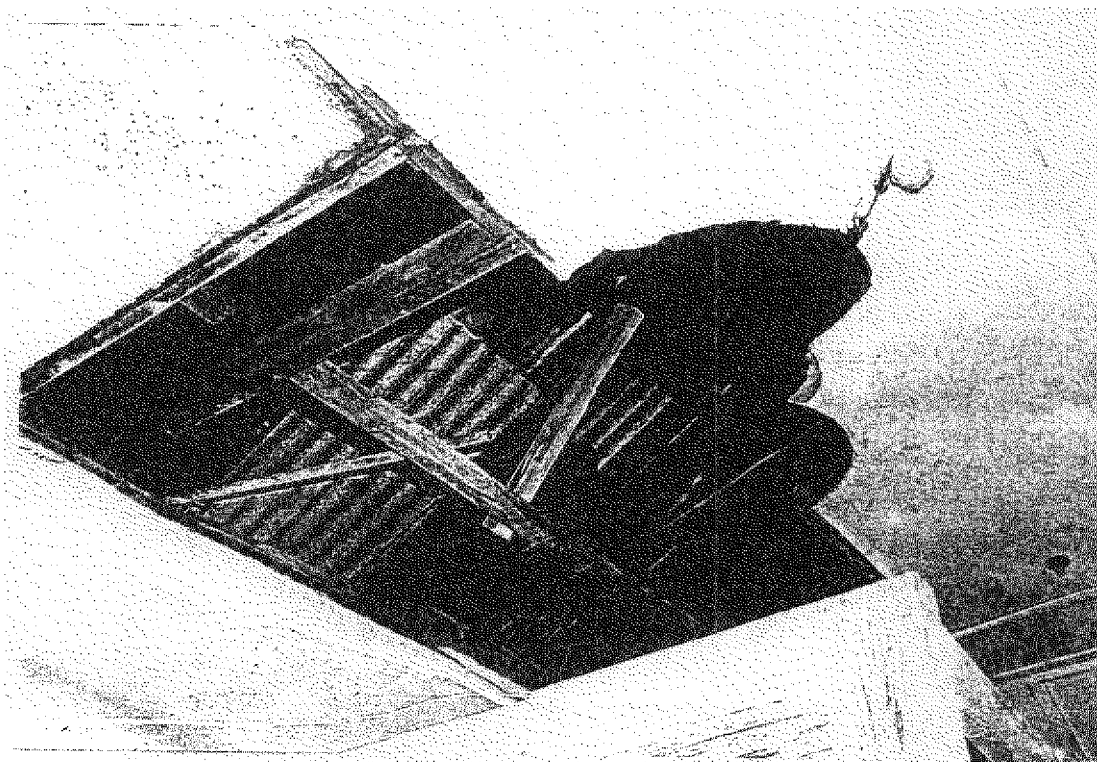
A section of the main roof sheeting was blown off and the ceiling under collapsed (photo H.L-2). The roof to the drying area was blown off.

Photo HL-2: Collapsed ceiling board.

1. Construct new roof.
2. Screed existing floor.
3. Repair wall to boiler room.
4. Rebuild and complete drying area.
5. Paint internally.
6. Replace windows and doors.
