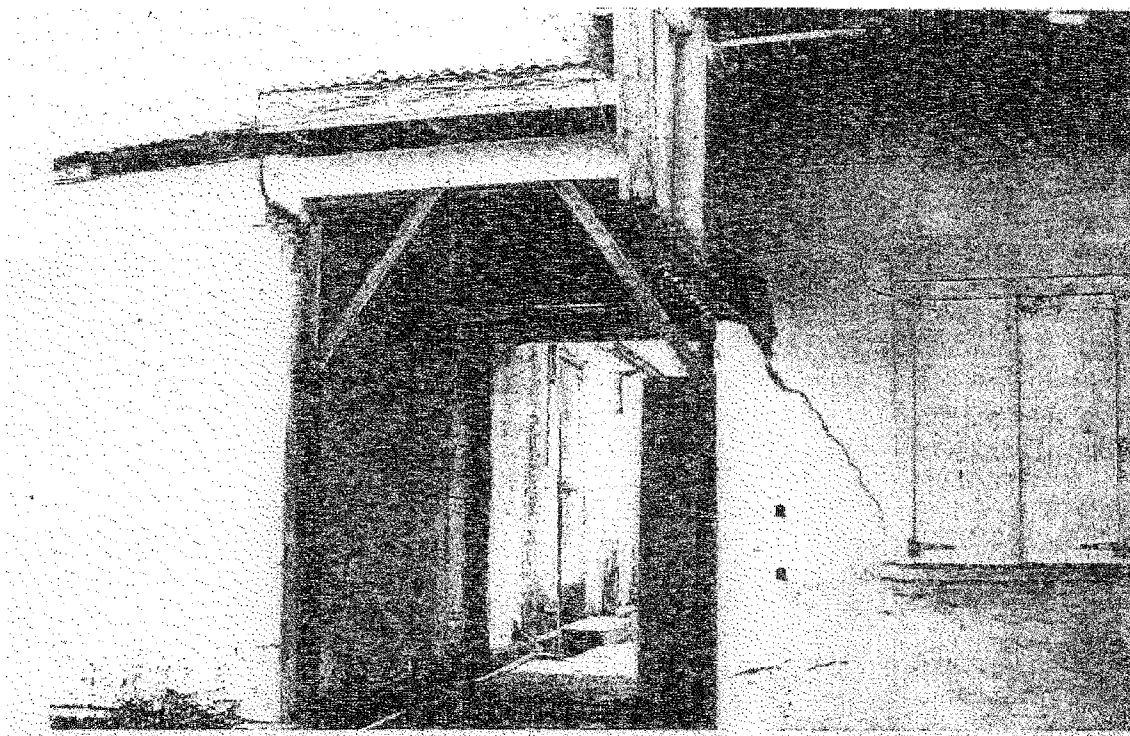
Photo HL-3: Cracks at corner of Boiler Room.

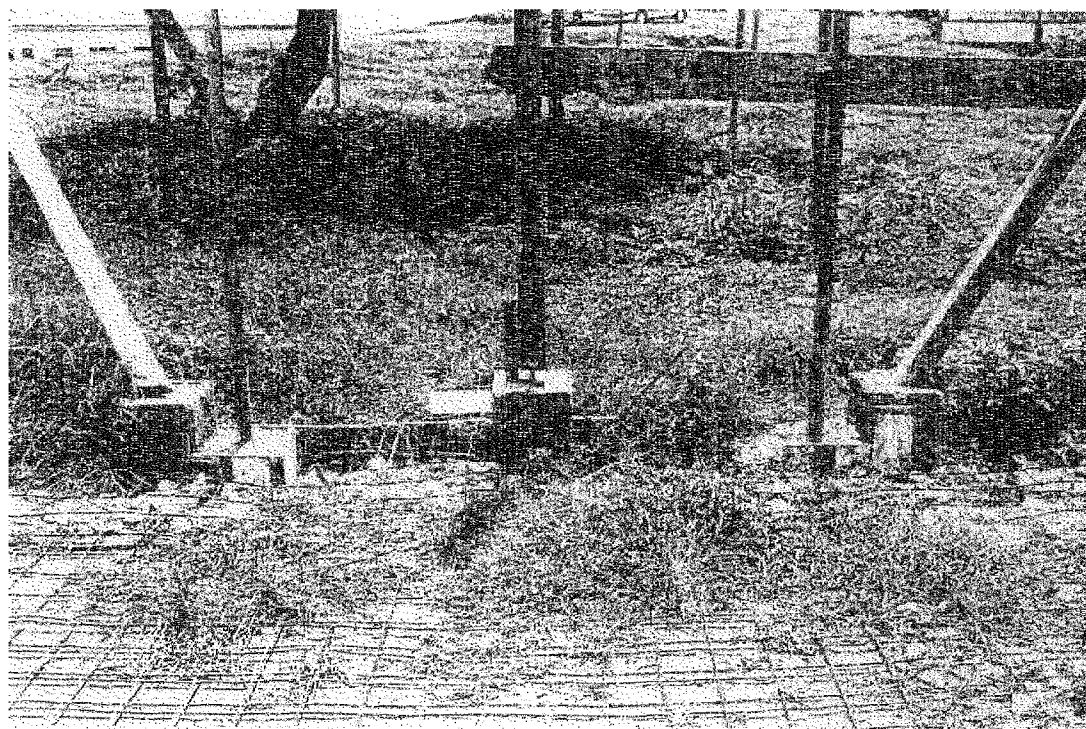
Photo HL-4: Base of some posts reinforced with angle iron.
