3.4 Electronic Workshop

Health Services Facilities - Antigua

Holberton General Hospital - Electronic Workshop

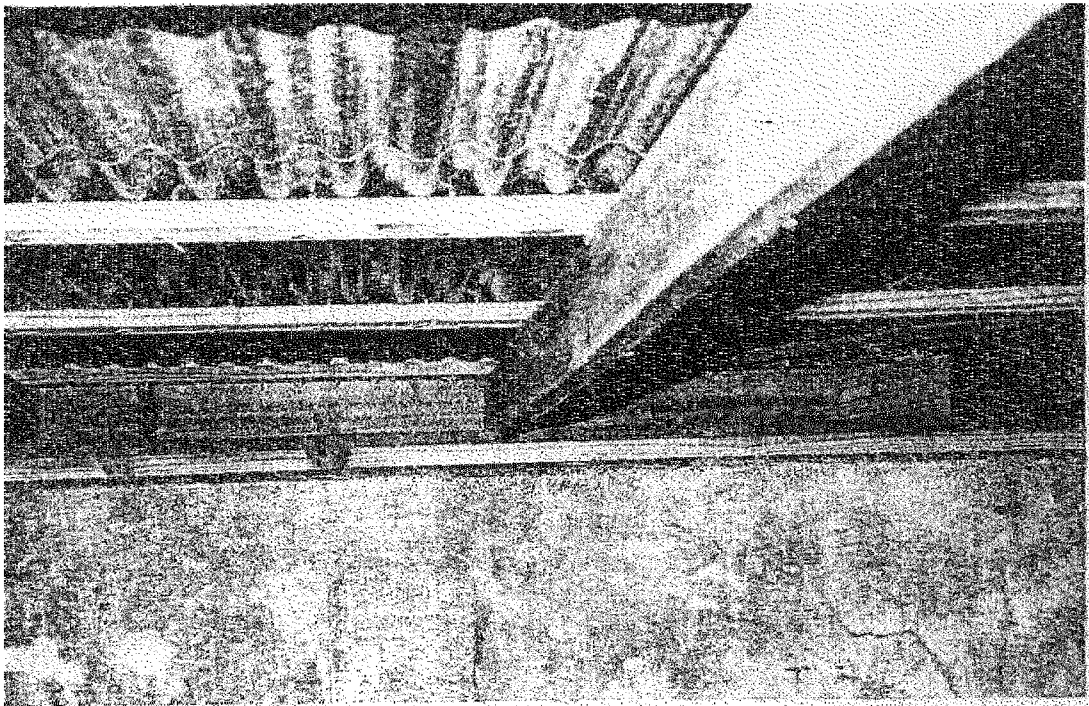
Photo HB-1: Good hurricane resistant construction.
