3.6 X-Ray Department

Health Services Facilities - Antigua

Holberton General Hospital - X-Ray Department

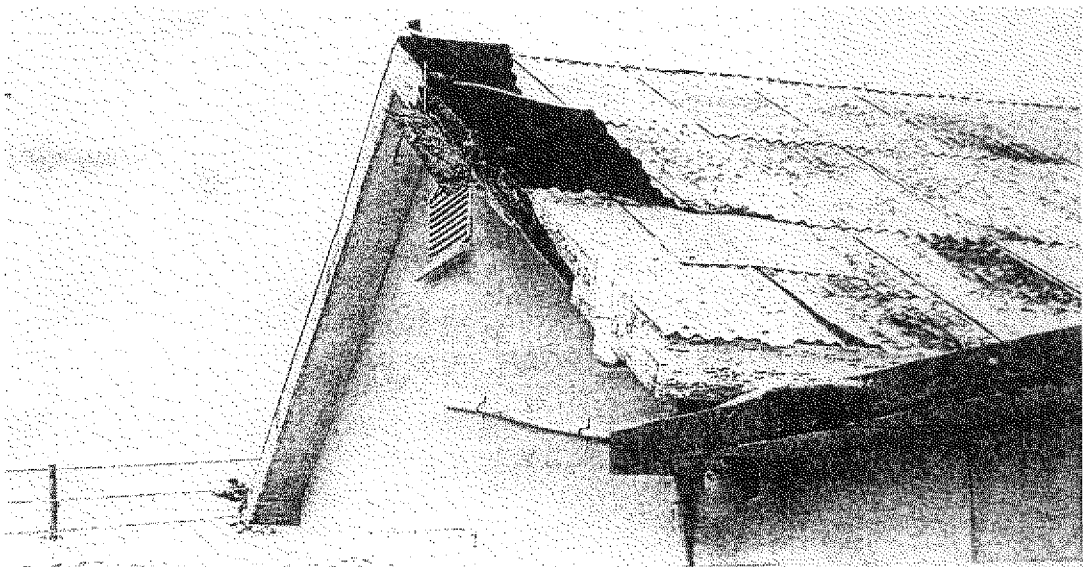
On either end of the western side, the galvanized sheets were dislodged .(Photos H.X-1, H.X-2) The double door to the housekeeping department had impact damage. The ceiling within housekeeping was damaged.

Photo HX-1: Roof sheeting damaged at gable ends.

1. Repair 6-ft in from the edge of the roof at each side.
2. Repair the ceiling and repaint the room.
3. Replace the damaged doors.

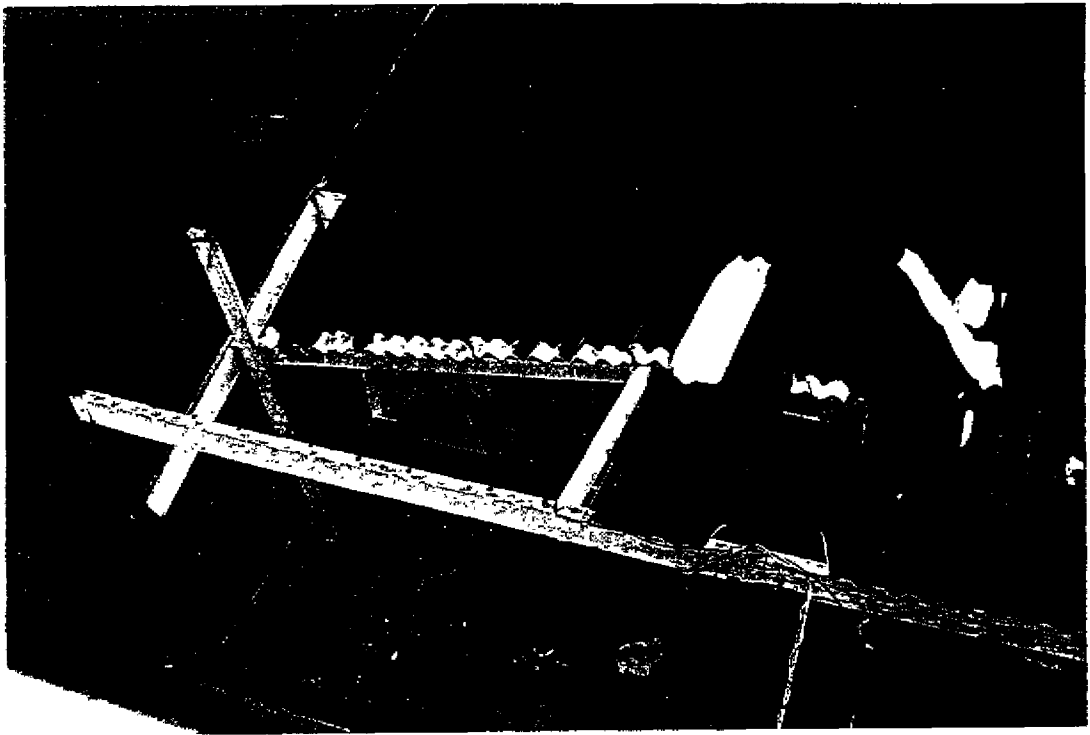
Glass patio door and two pivot doors to the lounge were damaged. The roof to the covered walkway between the dormitory and the lounge was blown off. The roof sheets and windows to the classroom block were broken. (Photo H.N-1). A number of students' desks were water damaged. Two double-doors to the classrooms were damaged. The asbestos sheets to the dormitory blocks were broken at five locations. The ceilings and built-in closets in the rooms under the broken sheets were water damaged.

Photo HN-1: Broken asbestos sheets.

1. Asbestos cement roof sheeting, although used in the past as a very popular roofing material with its non-corrosive and heat insulation properties, have been discontinued on the grounds of health. Its use in hurricane prone countries have been discouraged because of its fragile nature as demonstrated here, and also for its unavailability. Because of this, we recommend that the existing asbestos sheets be removed and a new roof installed.
2. Re-decorate top flats.
3. Replace vinyl tiles in the rooms with the damaged roof.
4. Re-build new built-in furniture.
5. Replace damaged doors and windows.

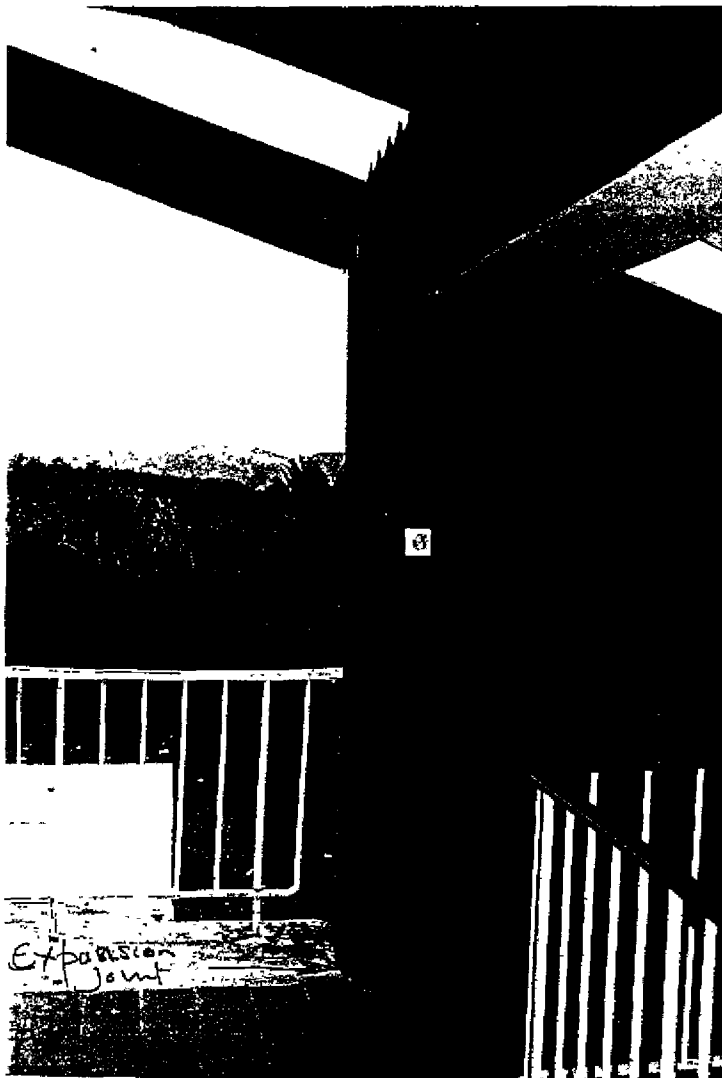
In addition, the expansion joint between the two northern blocks had moved. This expansion facility was not carried through all the structure. The handrail, the roof beam and sheeting were all continuous. (Photo H.N-2). On the steps some of the ceramic tiles were loose.

Photo HN-2: Expansion joint, no separation at roof level.

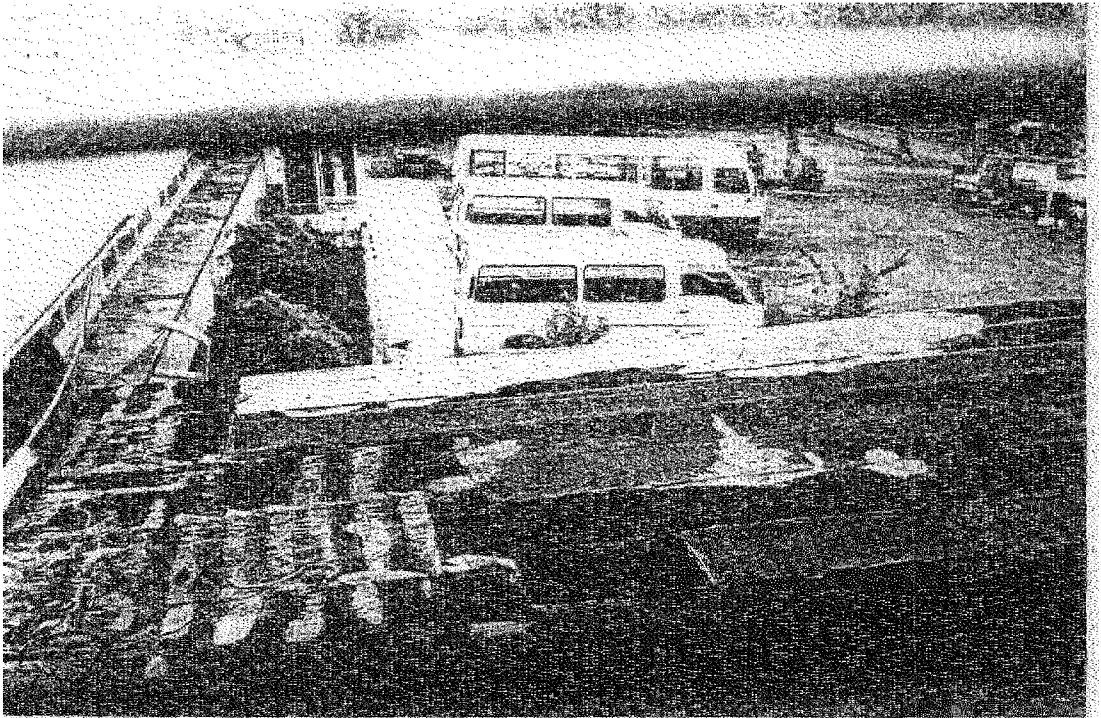
Photo HC-1: Partially-bonded roofing felt stripped from roof.
