## Health Services Facilities - Antigua

### Fiennes Institute

#### Estimated Cost of Repairs

## **MENTAL HOSPITAL**

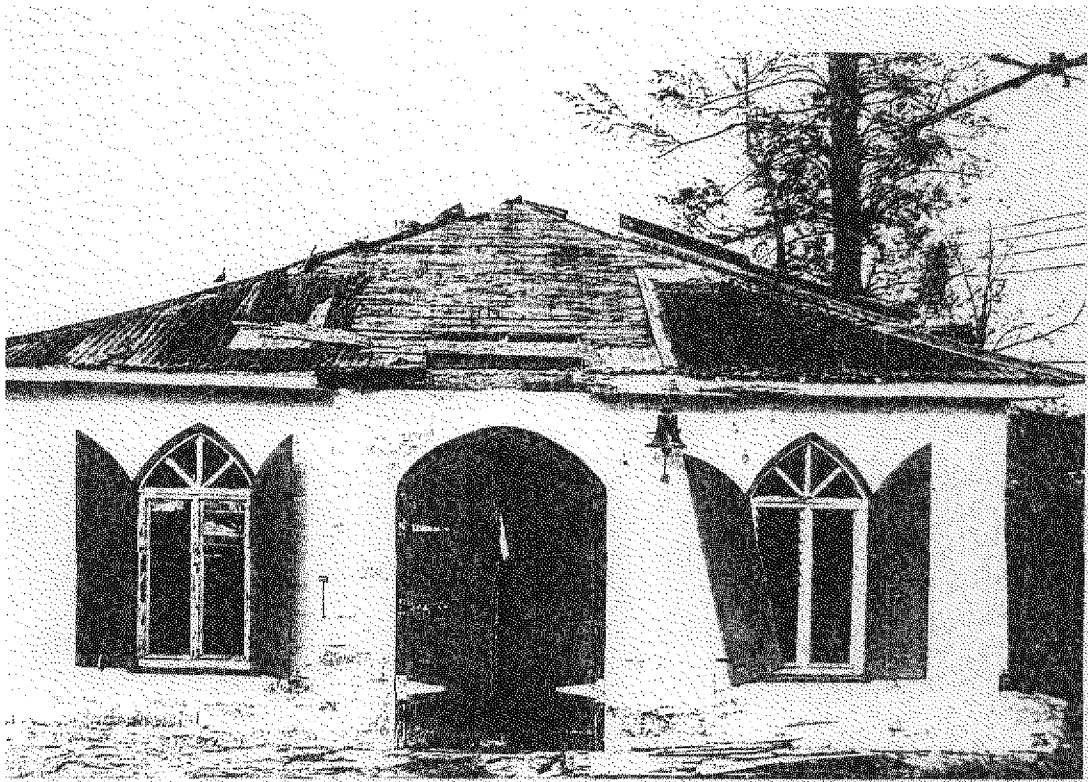
Photo FC-1: Chapel - west elevation.
