Health Services Facilities - Antigua

3.31 Swetes Clinic

3.31.2 Hurricane Damage

3.31.3 Inspections

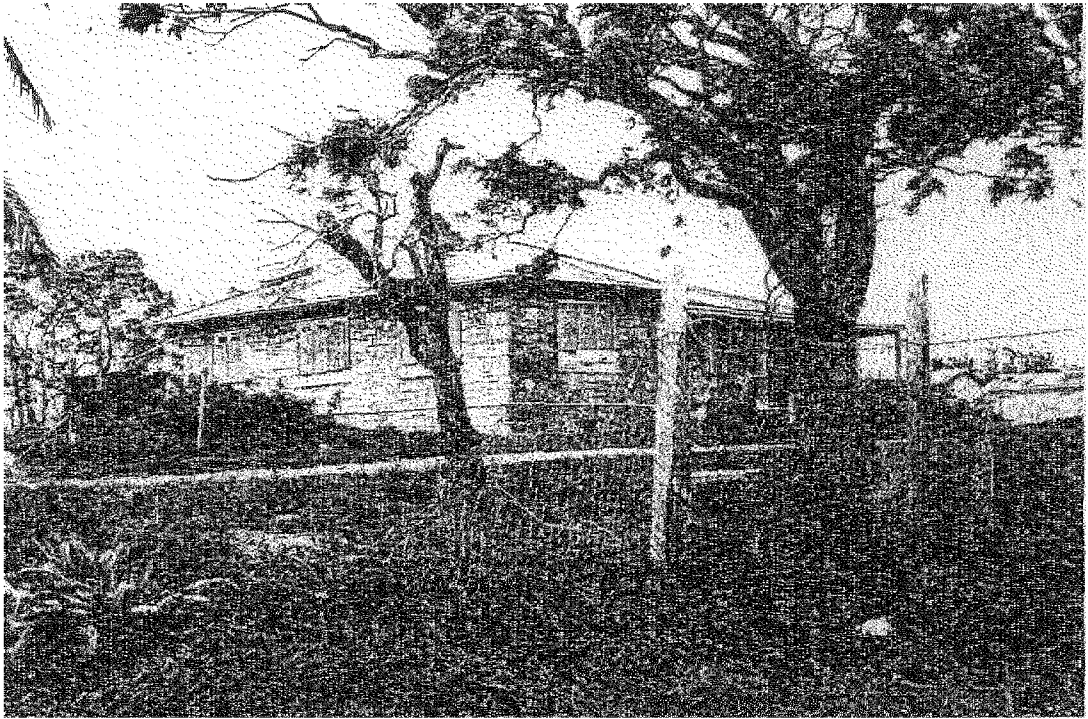
During the hurricane, the house was flooded. A section of the roof over the clinic lost its sheeting in two locations. A section of the roof over the home lost its sheeting but this area was resheeted before our inspection. One section of the roof over the clinic was covered with tarpaulin after the hurricane (Photos S-1, S-2). Some of the steel rods which had lost their nuts on the inside of the window had pulled out (Photos S-3, S-4).

Photo S-1: Clinic with tarpaulin on roof and plywood shutters at windows.

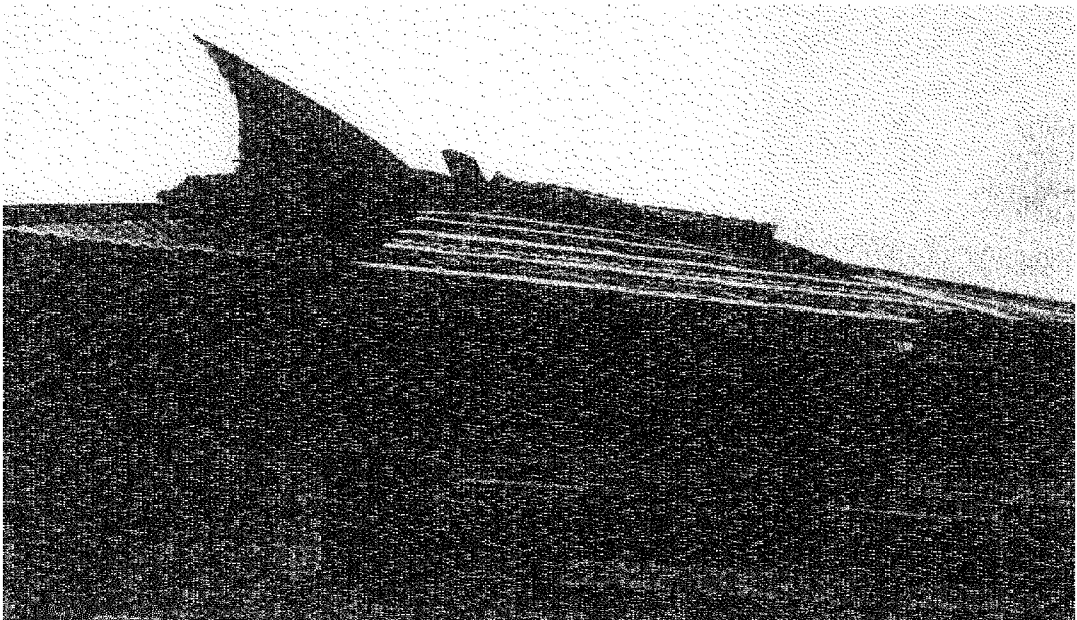
Photo S-2: Rear of clinic side of building with sheets missing.

1. Replace the missing sheets and ridge caps.
2. Replace the rusting nail heads.
3. Replace the missing lengths of gutter.
4. Repair the defective eaves soffit and fascia board.
5. Replace the defective taps to the sinks.
6. Re-tile the defective counters.
7. Replace the steel bars at the windows.
7. Replace the vinyl tiles.
8. Re-paint the house internally.

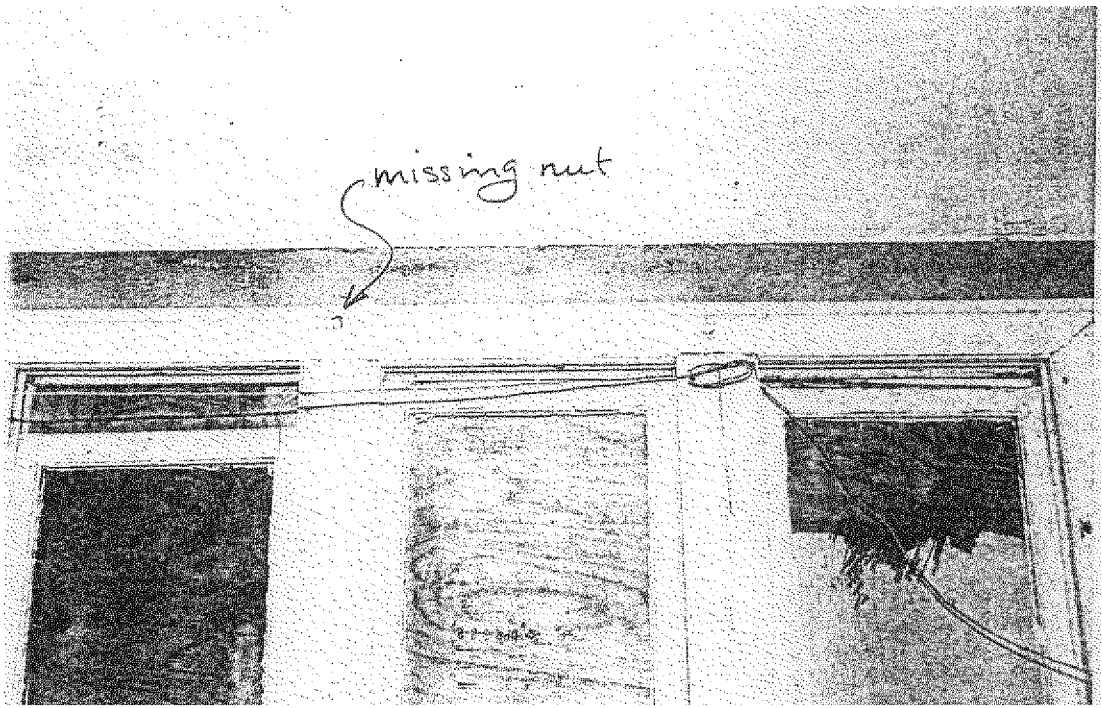
Close inspection revealed that the roof structure was still in fair condition. A section of the fascia board was termite infected but there was no live activity. The steel bars at the windows were rusting and a number of them had lost their nuts and washers on the inside of the window (Photo S-3). The heads of drive screws that fastened the replaced thin sheets were rusting.

Photo S-3: Missing nut.

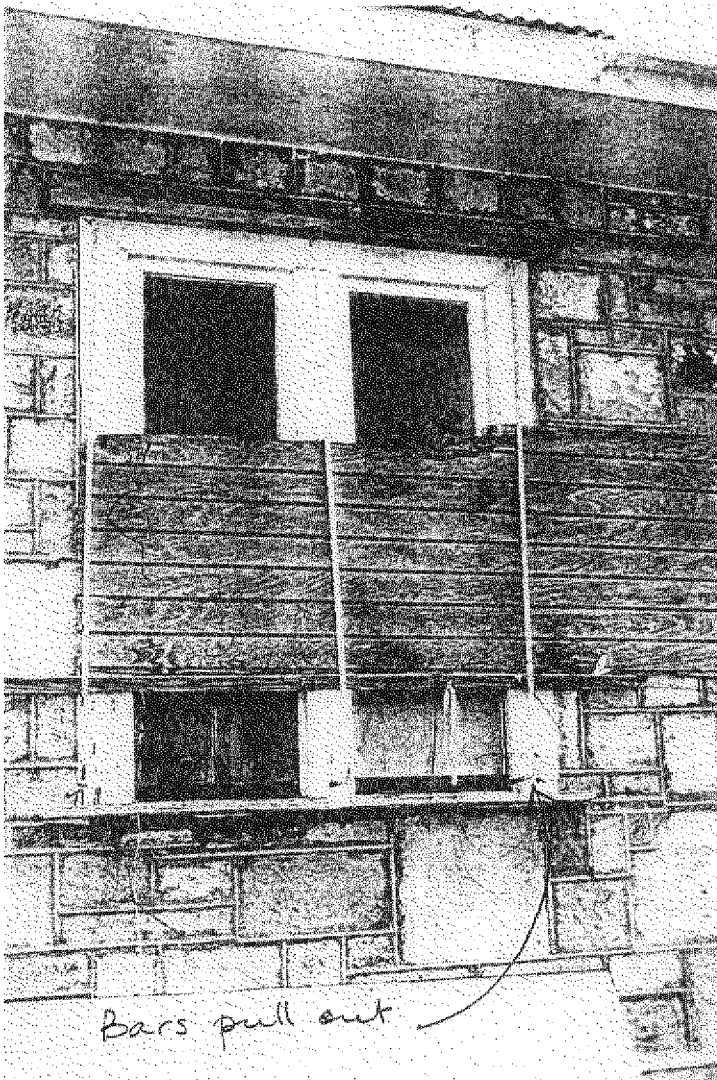
Photo S-4: Bars pulled out.
