3.32 Cedar Grove Clinic and Day-Care Centre

Health Services Facilities - Antigua

Cedar Grove Clinic and Daycare

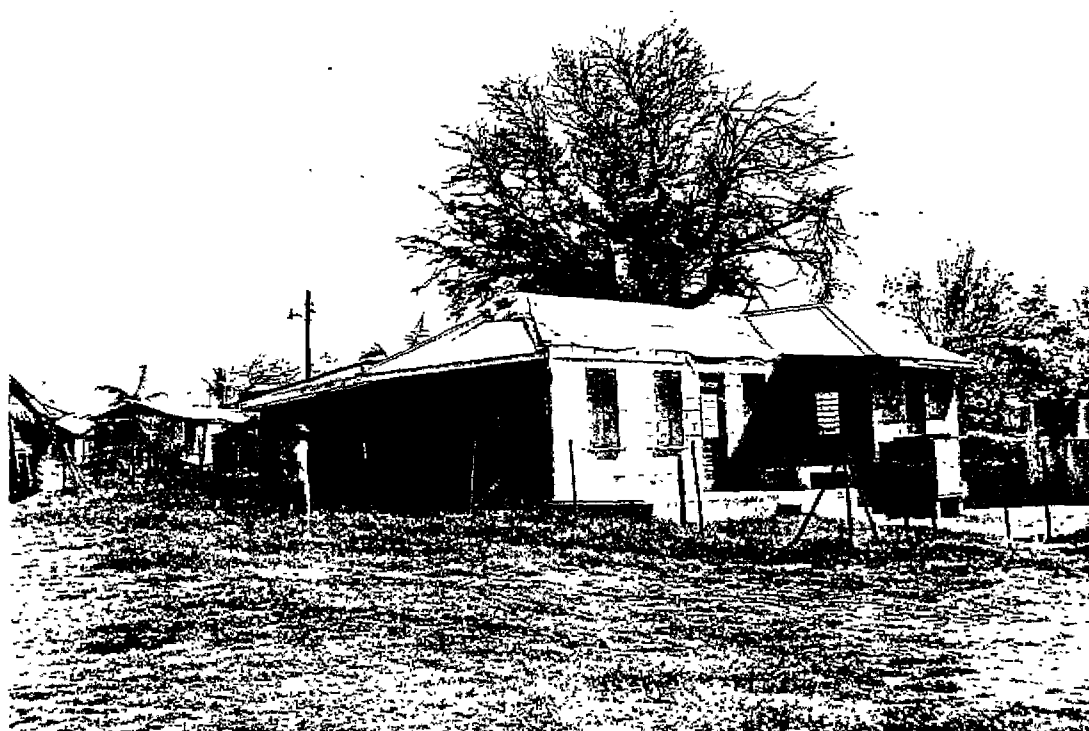
The building lost its verandah and a portion of its roof sheeting. At the rear of the roof, a section of the sheeting suffered impact damage (photo C-1).

Photo C-1: Verandah roof and section of the main roof sheeting lost.

1. Strengthen roof structure.
2. Replace roof sheeting and gutters.
3. Re-build verandah.
4. Repair windows and doors.
5. Repair cracks.
6. Repair plumbing and water tank.
7. Build new soak-away and well cover.
8. Re-place floor finishes and paint.
9. Replace fence wire.

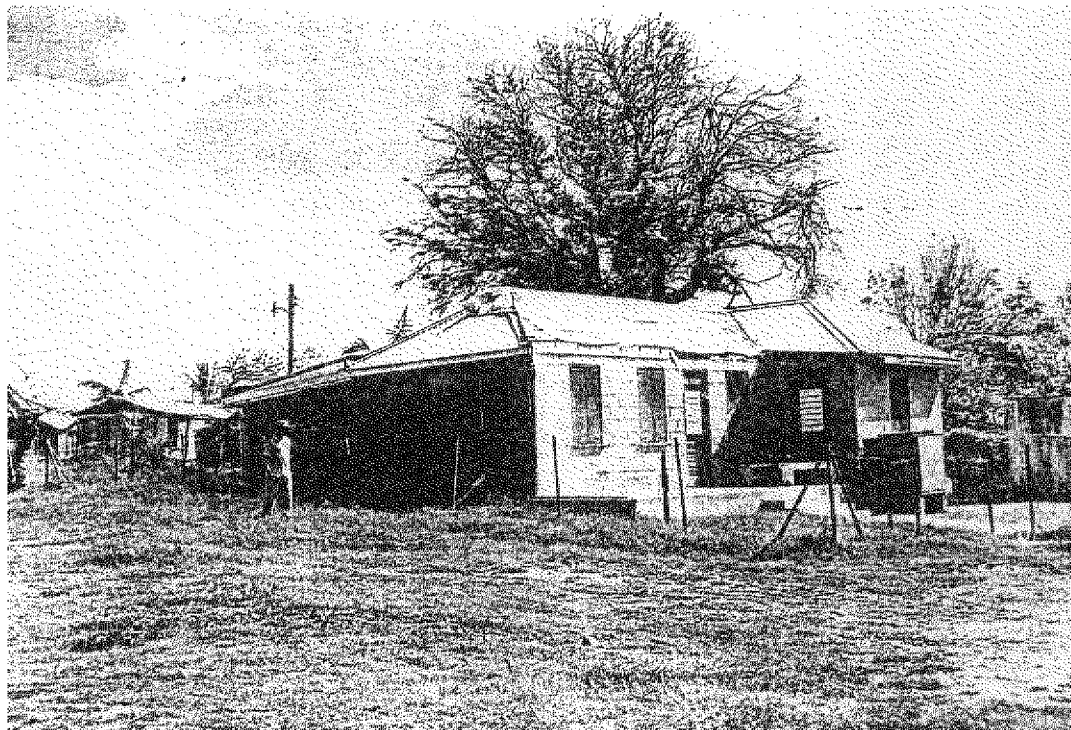
Photo C-1: Verandah roof and section of the main roof sheeting lost.

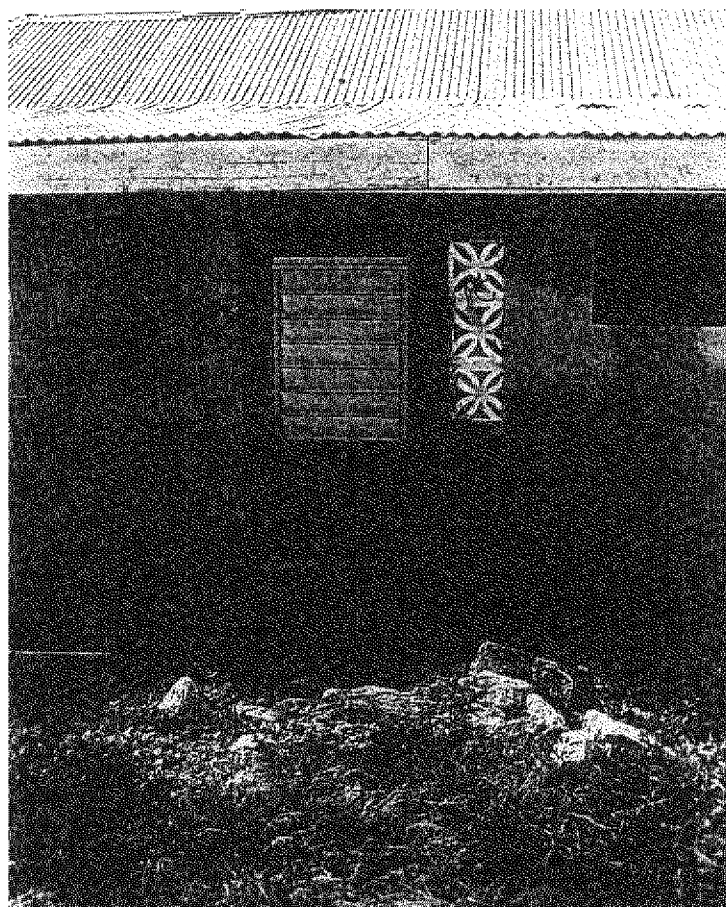
Photo C-2: Damaged rear door and grill
