3.33 John Hughes Clinic

3.33.2 Hurricane Damage

Health Services Facilities - Antigua

John Hughes Clinic

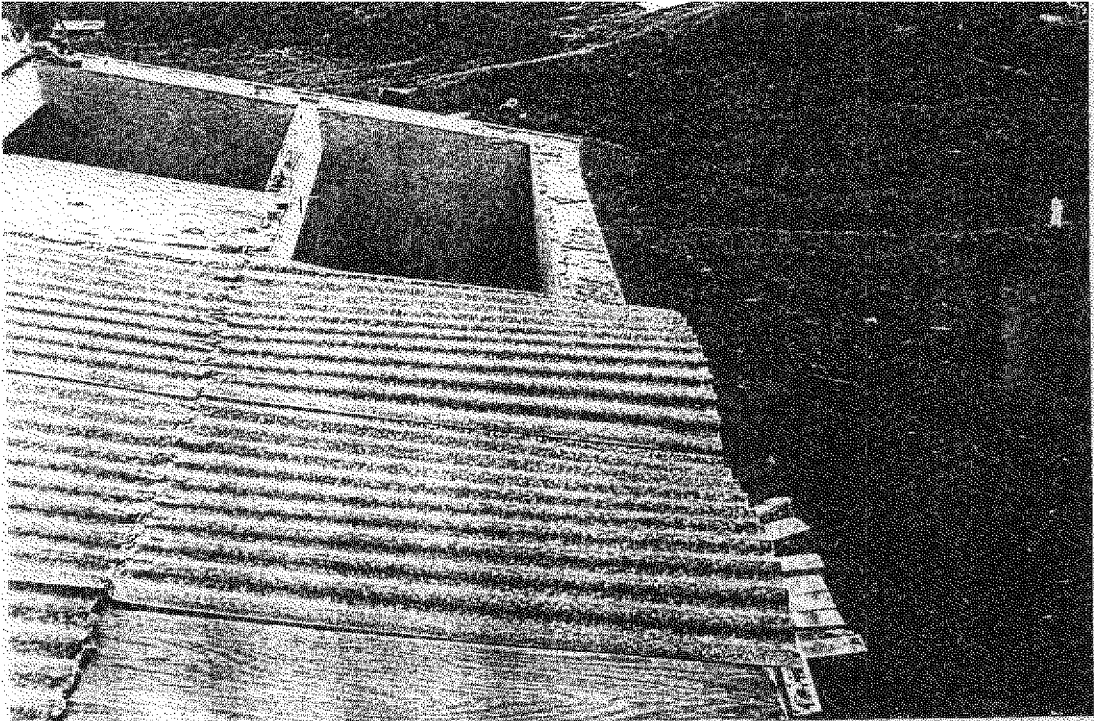
The galvanized sheets were peeled back from the edge purlin at the rear of the building. At one side of the roof, a section of the T1-11 plywood ceiling boards were sucked off by the wind. On the other side, a tree had fallen onto the roof (Photo JH-1, JH-2). The support blockwork piers to the water tank had collapsed (Photo JH-3). To the front of the building, on side of the roof to the open patio had fallen from its pipe support (Photo JH-4).

Close inspection revealed that the purlins had shown signs of termite infestation and rot where they were built into the walls. The ends of the sheets were not nailed into the edge/fascia purlin as shown in Photo JH-1. The water tank was elevated above the original 8" supports, by un-reinforced 6" blockwork which was not anchored into the original piers.

Photo JH-1: Area of sheeting and ceiling missing.
Note: No evidence of nails at end of sheets.

1. Re-build the roof and patio.
2. re-mount the water tank on new piers.
3. Cut down the tree.
4. Re-decorate the building internally.
5. Re-lay or replace the vinyl tiles that were lifted by flood water.

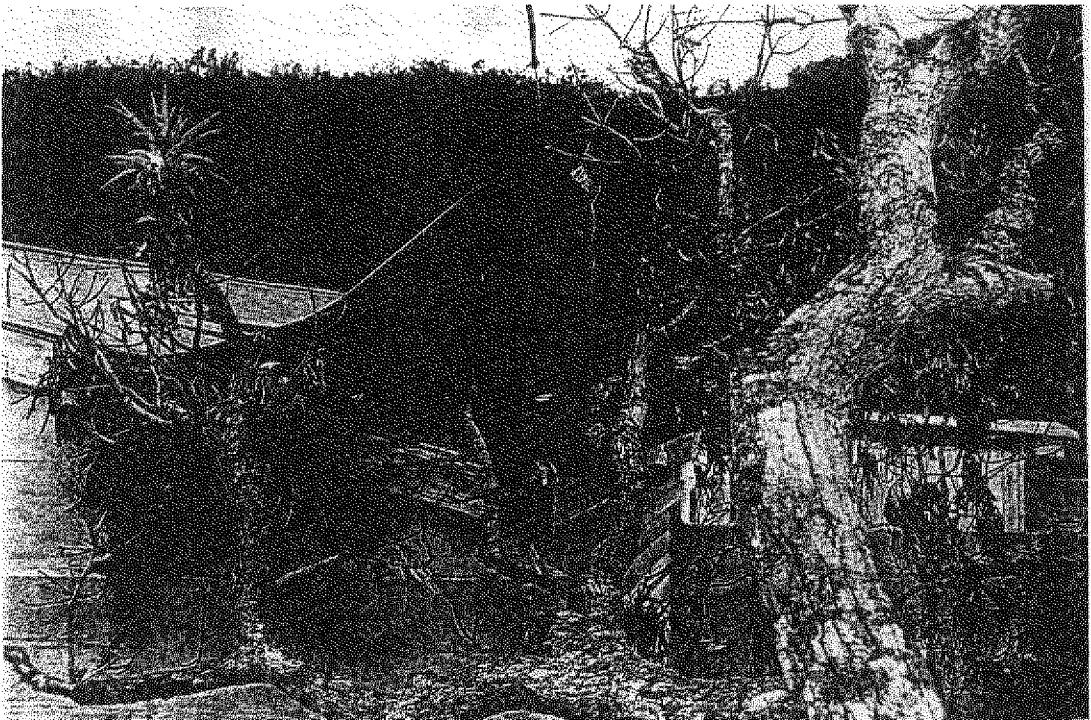
Photo JH-2: Sheets blown back and then tree fell on roof.
