3.2 Engineered Buildings

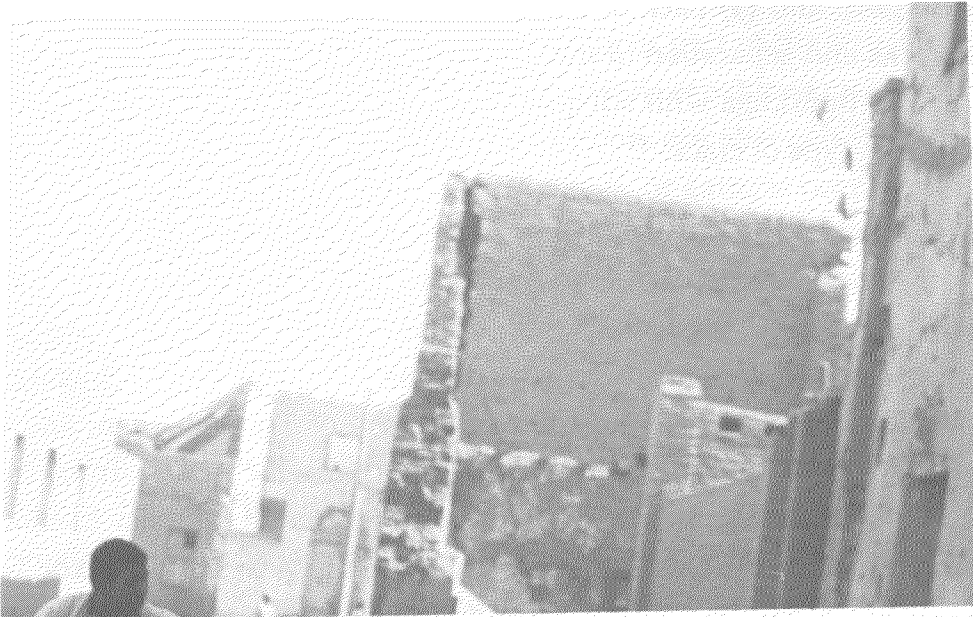
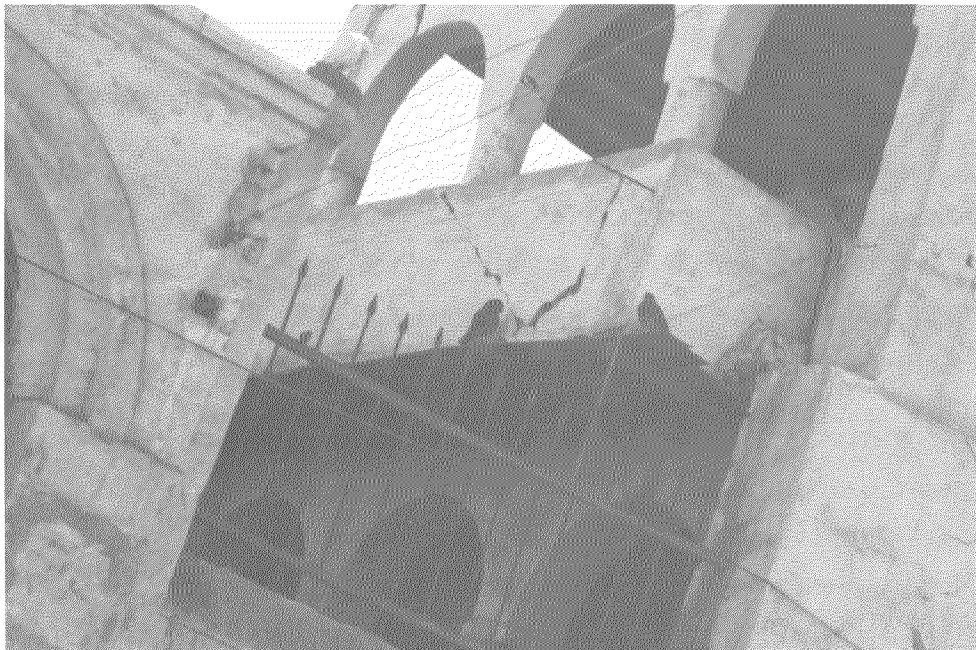
Figure 3-1b: Damage to unreinforced masonry buildings.

Damage to laterally unsupported walls and vertical cracks at wall connections due to lack of adequate anchorage.

the diaphragms, and (4) Lack of adequate anchorage between walls resulted in vertical cracks and separation in the corners at the connection between the walls (Figure 3-1b). Buildings with adequate anchorage in terms of tie-beams did not experience this type of crack.
