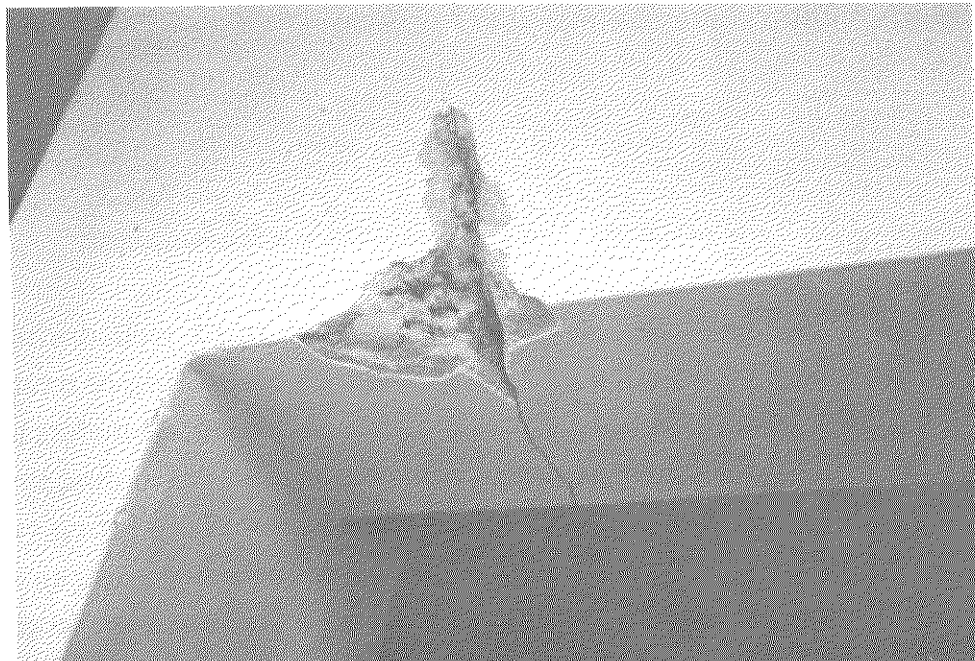
Figure 3-8: Structural damage caused by pounding.

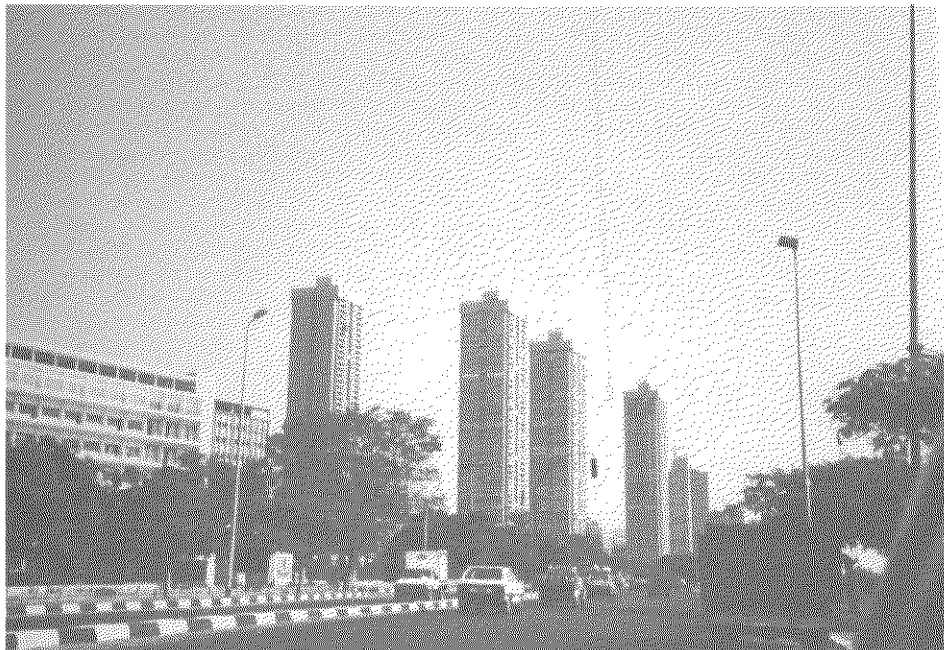
Figure 3-9: A 5-story concrete-frame hospital sustained only nonstructural damage.
