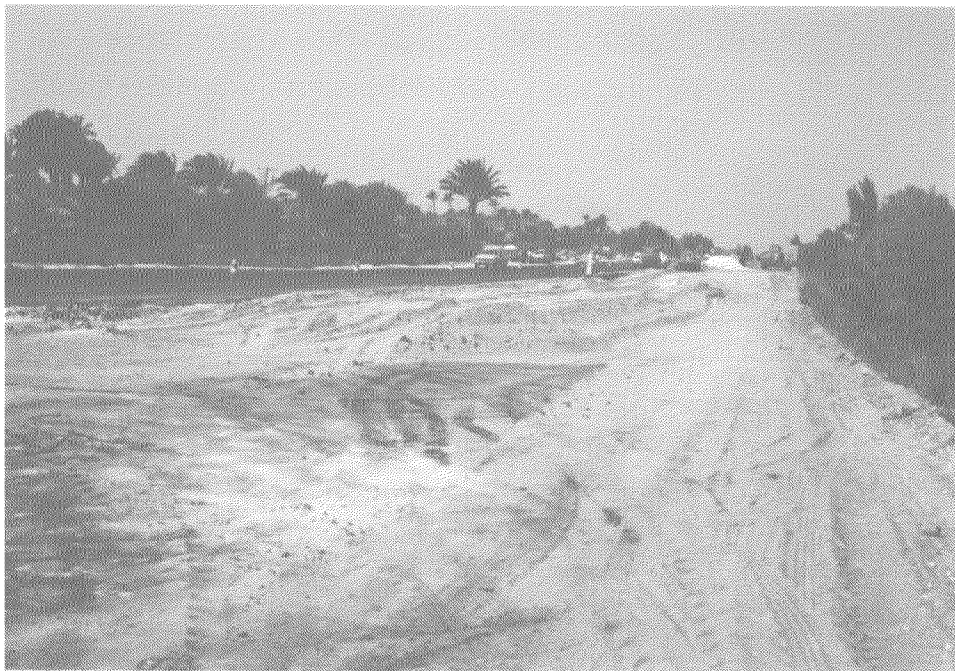
Figure 3-10: A main road between Cairo and Asiot settled about 0.5 meters due to lateral spreading.

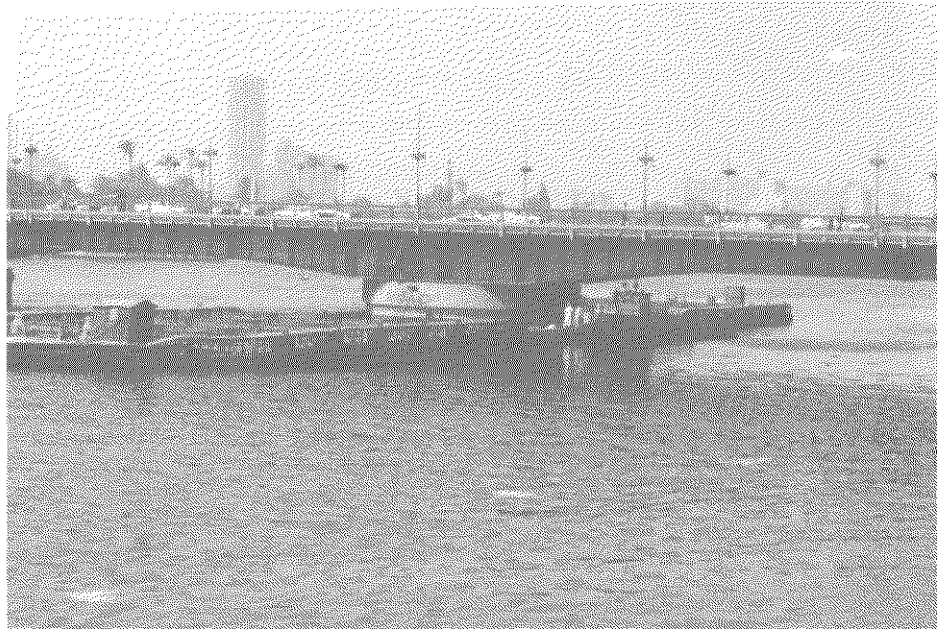
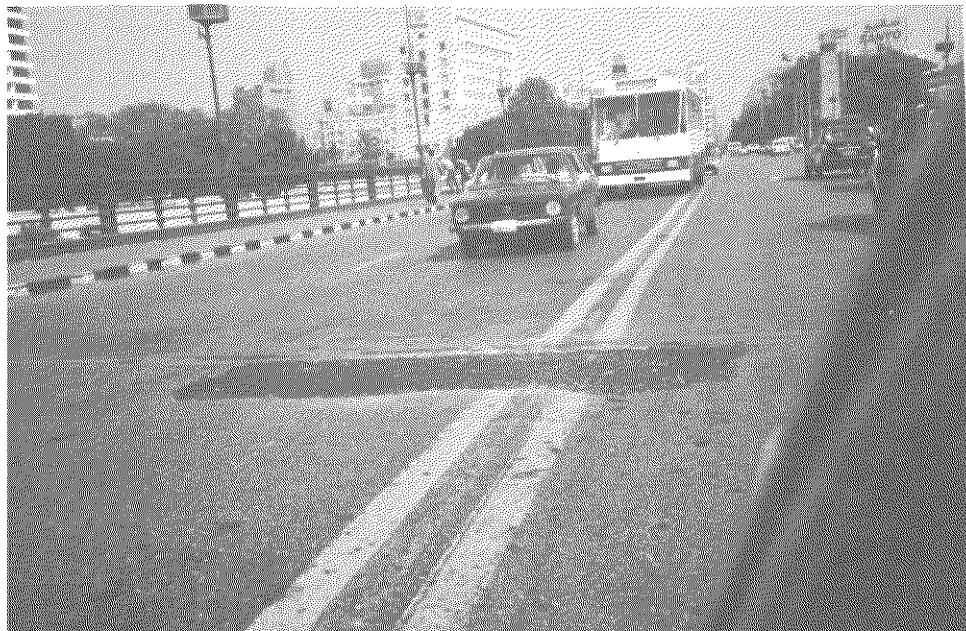
Figure 3-11: An old steel girder bridge with concrete deck lost part of the concrete deck.

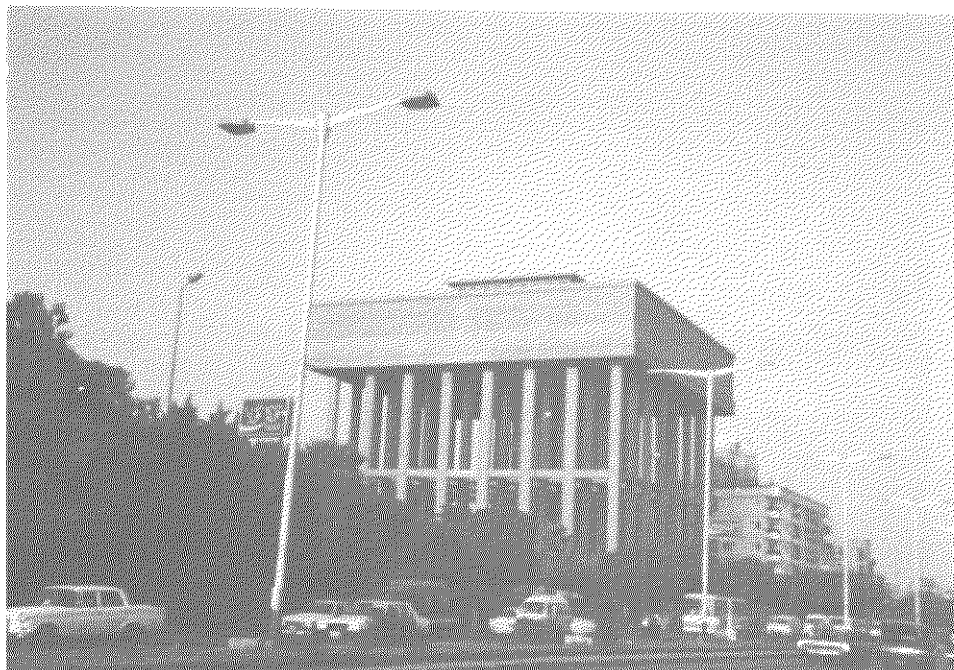
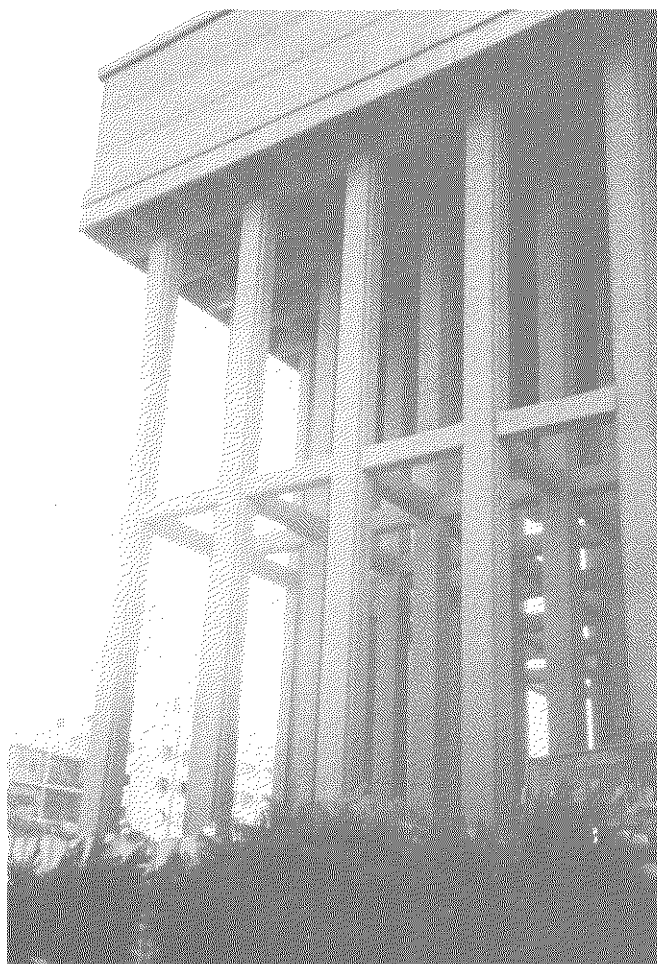
Figure 3-12: The roofing system of this elevated water tank in the City of Giza was damaged during the earthquake.
