10.1.2 Case Study 2

• *Television Studios & Offices*

10.1.3 Case Study 3

Motor Hotel (Motel) Building

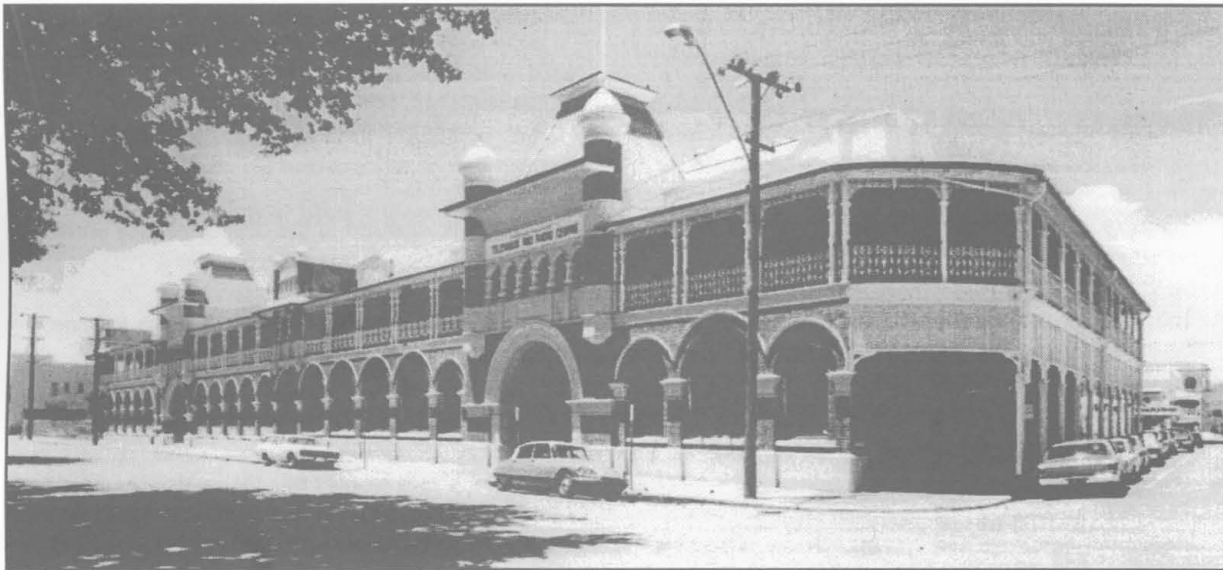
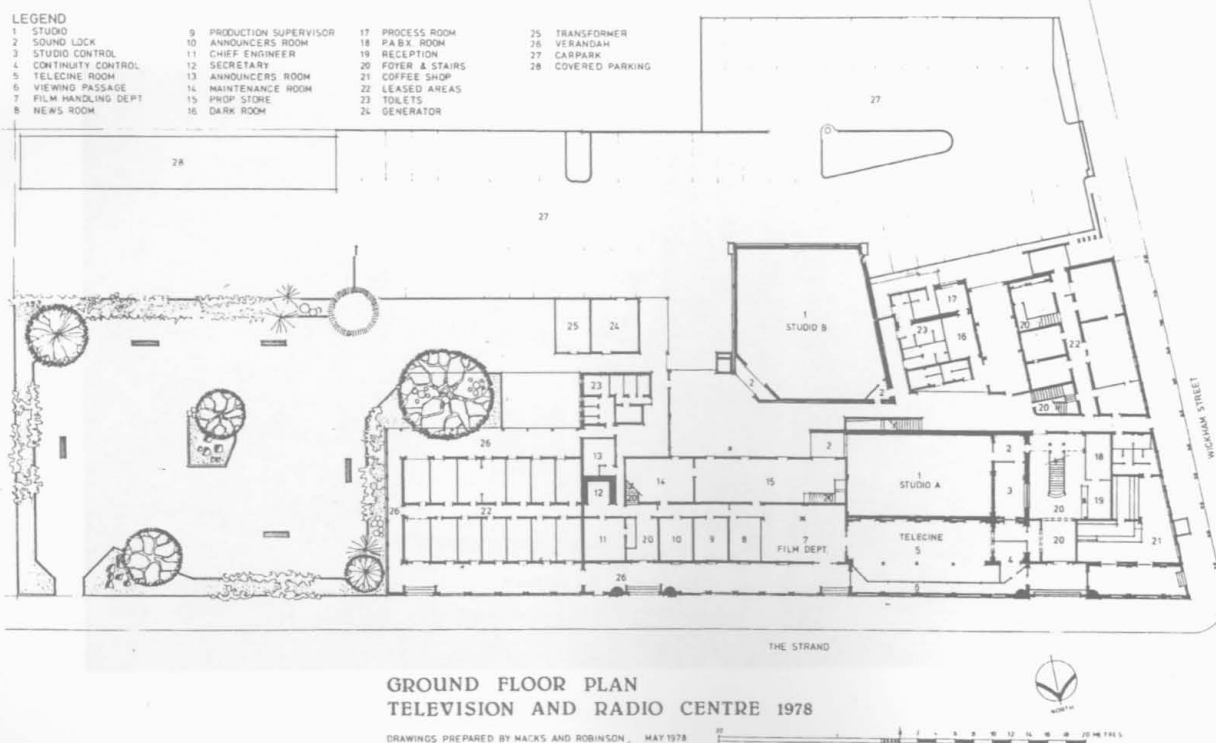
This Queen's Hotel building in Townsville, Australia, erected between 1896 & 1920, which was, in 1976 recycled to a Television Studio Complex, suffered in a 1971 cyclone (as it did also in 1903).

The historic building showed weakness in the roof truss framing, the holding down mechanism to the top bearing plates, in the stability of some of the brick walls to the top floor and in transfer of loads down to first floor level where adequate dead weight was available to counteract the uplift wind forces.

- installation of steel stiffening to the existing traditional roof trusses;
- metal strap connections from roof battens to trusses;
- new roof sheeting, installed in stages;
- special tie down details to first floor brick walls;
- the whole of the work done without interrupting the operation of the Station.

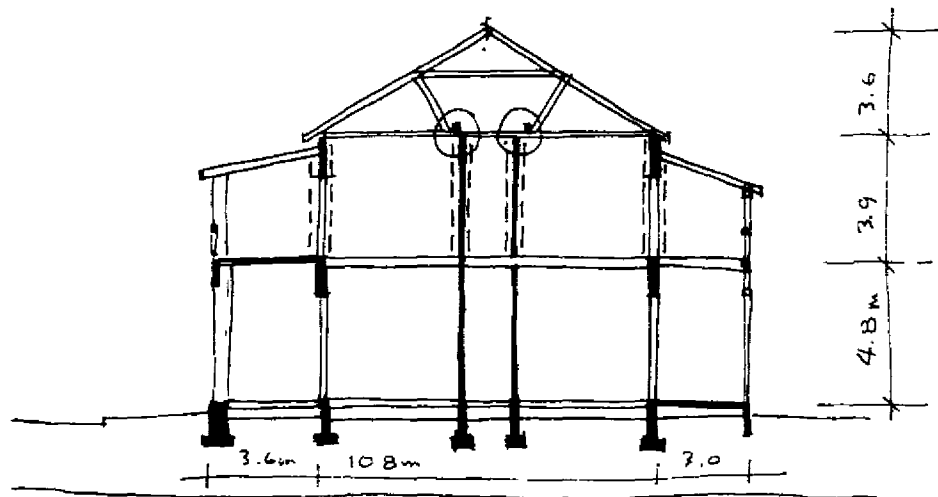
SECTION

LOCATIONS OF TIE DOWN POSTS OR STRAPS

POSITIONS OF NEW TOP PLATES (STEEL)

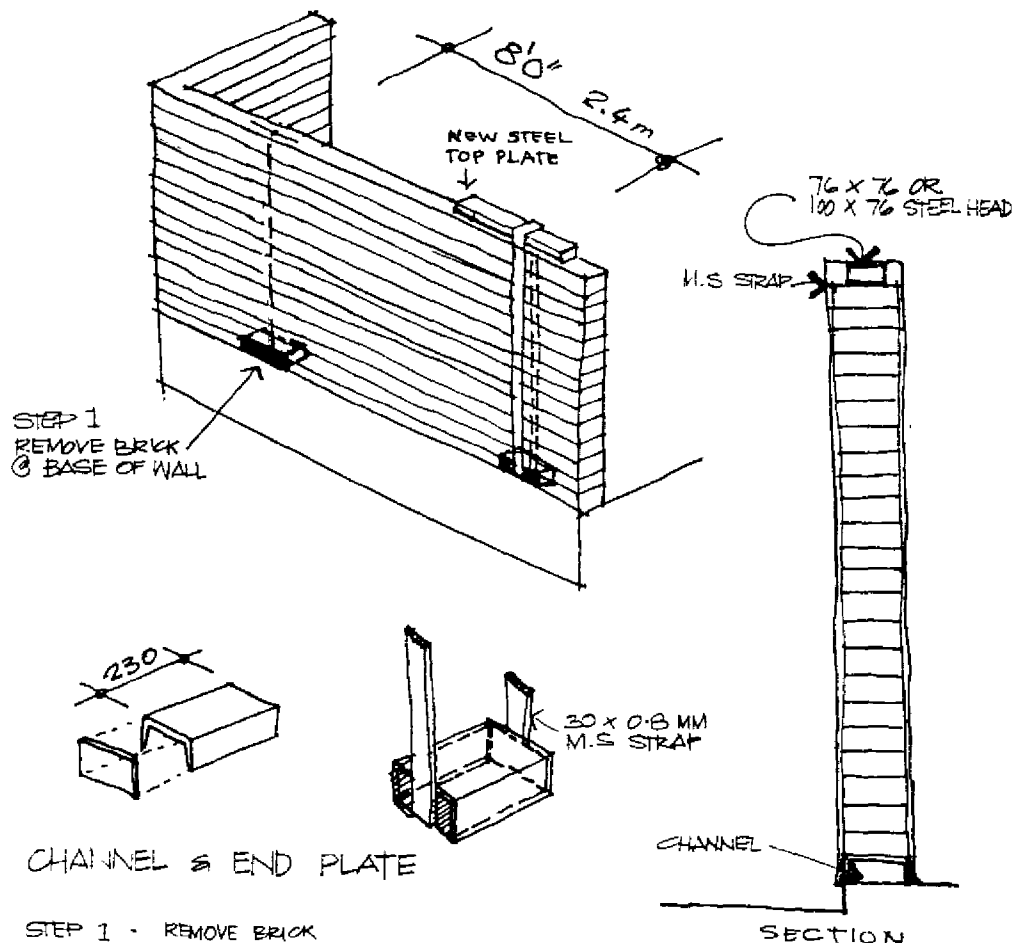
CHANNEL & END PLATE

IF WALL IS 9'0" HT (2.7M)
 AND IF STRAPS ARE FITTED @ 8'0" CENTS. (2.4M)

AREA BRICKWORK 72 SF - 1/2 SF = 56 x 90 # = 5040 #
 ALTERNATE USE 76 x 76 RHS IN LIEU OF STRAP.

- STEP 1 - REMOVE BRICK
 STEP 2 - INSERT CHANNEL SECTION
 STEP 3 - WELD ON HOLDING DOWN STRAPS

NOTE
 STRAP CAN BE CONCEALED
 BEHIND ARCHITRAVES IF
 INSTALLED BESIDE
 DOORWAYS IN HERITAGE
 BUILDINGS

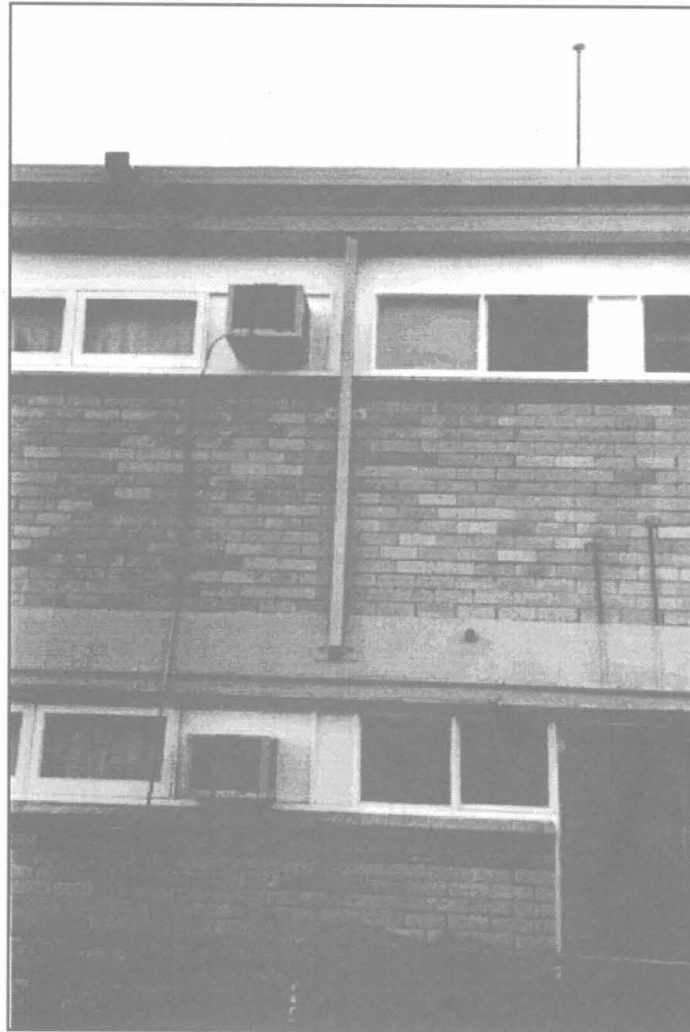
New Steel Post

The motel building illustrated lost its roof in a cyclone due to very poor connections from walls to roof.

The connections were so weak that the roof blew off cleanly early in the cyclone leaving little damage to the walls and structures which, with lesser loads to contend with, mostly survived.

They imposed at each end a steel post fixed to the concrete floor, bolted at regular centres to the existing brick walls and connected to a timber and steel framing structure in the roof which collected and transferred the wind forces to the new columns.

Fixed to Concrete Beams and to New Top Plate in New Roof Structure
