4. LIQUEFACTION IN COASTAL REGION

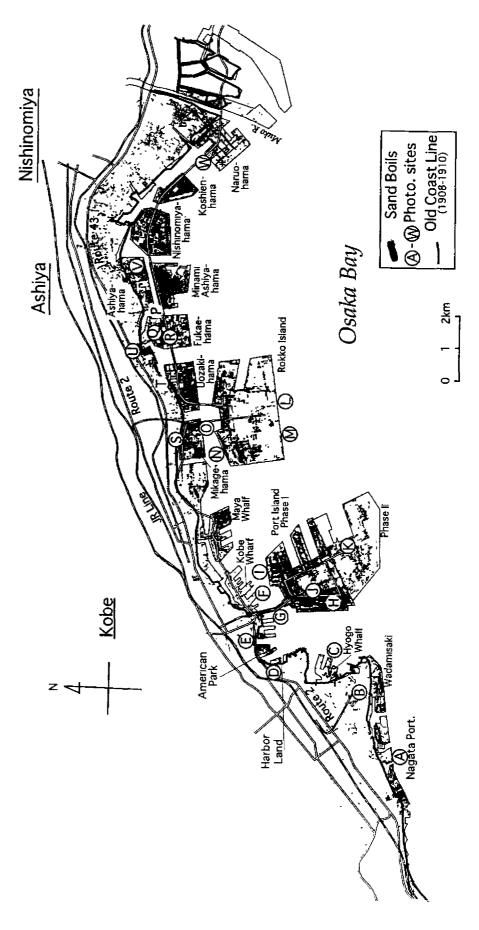
Figure 4. Zone of liquefaction in Kobe, Ashiya and Nishinomiya⁰

The results of the photographic interpretation of ground surface failures from the aerial photographs was originally plotted on 1/2,500 scale maps, and they reduced to 1/4,000 scale in Hamada et al. (1995). Figure 4 shows an outline of the liquefied areas in the entire surveyed region. In this figure, the old coastline is also shown based on the topographical maps compiled by the Geographical Survey Institute during 1,908-1,910. It was found that liquefaction concentrated in reclaimed areas, and was particularly extensive in the newly reclaimed areas. Described in the following is the overview of ground failures in the reclaimed land areas.

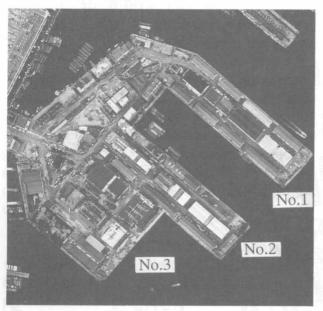
Nos. 1 and 2 Piers of Hyogo Wharf in Photo 3, north of Wadamisaki were built in 1932 and No.3 Pier was in the 1960's, respectively. Significant liquefaction effects were observed in the newer pier, whereas less effects in the older pier. Damage to quaywalls was, by contrast, severer in the older ones. Quaywalls of the Pier Nos. 1 and 2 were completely collapsed and submerged due to the ground movement toward the sea, which resulted in large separation of a warehouse near the quaywall (Photos 4 and 5).

Photo 3 Post-earthquake aerial Photograph of Hyogo Wharf

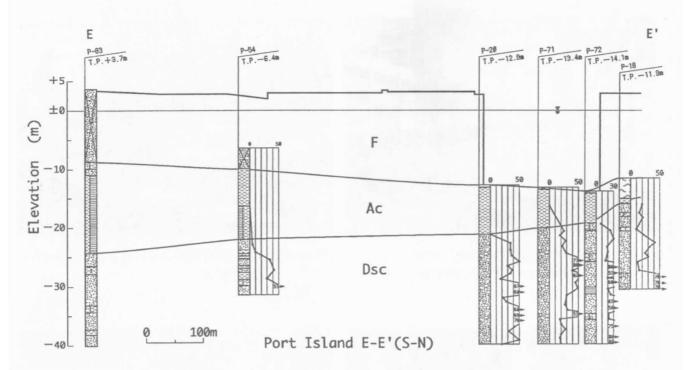
Figure 5. Soil Profile across northern part of Port Island¹⁾

Port Island is a man-made island due south of Pier No. 4. A 436 hectares area was reclaimed first from 1966-1980 using decomposed granite from the Rokko Mountains to develop a city area in addition to expanding the port facilities. From 1986-1996, the island was then extended southward by reclaiming 319 additional hectare by using mainly crushed tuff, conglomerate, sandstone and mudstone of Kobe and Osaka Groups from western Kobe. Figure 5 shows a typical soil profile across northern part of Port Island (E-E' line in Figure 6). Thickness of the fill overlying soft Holocene marine clay are from 10-25 meters for the northern half of Port Island, called Phase I, and more than 25 meter for southern half, Phase II.
